Report of the Task Force on American Iron & Metal Operations and September 14, 2023 Fire

EXECUTIVE SUMMARY

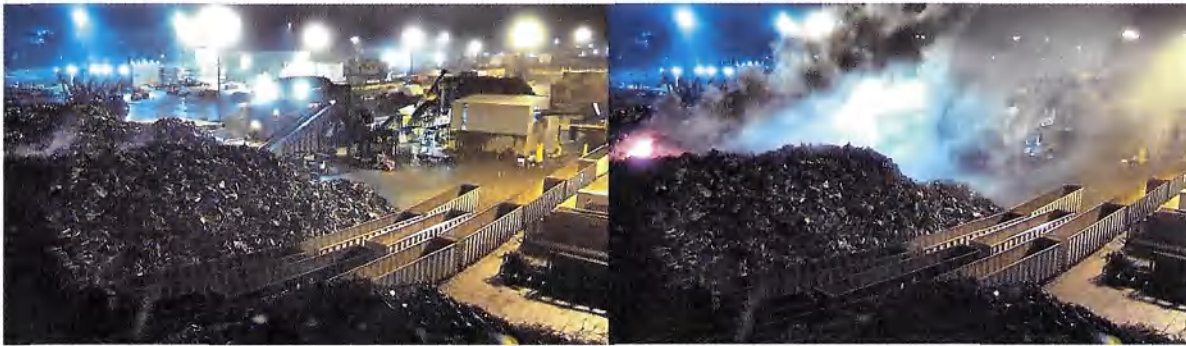
At approximately 1:18 a.m. on September 14, 2023, smoke began emanating from a pile of pre-shredded ELVs awaiting processing by the metal shredder.¹³ The pile was massive, with an estimated height of 40-50 feet; a length of more than 200 feet long; and a width of approximately 137 feet wide at its widest point. The area covered was 2,100 m², more than four basketball courts. The fire originated near the top of the pile, about 70 feet from the perimeter of the pile and more than 40 feet above the ground. Fire investigators concluded that the probable ignition source was failure of discarded rechargeable batteries.¹⁴

Thurs. Sept 14th, 1:18a.m. and 1:33a.m. – Smoke quickly progresses to major fire.

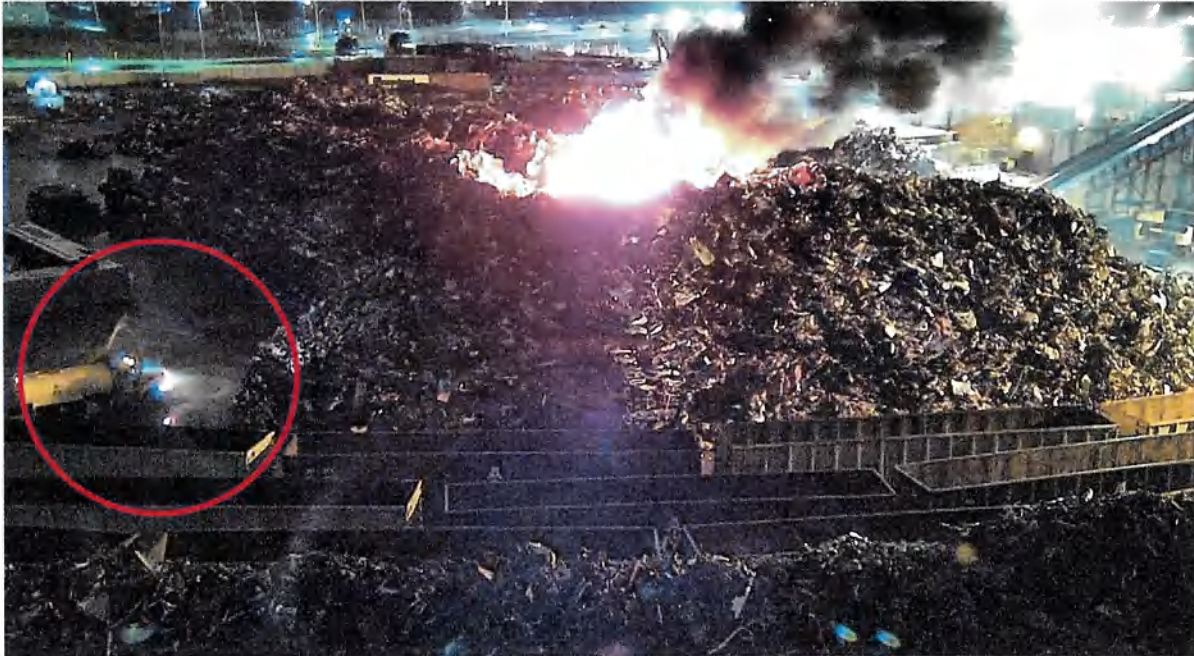
At 1:33 a.m., AIM dispatched its own water truck. An AIM employee called 911 at 1:38 a.m.¹⁵ The AIM water truck was entirely incapable of providing any effective mitigating response to the fire because of the massive size of the pre-shred pile. The water stream of the AIM truck had a reach of approximately 20 feet,¹⁶ which was not even sufficient to reach the perimeter of the pile, much less the fire:

Sept. 14th, 1:42a.m. - AIM water truck ineffective at reaching flames.

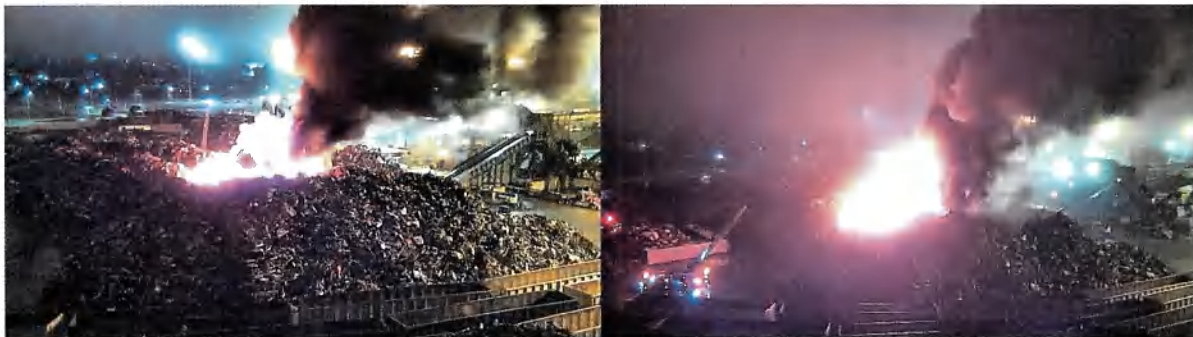
Thurs. Sept 14th, 2:04a.m. and 2:34a.m. - 30 minutes of SJFD firefighting activity from fire ladder as flames worsen.

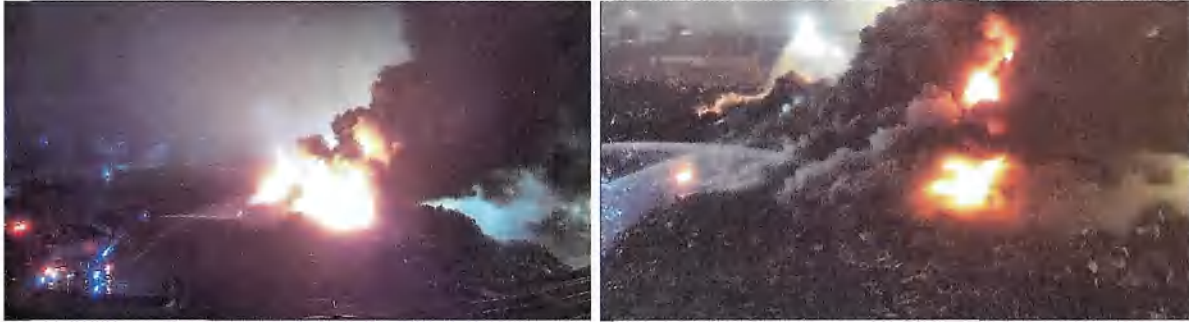
Because the AIM fire hydrants on site were only sufficient to support three firetrucks, subsequent firetrucks connected to City of Saint John hydrants in the nearby residential area. By 3:00 a.m., the situation was worsening and the SJFD was advised that it would not be able to continue to draw water at its current rate without depleting the water supply of the City's west side to critical levels. Emergency responders began identifying a plan for an alternate water source.

**Sept. 14th, approx. 2:50a.m. :
Fire grows uncontrollably despite efforts of 2 ladder trucks and 1 ground line**

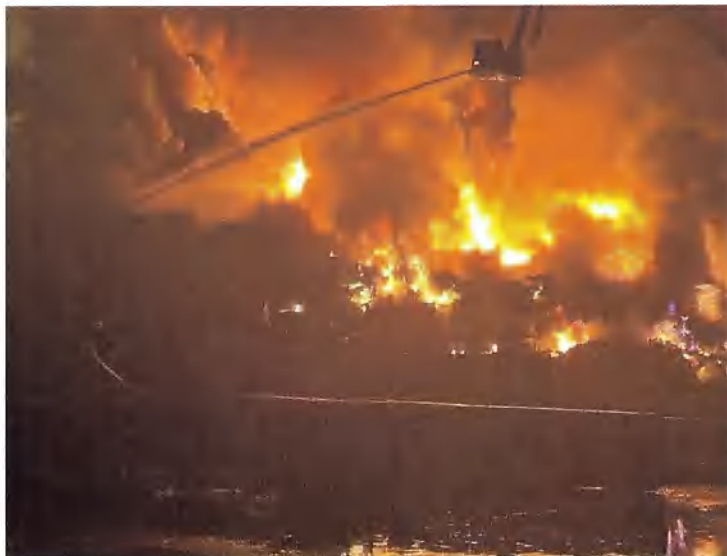
By 4:35 a.m., an effective alternate water source was urgently being sought and the blaze was completely out of control. The size and location of the pile made it extremely difficult to effectively position firefighting resources to fight the fire. Black smoke and dense fog severely reduced visibility. Explosions and flying projectiles from the fire pile made it increasingly unsafe for firefighters, requiring equipment to be pulled back from the perimeter. While emergency responders on scene were advised to wear breathing apparatuses for their own health and safety, it was impractical for firefighters to wear self-contained breathing apparatuses for the entire duration of the fire. The SJFD was and is simply not equipped or resourced to combat a dangerous industrial fire of this size and scale at such a site.

Thurs., Sept. 14th, 4:35a.m. - Fire burns at AIM Site.

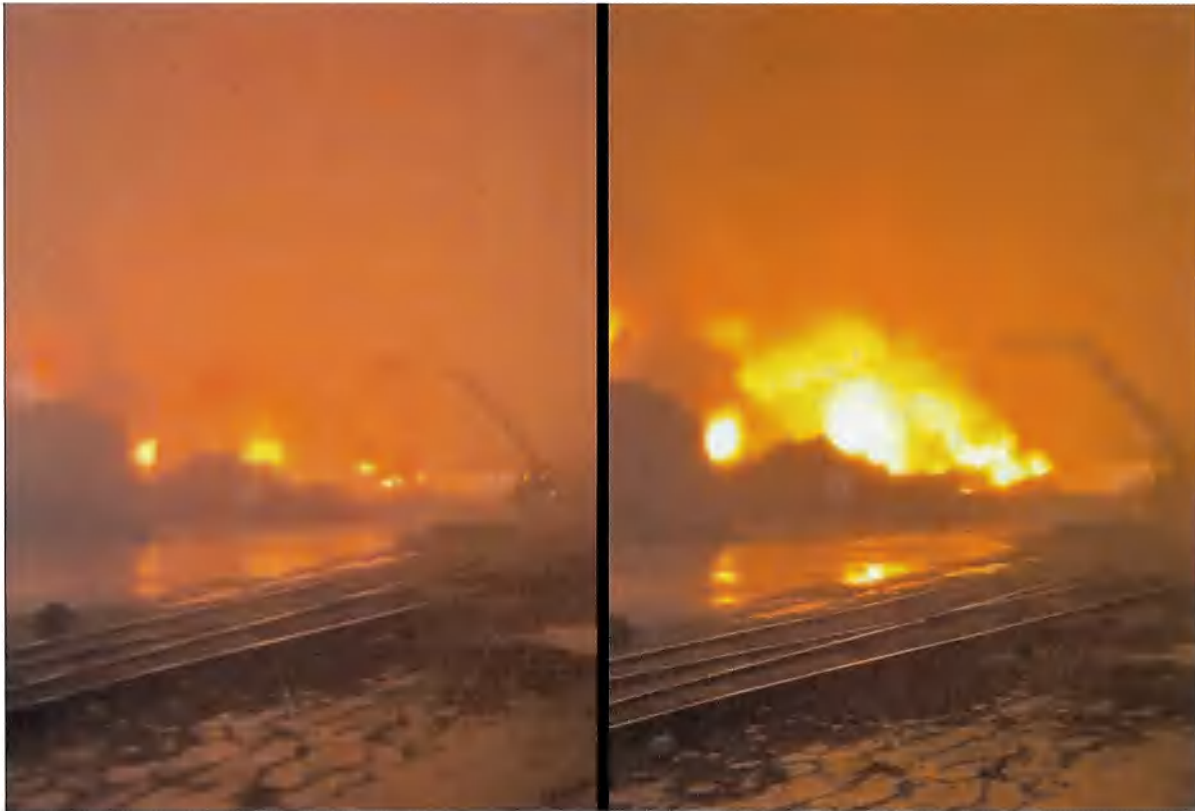
Thurs. Sept. 14th, 6:14a.m. - Moments before and after explosion occurs on AIM Site as SJFD work to combat the fire.

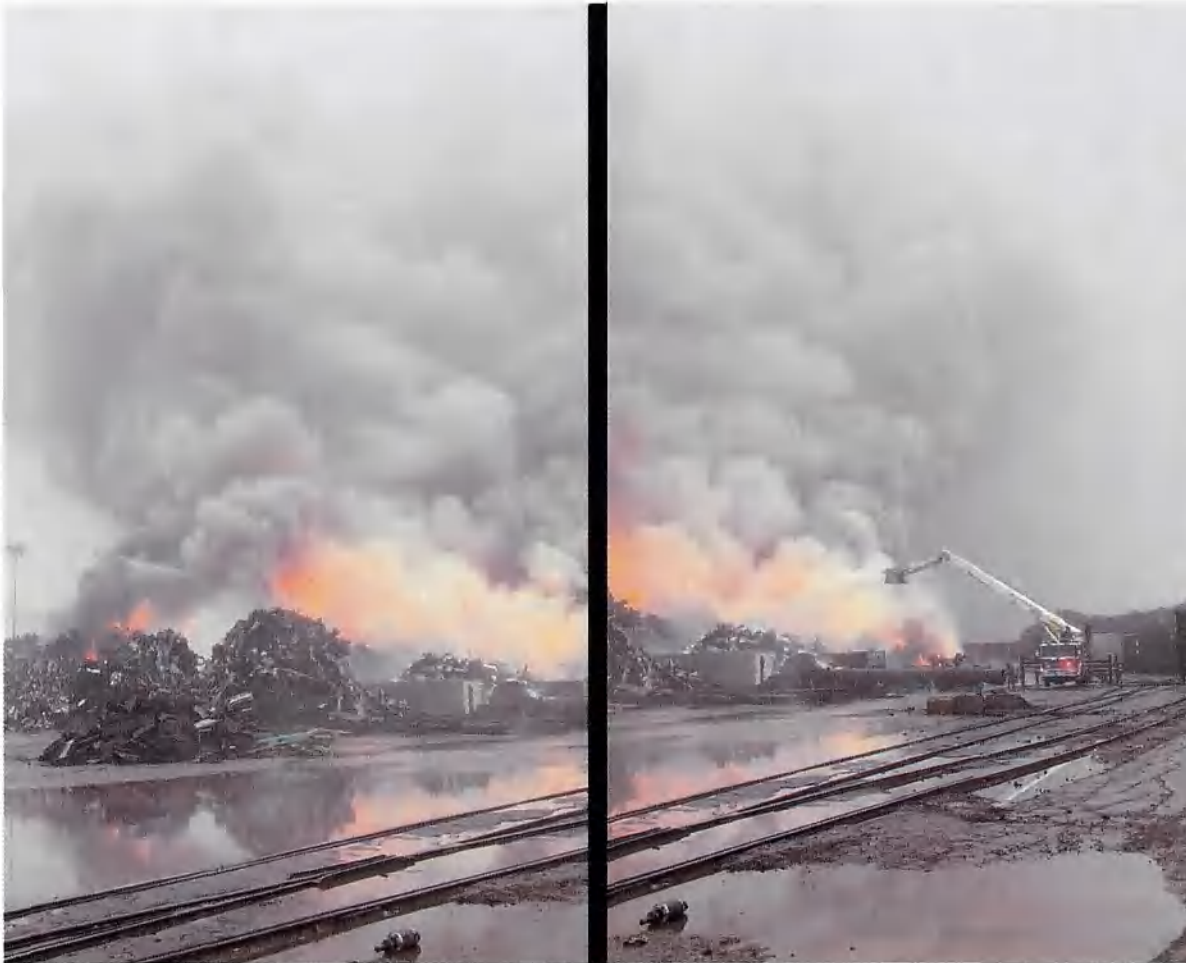
Thurs, Sept. 14th, 7:43a.m. - SJFD works to combat fire at AIM Site.

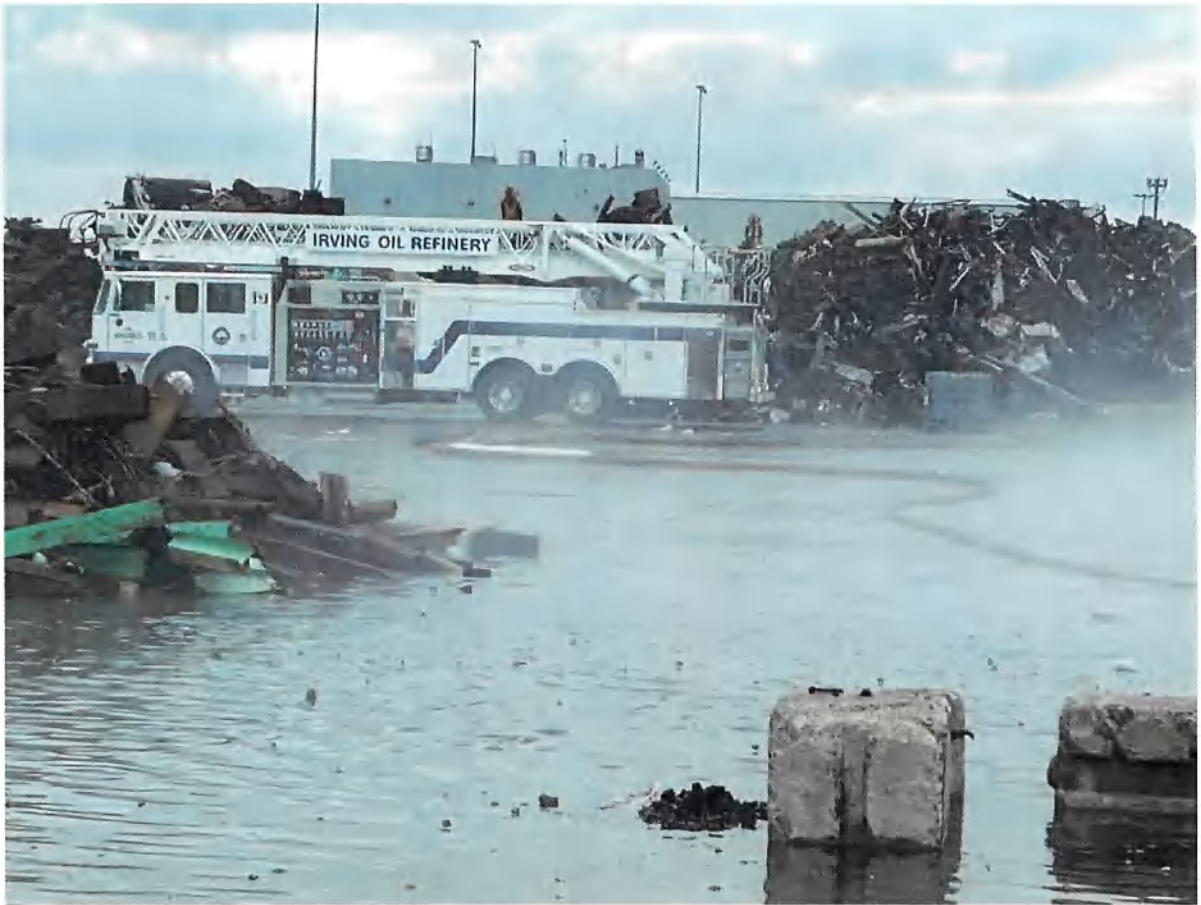
Thurs., Sept. 14th, 2:39p.m. - Irving Oil on AIM Site providing assistance to SJFD.

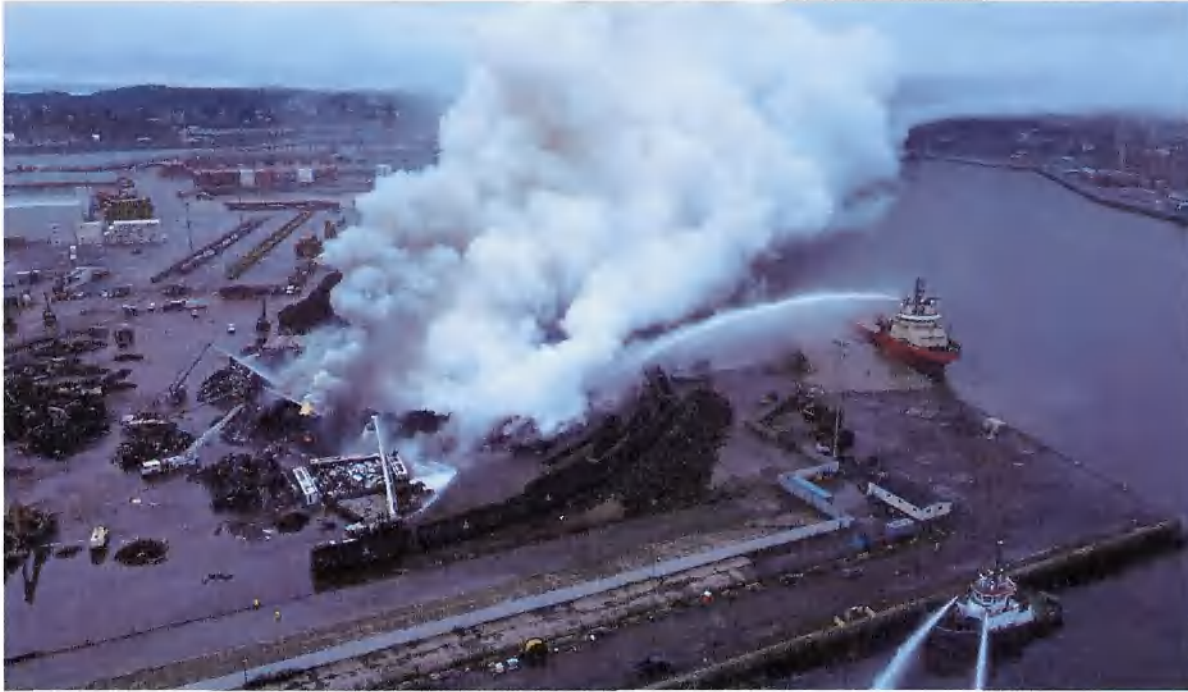
Sept. 14th, approx. 1:06p.m. - Efforts to fight the AIM Site fire include three SJFD trucks, other SJFD equipment, an Irving Oil truck, the Atlantic Osprey, and the Spitfire III.

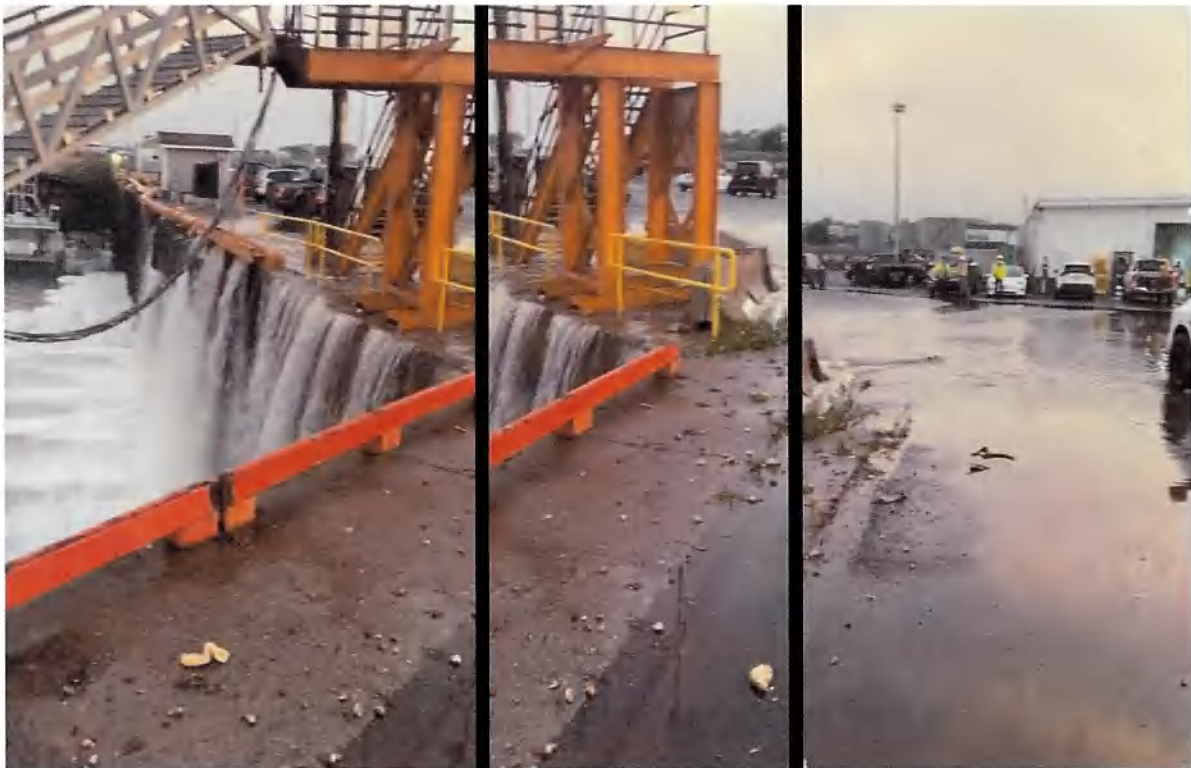
The presence of the Osprey averted massive disaster. After having burned unabated for approximately 12 hours, progress was finally being made in battling the blaze. The volume of water delivered by the Osprey was extraordinary, causing the area to flood to knee deep levels. The water volume overwhelmed the stormceptor system and began flowing over into the harbour, while debris from the site migrated to nearby properties.

22 million gallons used to combat fire at AIM Site running into harbour.

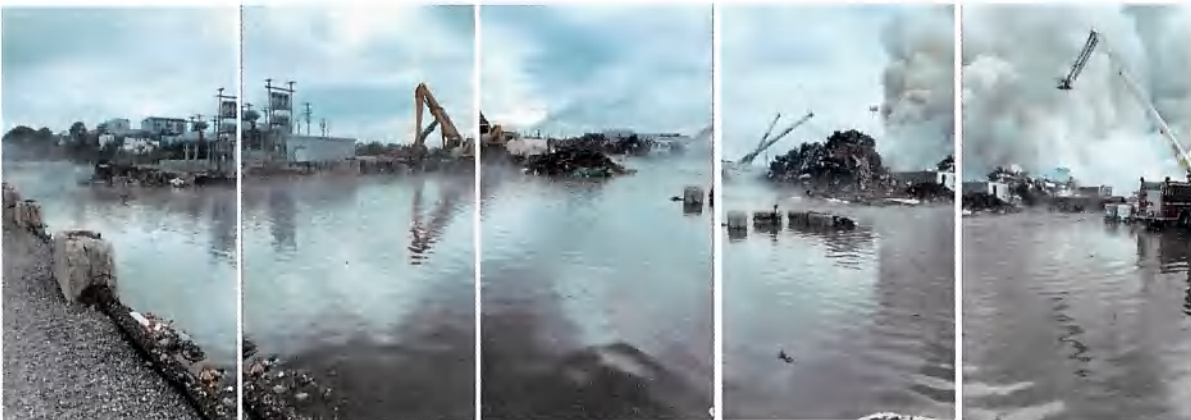
The surrounding area flooded, with floating propane tanks, a gas tank and other hazardous debris from the site littering the area.

Thurs., Sept 14th, 2:41p.m. - 22M gallons of standing water at AIM site destined to run into harbour.

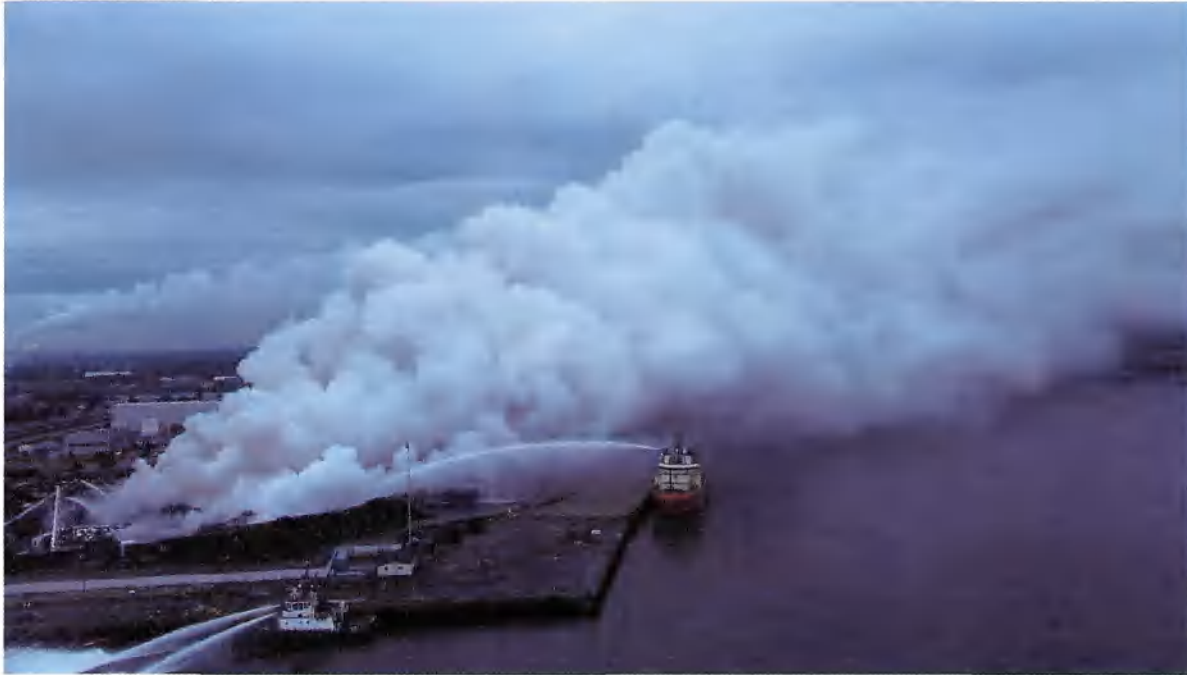
The Osprey delivered a steady stream of water to the heart of the fire until 4:31p.m. At that juncture, the intensity of smoke, ash and soot gave rise to concerns for the health and safety of the Osprey crew, requiring the Osprey to temporarily disengage.

Sept. 14th, approx. 1:06p.m. - Dense smoke from AIM fire flows into city center.

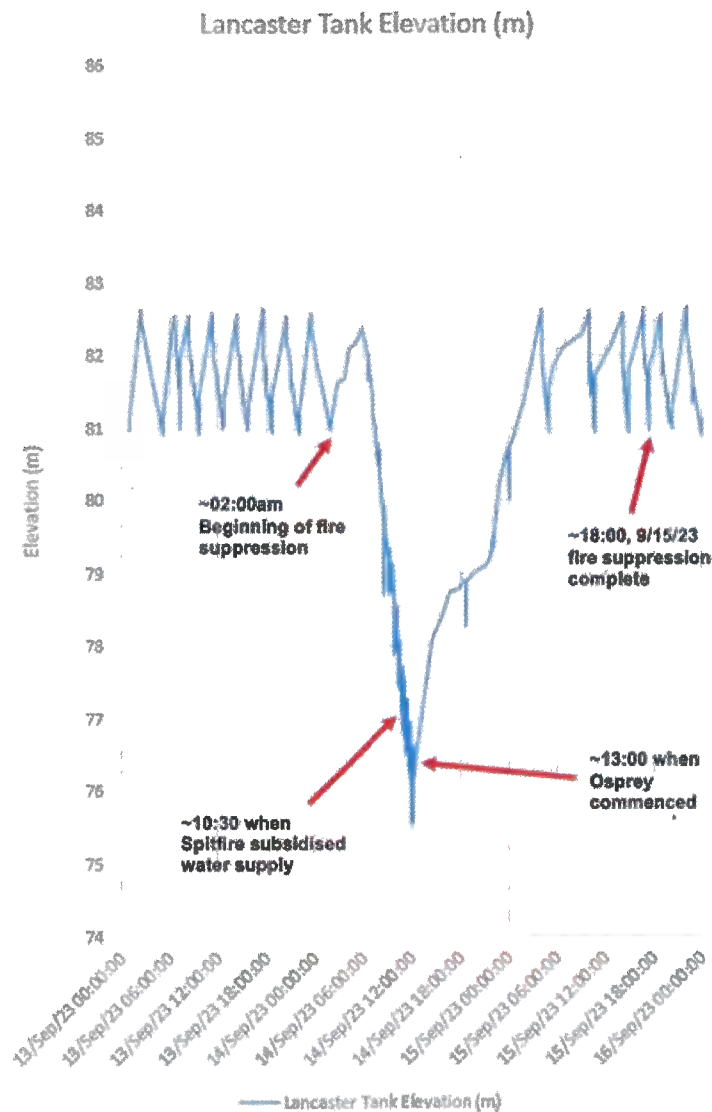
Figure 7 in the Arcon report,⁴⁷ copied below, shows the beginning of the firefighting efforts and the substantial dip in the reservoir levels as the firefighting efforts continued. The draw down in the reservoir was only alleviated as a direct result of the Osprey's assistance.

Arcon determined that the Lancaster reservoir was drained of almost half its capacity during the first 6 hours of firefighting efforts, and could not have been maintained for more than an additional six hours without critically affecting the water supply to the West Side of Saint John.⁴⁸

Arcon concluded that the likelihood of future fire events at the AIM facility is high.⁵⁰ Given that the size of pre-shred piles exceeds engineering recommendations and that the capacity of the existing water service of the City of Saint John is insufficient to combat a similar fire in the future, Arcon concluded that it would be necessary to substantially reduce the size of the scrap piles and the amount of combustible material contained in a pile, and to substantially increase the available supply of water⁵¹ for fire suppression purposes.

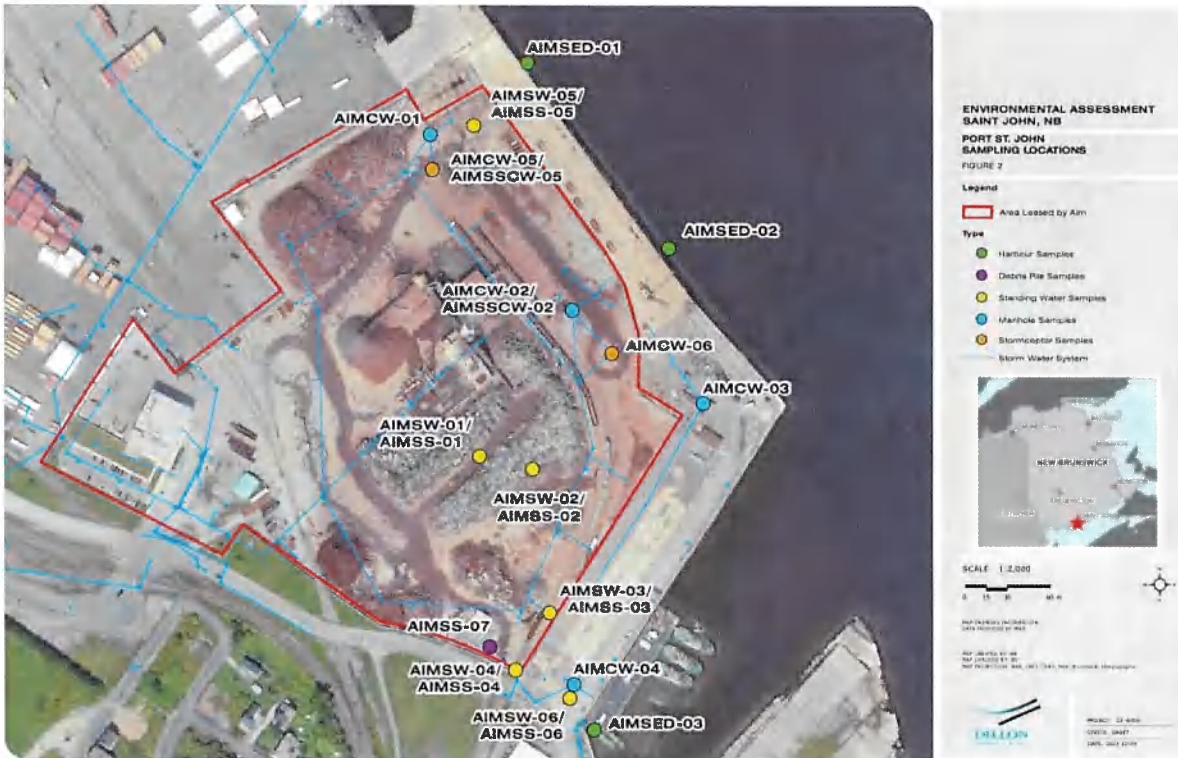
Dillon tested soils, surface water and in catch basins and stormceptors at the AIM site for contaminants. Figure 2 shows the Sampling Locations.⁵⁴

Testing was completed for various metals that can be harmful to human health and found metals present at levels which exceed human health criteria by up to 18 times the allowable levels, and ecological health criteria by up to over 1,890 times allowable levels. Examples of excess metal contaminants are set out below:

- Concludes the site contains environmental contaminants, some of which pose risks to both human and likely ecological health.⁶²
- Recommends that an environmental site assessment be completed and remediation take place.⁶³
