Appendix L

Photo Appendix of Existing WwTF

Photography of Existing WwTF

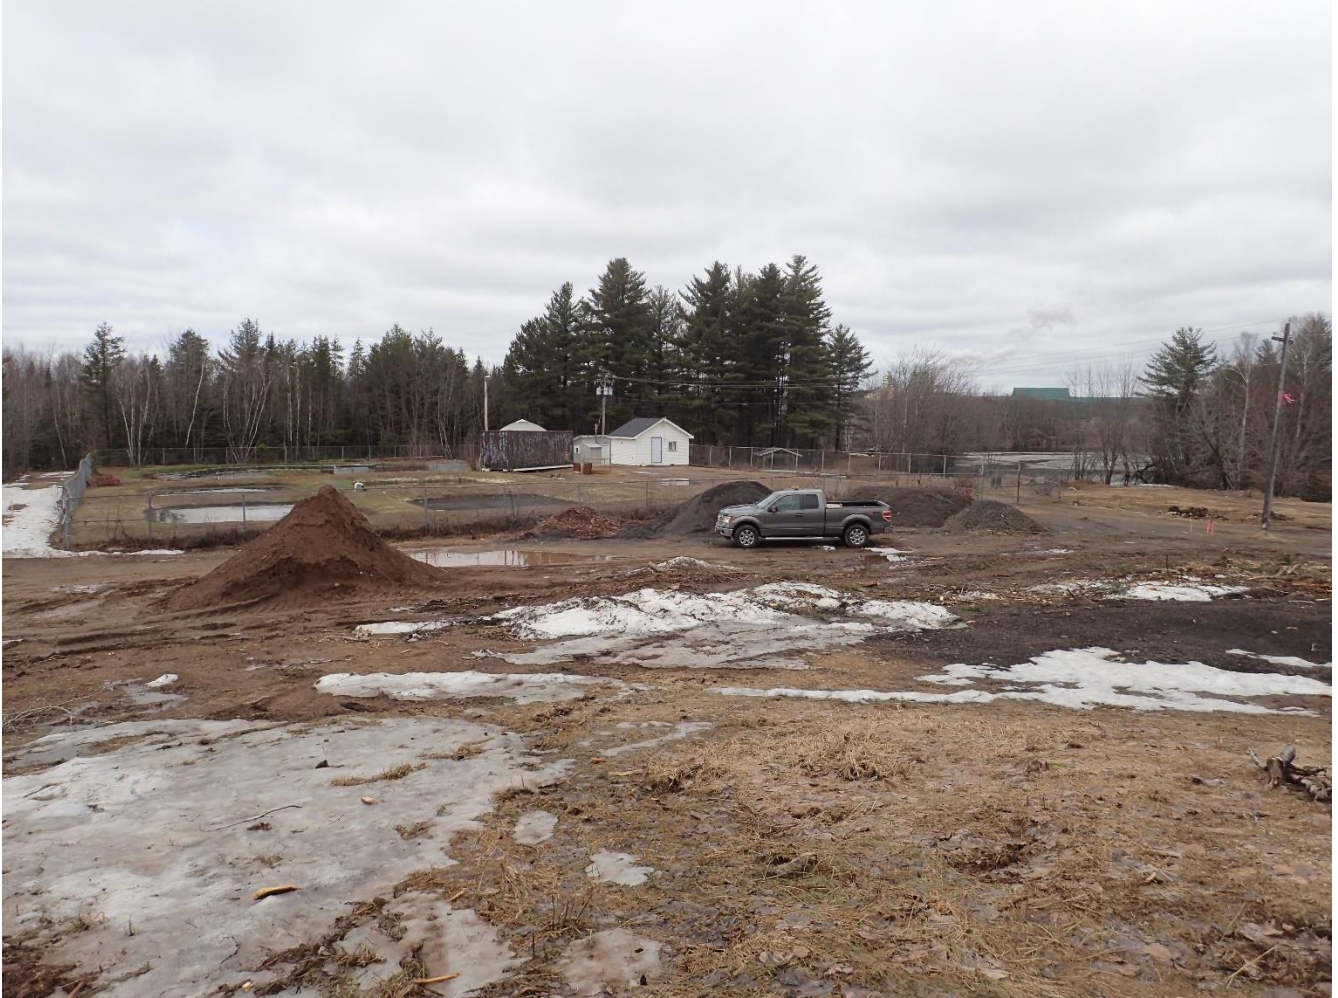
Figure 9 - Photo of Existing WwTF

Photo of existing WwTF from the south looking north with Henderson Brook and Grand Lake Timber visible in the background. The current sludge drying beds are visible in the foreground along with the office/lab. From the right of the phot you can see the 3-phase power line entering the site.

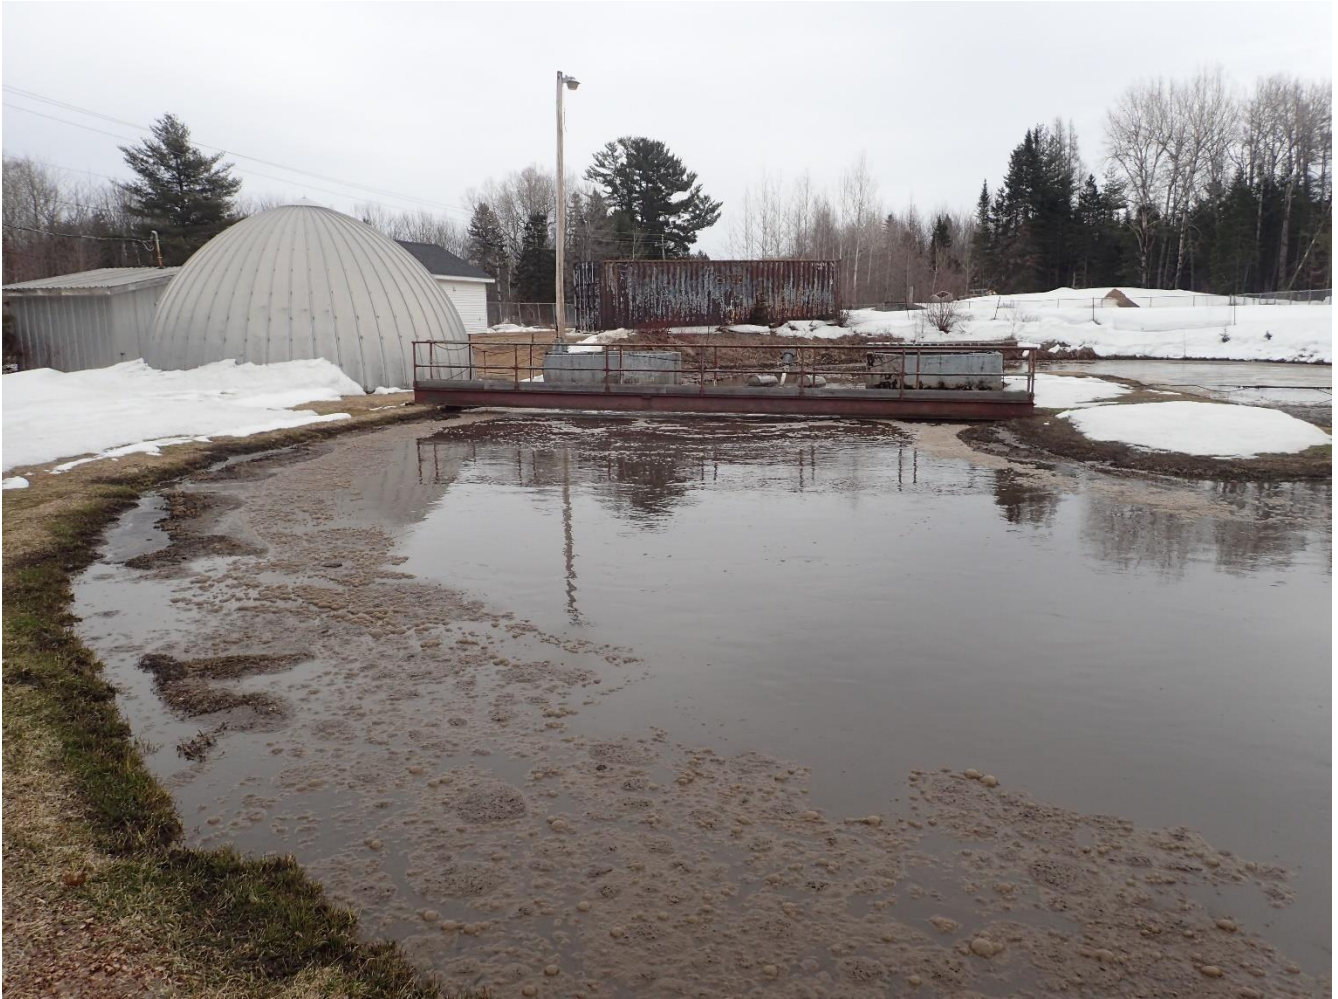
Figure 10 - Current WwTF from western edge end of ditch

The current WwTF from the western end of the oxidation ditch looking to the east. Structures visible from left to right are the building above the chlorination hold, the clarifier dome, the office/lab and the gangway to cross the oxidation ditch to access the center island. Behind the gangway are concrete structures previously used to mount paddlewheels used to create the driving current around the ditch.

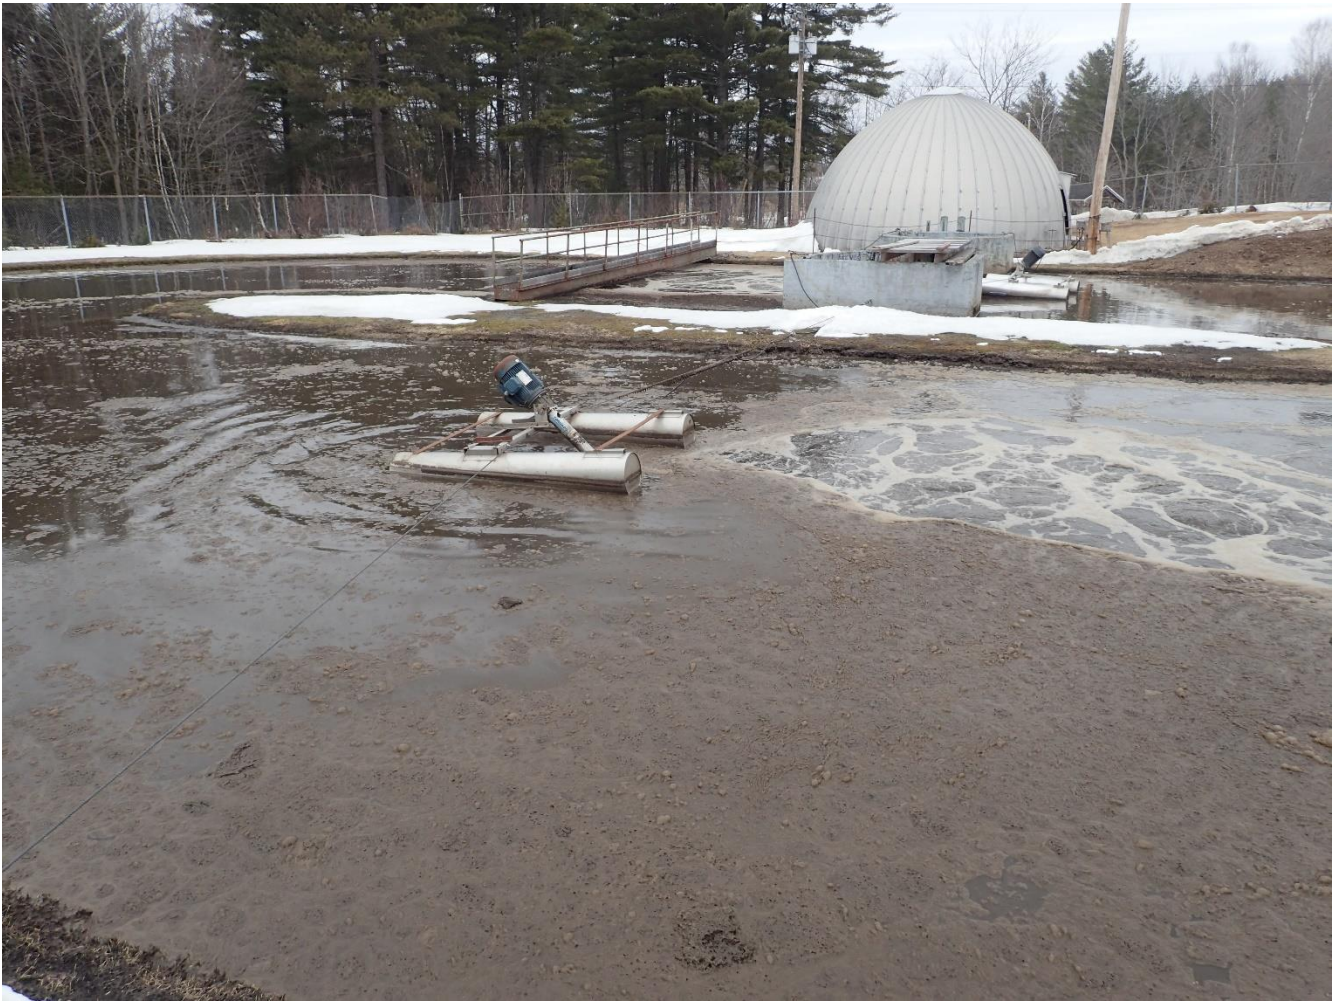
Figure 11 - Looking north from the oxidation ditch

Looking north towards Henderson Brook. The clarifier dome is shown along with the concrete structures used to mount the paddle wheel in the original design. The pontoon mounted aerators are visible between those concrete structures and the second is shown in the middle of the photo.

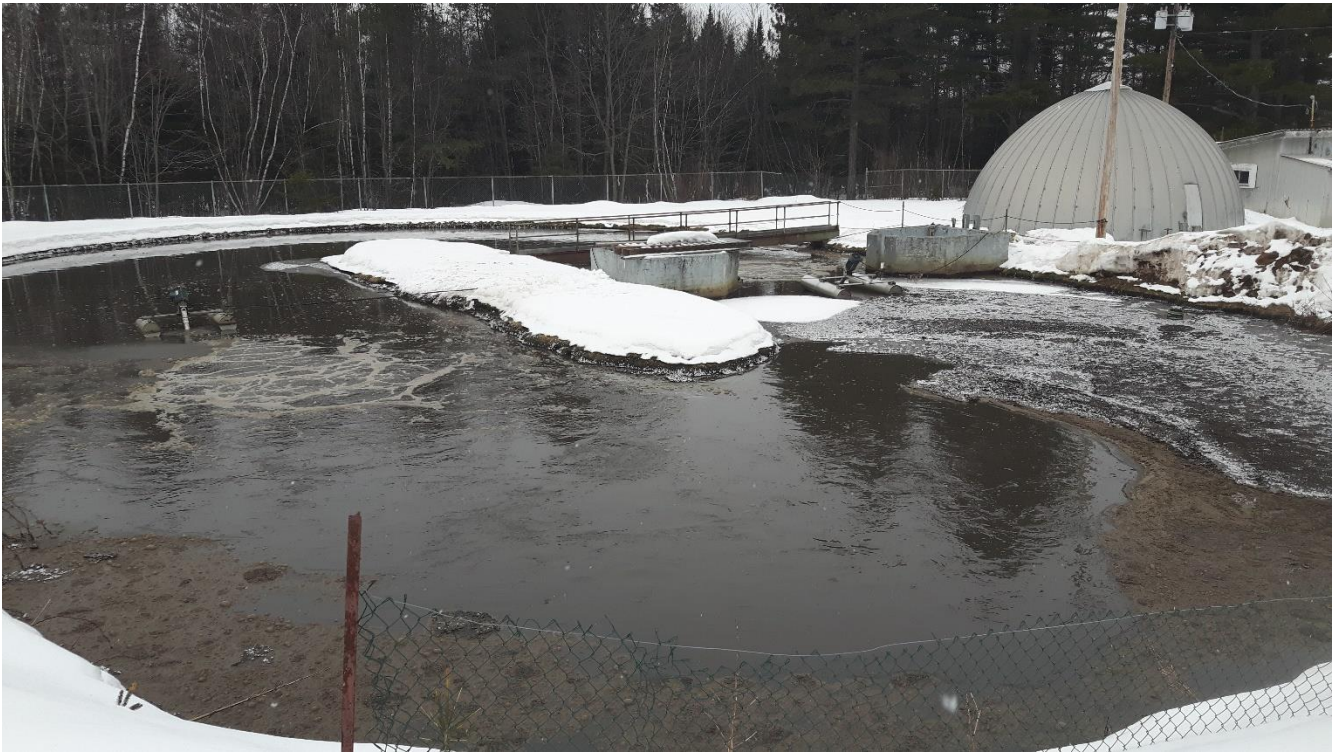
Figure 12 - Oxidation ditch

A view from the eastern edge of the oxidation ditch, looking towards the unused concrete structures and the clarifier dome.

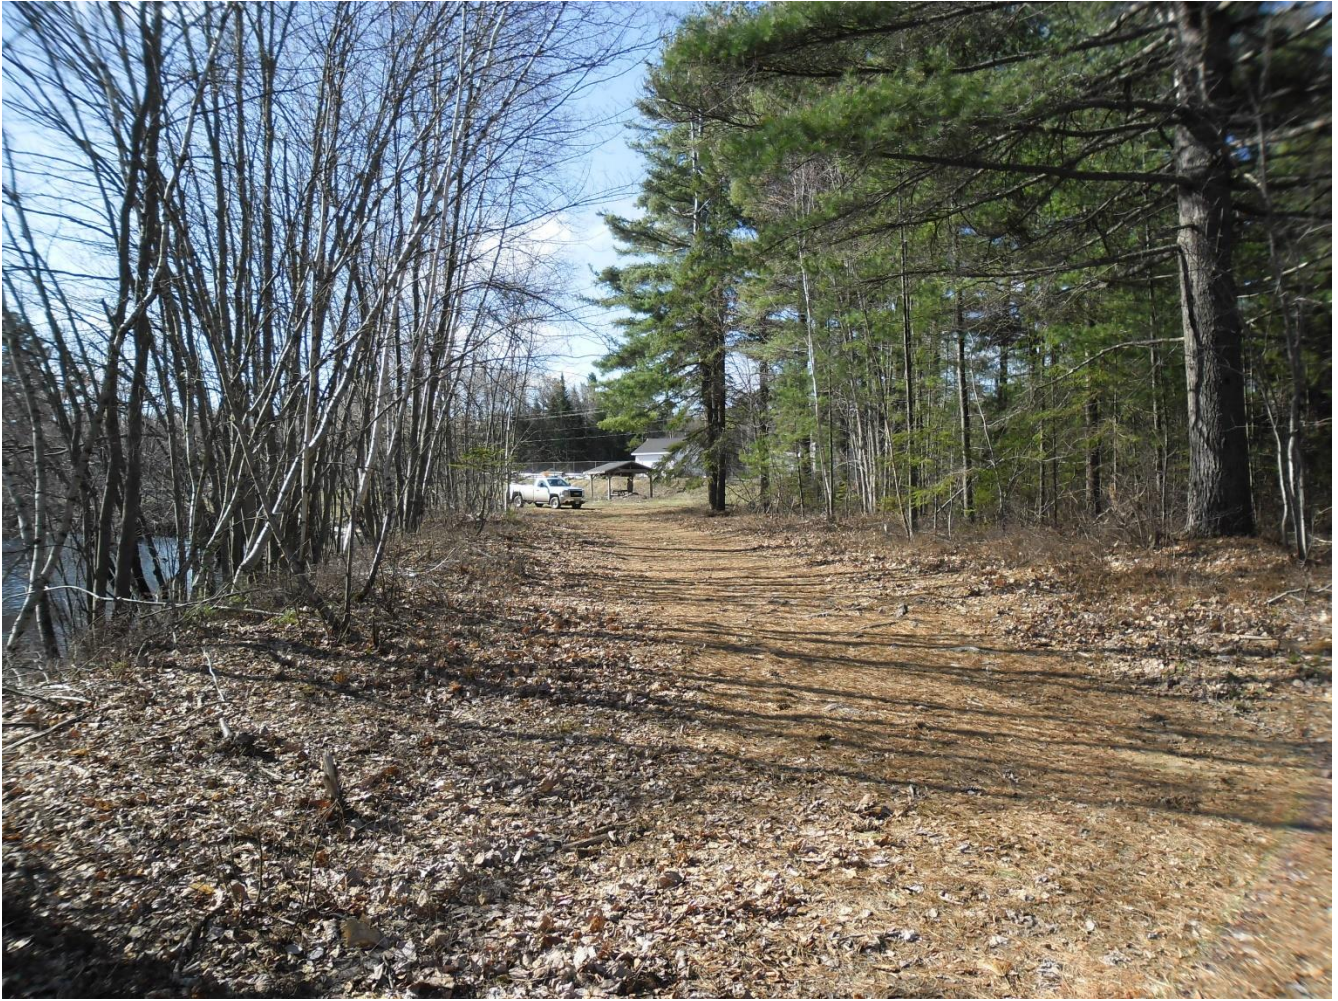
Figure 13 - Looking up the current outfall alignment

Looking up the current outfall alignment towards the current wastewater treatment facility. The Chipman Garden Club picnic structure is visible in the center of the photo with the WwTF lab/office behind.

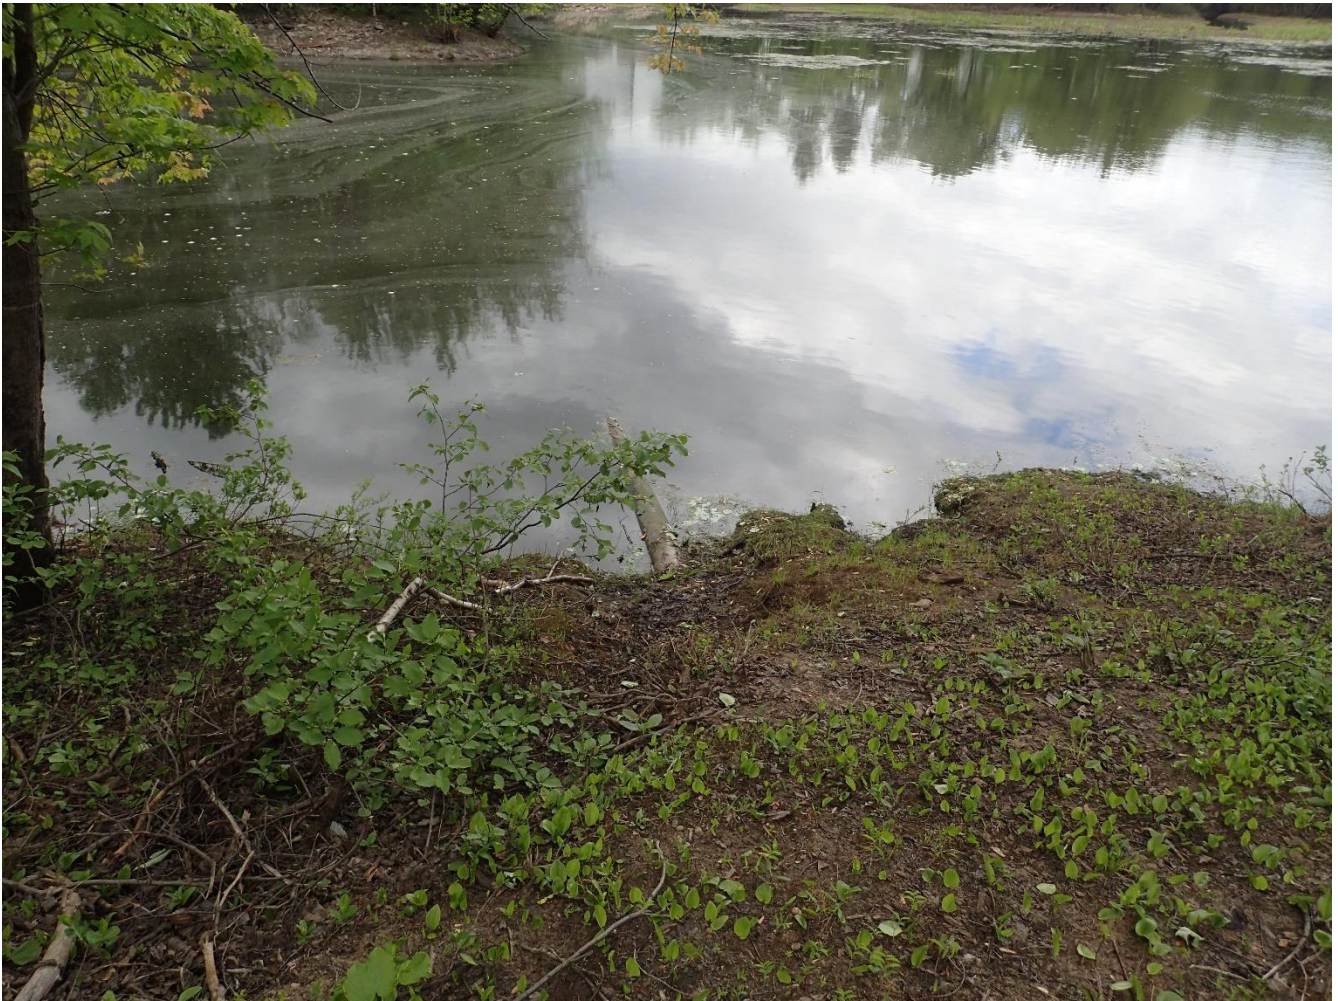
Figure 14 - Looking down the current outfall alignment

Looking down the current outfall alignment, out across Henderson Brook. Outfall pipe is just out of the water and the end is visible.
