LITTLE SOUTHWEST MIRAMICHI RIVER RESTORATION PROJECT – THE OXBOW

Report prepared for North Shore MicMac District Council Aboriginal Aquatic Resource & Oceans Management and Metepenagiag Mi'kmaq Nation, June 2015

LITTLE SOUTHWEST MIRAMICHI RIVER OXBOW BANK RESTORATION

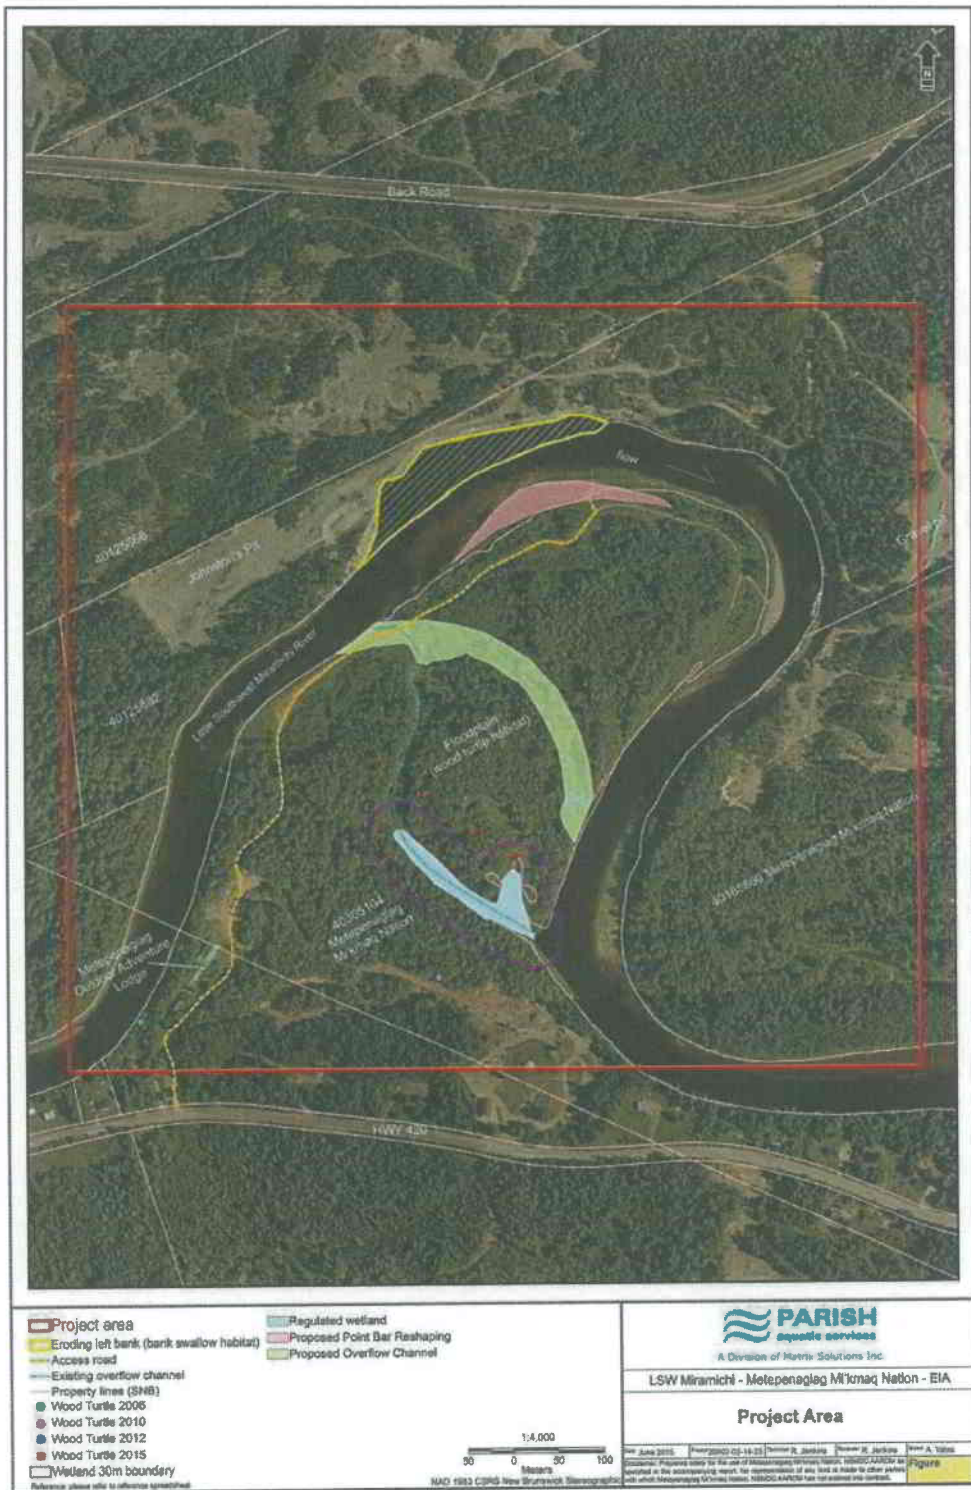
A preliminary site plan has been provided showing the various physical components of the proposed undertaking and environmental features on and near the site (Figure 1). For detailed CAD illustrations of the restoration plan refer to the design drawings in Appendix A.

Figure 1. Project site plan and environmental features

The proposed undertaking is to take place on a land parcel that is part of the Metepenagiag Mi'kmaq First Nations reserve. The property lines encompass a total area of 561,327 m² which extends from the southern floodplain of the LSW Miramichi River, at the oxbow, and continues southeast to the confluence of the Northwest Miramichi River. The property is bound to the south by NB Route 420 and to the east by the LSW Miramichi River. In total, the proposed undertaking is to impact an area of 16,820 m², including the point bar on the south bank of the LSW Miramichi River which accounts for 6170 m² and 10,650 m² associated with construction of the overflow channel on the southern floodplain.

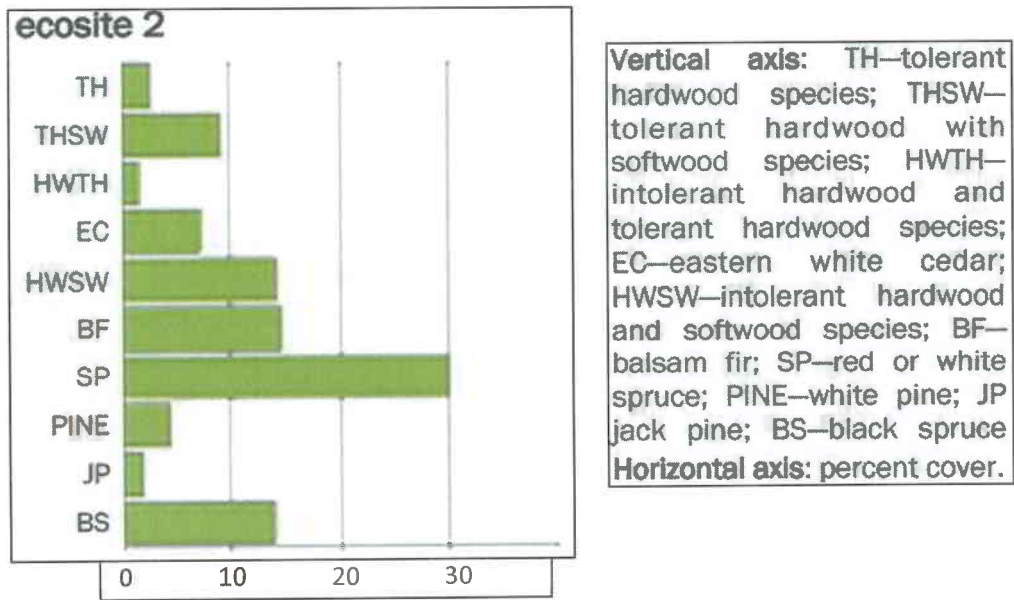
Figure 4. Percent forest cover from ELC

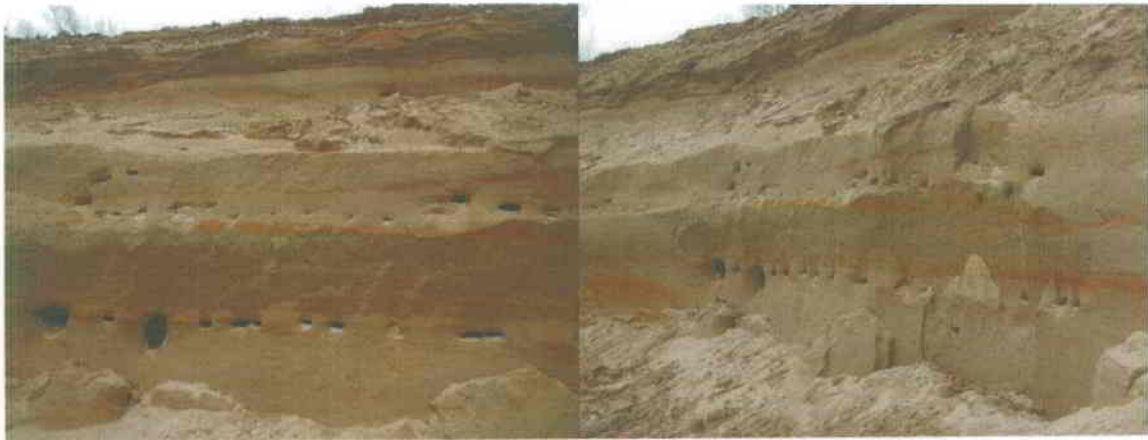
One bird species of particular conservation concern identified in the area was the Bank Swallow (*Riparia riparia*). Nesting cavities were observed on a field visit on November 25-26, 2015 (see Figure 5). The nesting cavities were observed on the north bank (eroding left bank) of LSW Miramichi River near the project site.

Figure 5. Bank swallow nesting cavities near the project site (photo taken Nov. 26, 2014)

The Bank Swallow is a migratory species which establishes nesting colonies in areas where a watercourse is actively eroding banks composed of silt or sand, with a strong preference for vertical faces which are renewed each year (Givertz, 2010; Wright et al., 2011). Nests are located in the top third of the bank, low enough such that predators cannot dig in from the top of bank and high enough as to be inaccessible from the toe or talus. This position also offers protection from flooding and limits the negative effects of rainwater percolating into the nest (Heneberg, 2013). Colonies exhibit some breeding site fidelity, with most individuals returning to a suitable bank within a ten kilometer radius of the original site. It should be noted that banks or bluffs which are not actively eroding are used less over time, presumably due to a lack of favorable nesting sites (Szabo, 2010; Wright et al., 2011).

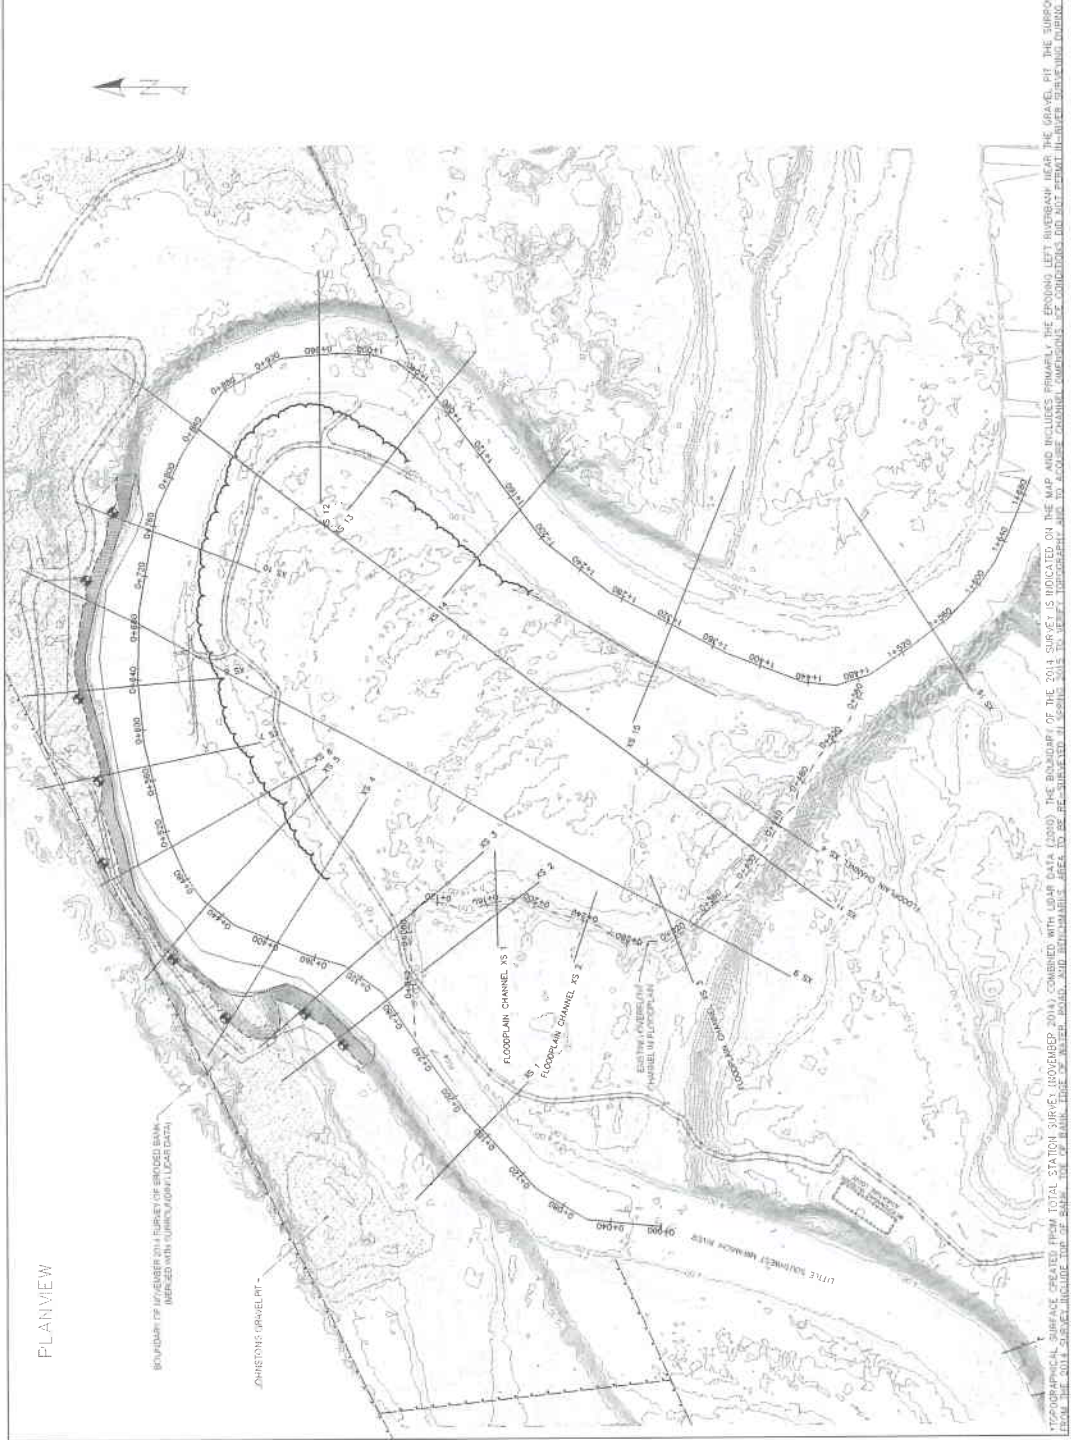
EXISTING PLANVIEW

TOPOGRAPHICAL SURFACE CREATED FROM TOTAL STATION SURVEY (REVISED 2014) COMBINED WITH LIDAR DATA (2010). THE BOUNDARY OF THE 2014 SURVEY IS INDICATED ON THE MAP AND INCLUDES FROM THE BARRAGE LEFT THROUGHOUT THE RANGE. FOR THE SURVEYING INFORMATION, THE SURVEYING IS DERIVED FROM 2010 LIDAR DATA. EXISTING FEATURES FROM THE 2014 SURVEY INCLUDE THE TOP OF BANK, EDGE OF WATER, ROAD, AND BENCHMARK. AREA TO BE RECONSTRUCTED IS SHOWN WITH A DOTTED BOUNDARY. THE TOPOGRAPHICAL SURFACE IS DERIVED FROM 2010 LIDAR DATA. EXISTING FEATURES FROM THE 2014 SURVEY INCLUDE THE TOP OF BANK, EDGE OF WATER, ROAD, AND BENCHMARK. AREA TO BE RECONSTRUCTED IS SHOWN WITH A DOTTED BOUNDARY.

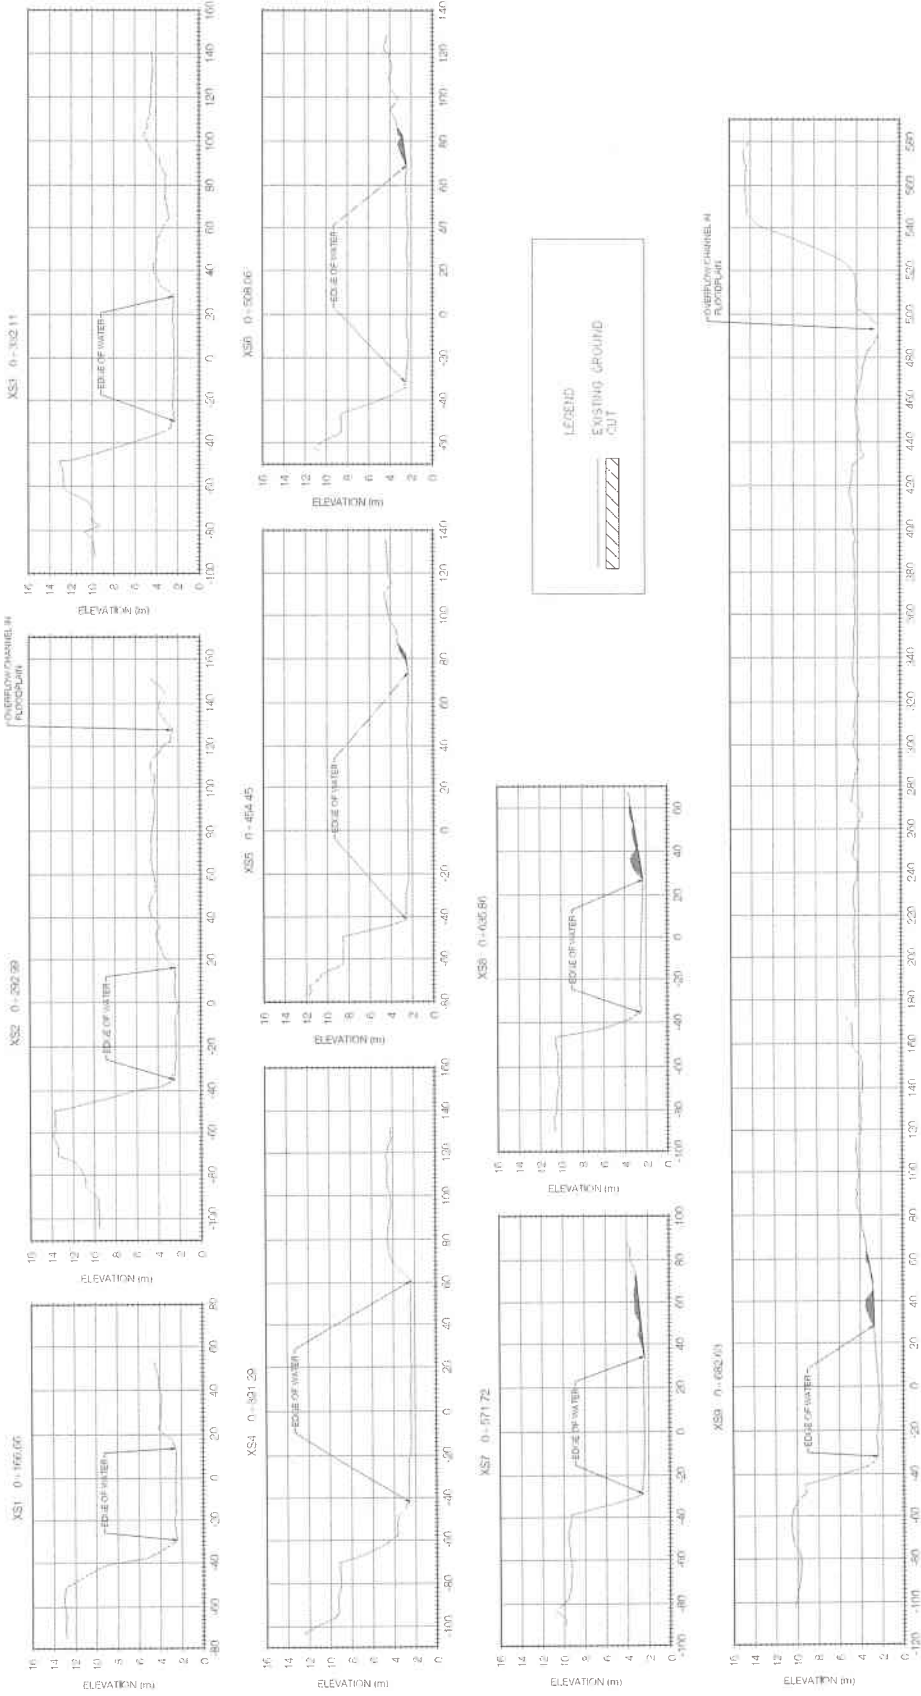
*CROSS SECTIONS SHOWN WITH 5% VERTICAL EXAGGERATION
 **CROSS SECTIONS DERIVED FROM TOTAL STATION SURVEY AND LIDAR DATA (CHANNEL GEOMETRY BEHIND WATER SURFACE OF RIVER CROSS SECTIONS NOT SHOWN)

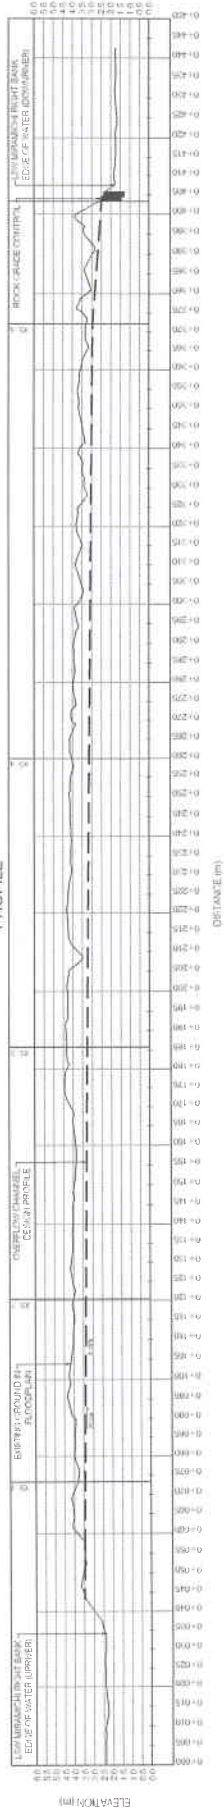
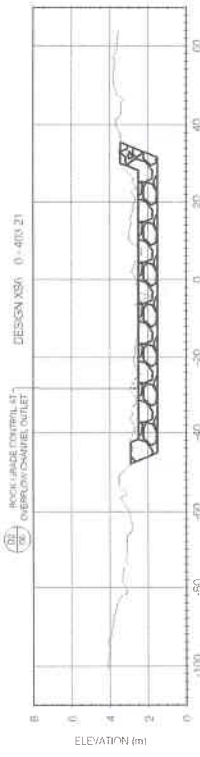
PROFILE & CROSS SECTIONS SHOWN WITH SIX VERTICAL EXAGGERATION

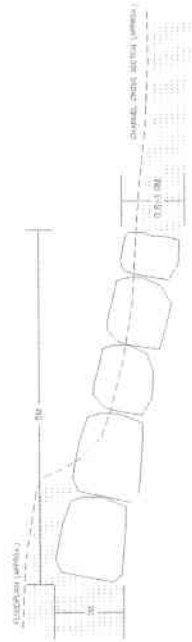
CROSS SECTION VIEW OF SPUR (N.T.S.)

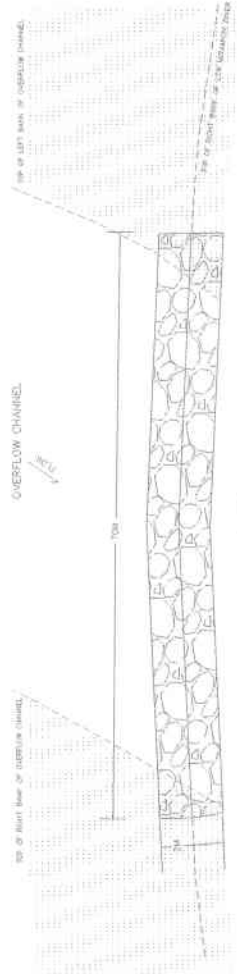
PLANVIEW OF GRADE CONTROL (N.T.S.)

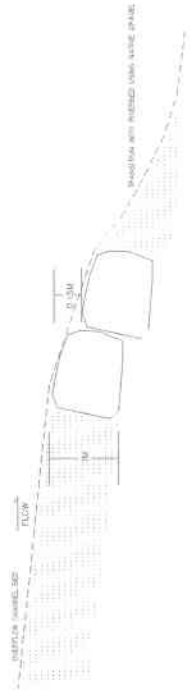
PROFILE VIEW OF GRADE CONTROL (N.T.S.)

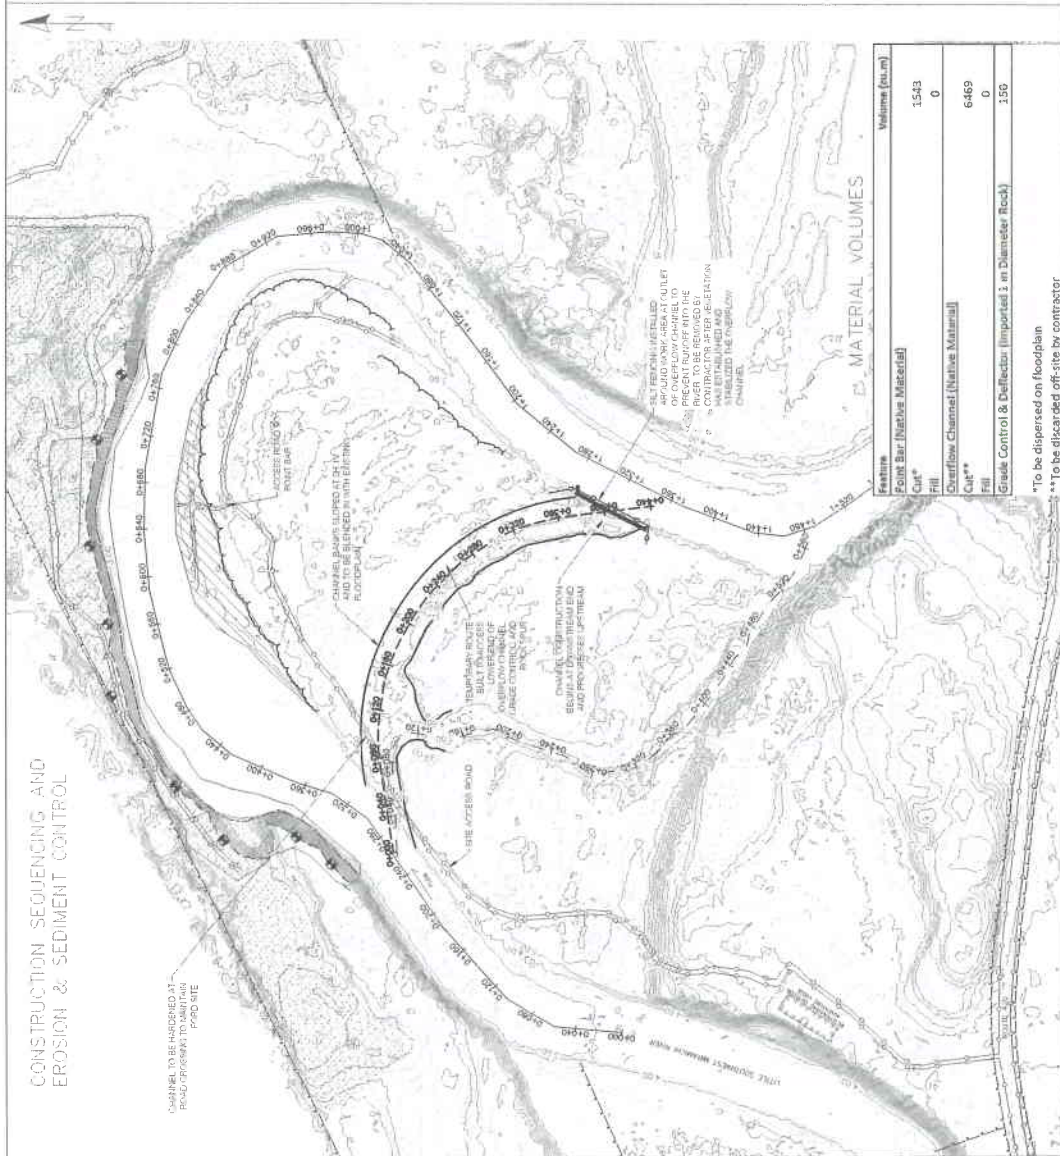
CONSTRUCTION SEQUENCING AND EROSION & SEDIMENT CONTROL

- CONSTRUCTION PHASING**
- GENERAL NOTES**
- THE FOLLOWING DETAILED EROSION CONTROL AND CONSTRUCTION PHASING METHODS ARE RECOMMENDED BASED ON THE CONSTRUCTION PHASING AND SEQUENCING METHODS. THE CONTRACTOR AND DESIGNER MAY WISH OR NEED TO ALTER THE METHODS BASED ON SITE CONDITIONS IDENTIFIED AT THE TIME OF CONSTRUCTION.

- PHASE 1 - PREPARATION**
- WORK INCLUDES
1. ESTABLISH STABLE SITE ACCESS ALONG EXISTING GRAVEL ROAD LEADING DOWN TO THE FLOODPLAIN FROM METEPENAGIAG MIK'KMAQ OUTDOOR ADVENTURE LODGE.

- EROSION AND SEDIMENT CONTROL**
1. SEDIMENT AND EROSION CONTROL MEASURES SHOULD BE IMPLEMENTED PRIOR TO WORK AND MAINTAINED DURING THE WORK. GENERAL RECOMMENDATIONS ARE LISTED BELOW.

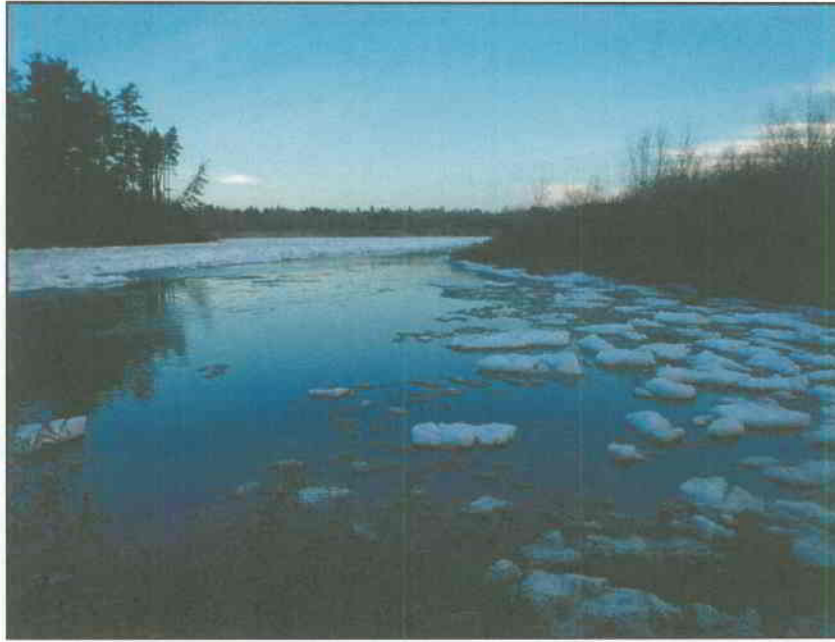
1. Upstream end of site – looking downstream towards bank erosion

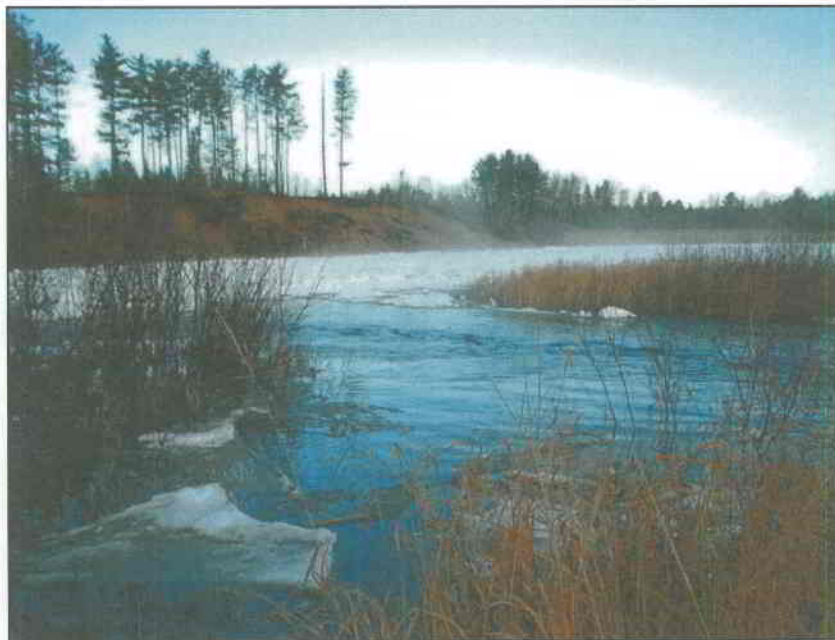
2. Upstream end of overflow channel through the floodplain (right bank)

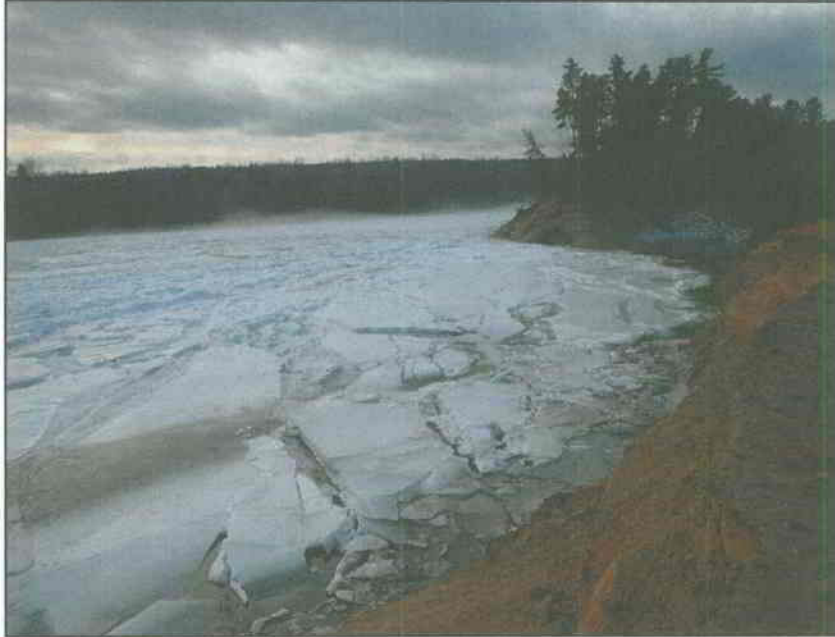
3. View taken from top of left (north) bank – looking upstream at erosion.

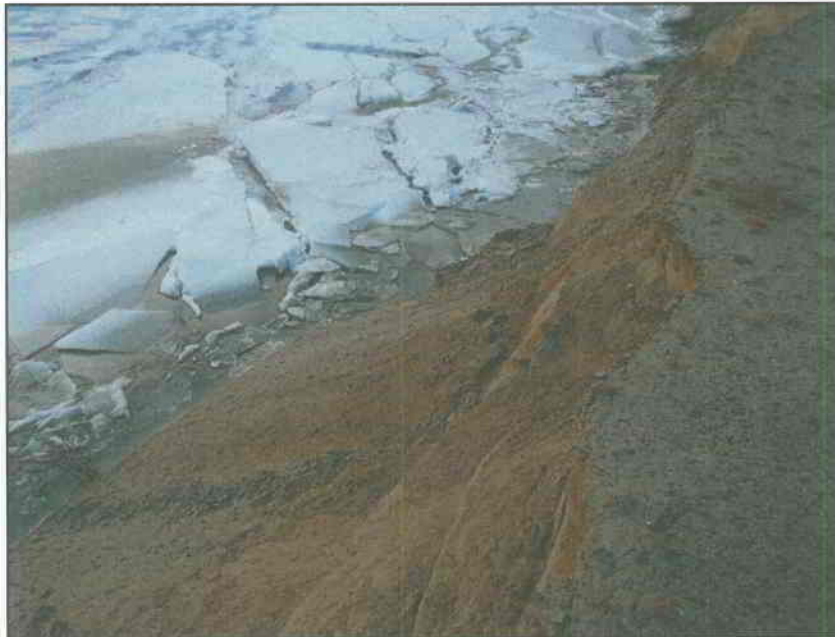
4. View looking at sand material on right (north) bank.

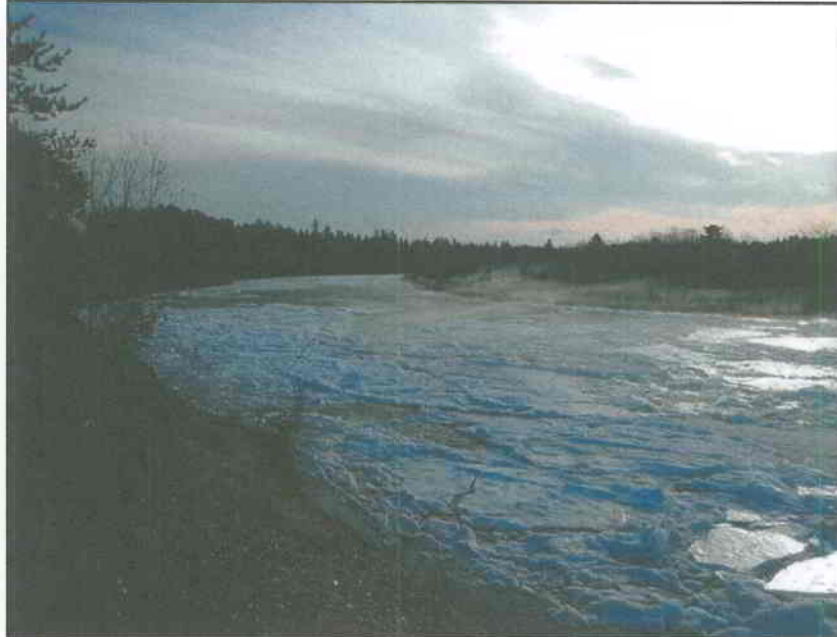
5. Upstream end of site – looking downstream towards bank erosion on left (north) bank.

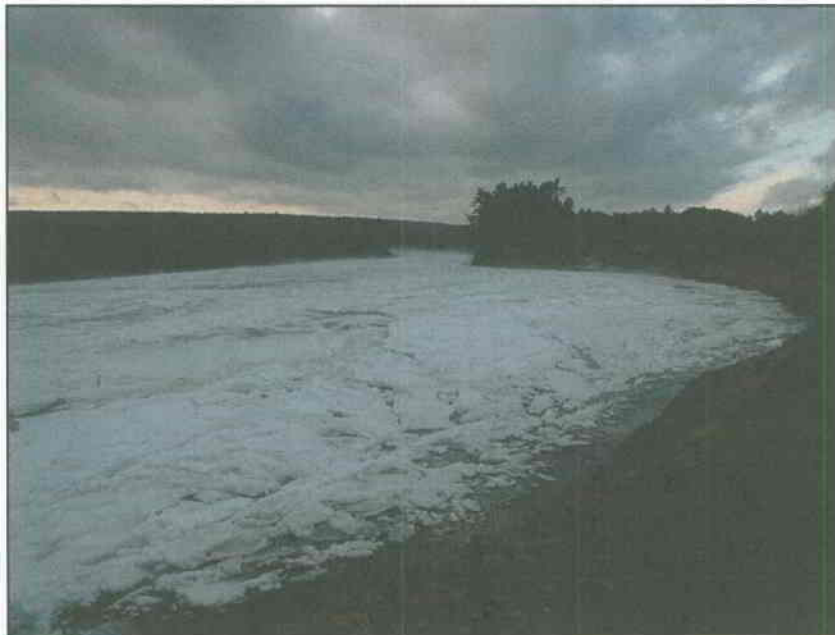
6. Downstream end of site – looking upstream towards bank erosion.

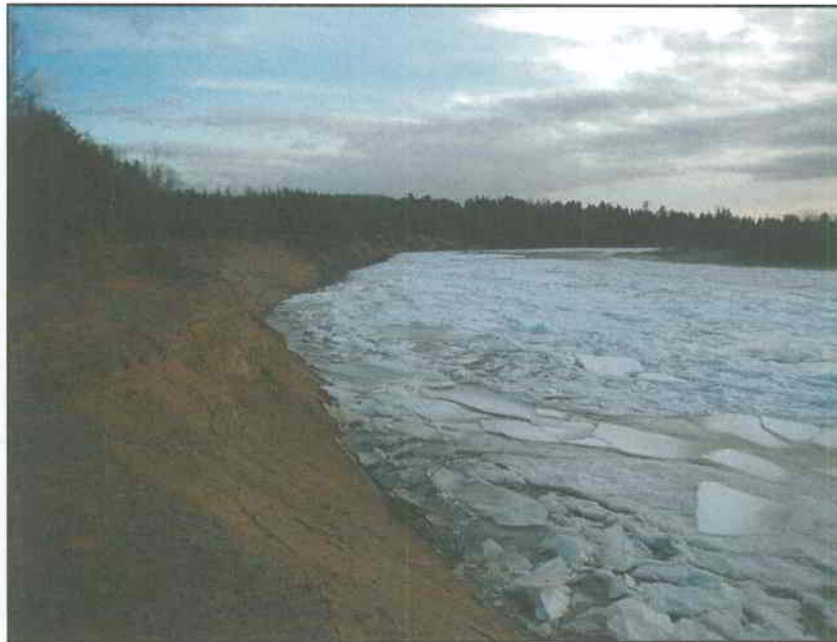
7. Upstream end of site – looking downstream towards bank erosion on left (north) bank.

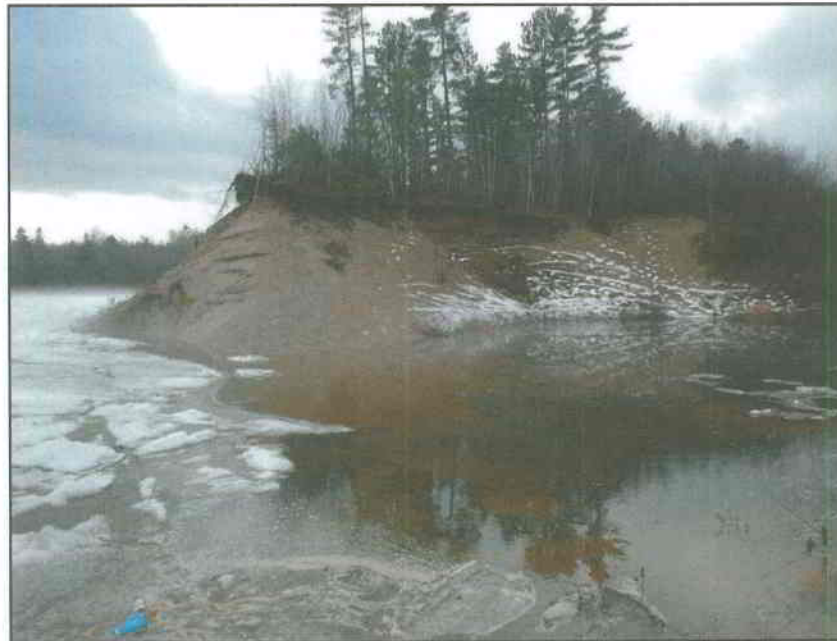
8. Upstream end of site – view looking at left bank erosion (north bank)

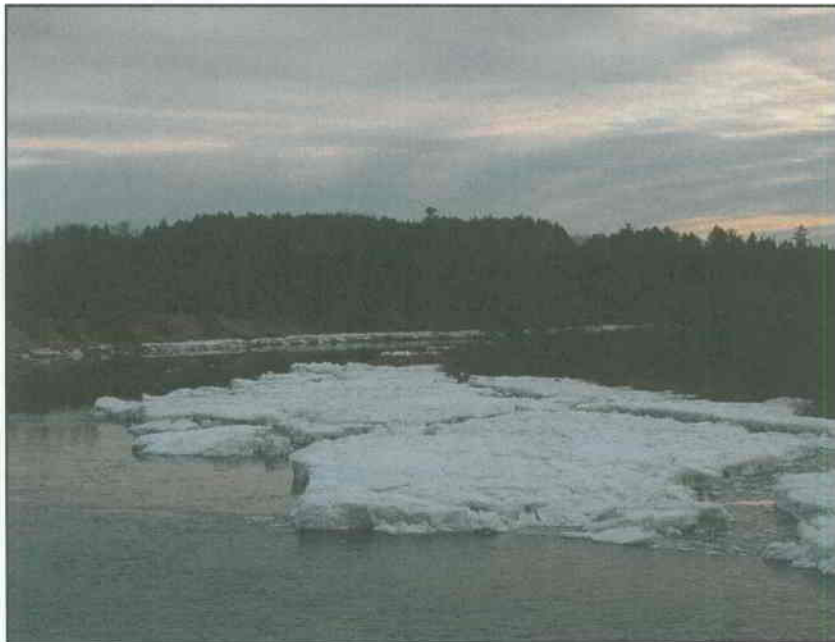
9. Upstream end of site – looking downstream towards point bar location on right (south) bank.

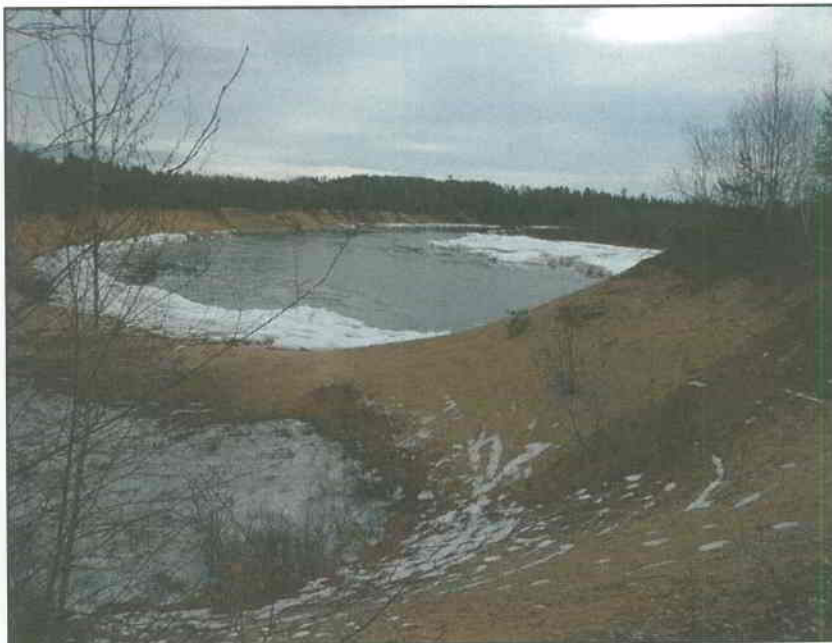
10. Downstream end of eroding left (north) bank – looking upstream

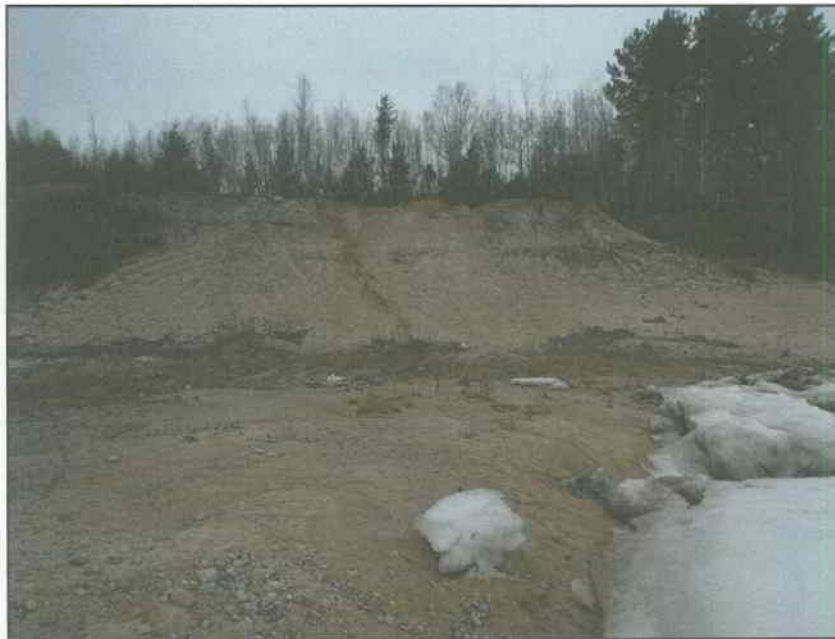
12. Erosion at top of left (north) bank.

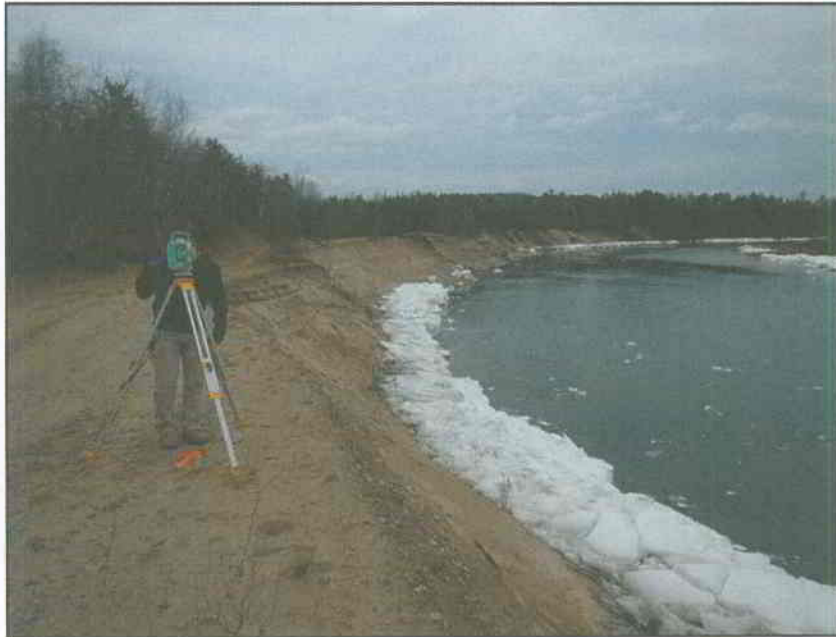
13. Upstream end of site – looking downstream towards bank erosion on left (north) bank. Note access road for Johnson's Pit on left of photo.

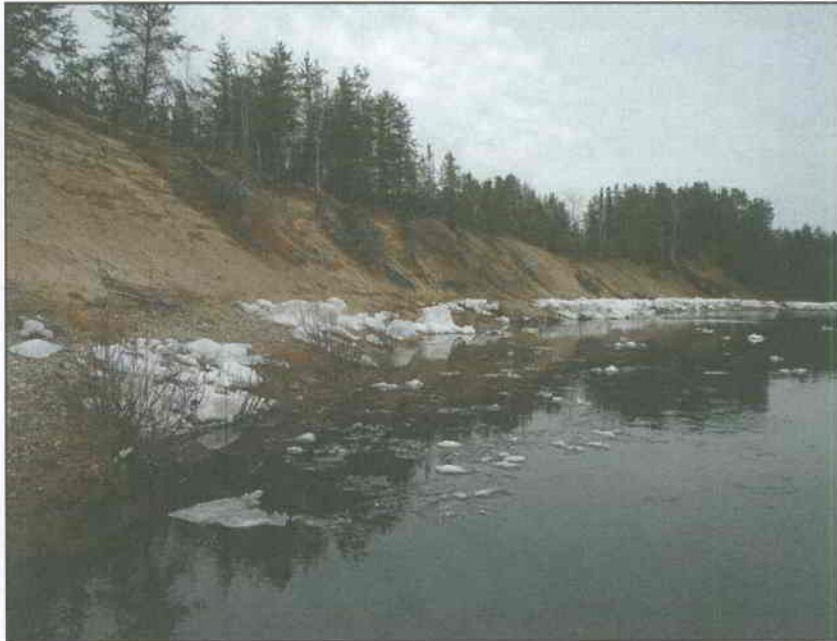
15. Downstream end of site – looking downstream towards bank erosion.

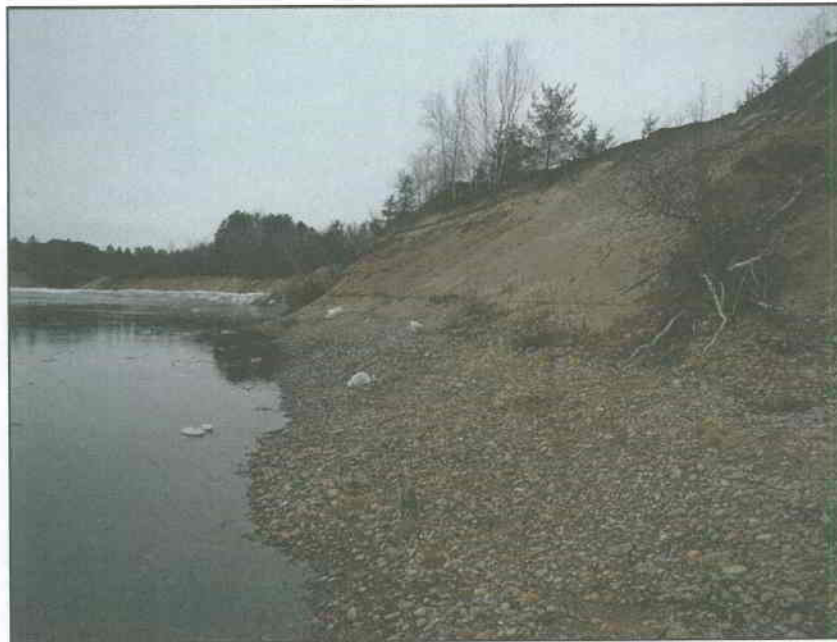
16. Downstream end of site – looking upstream at erosion on left (north) bank.
Note deposition of gravels at toe of bank.

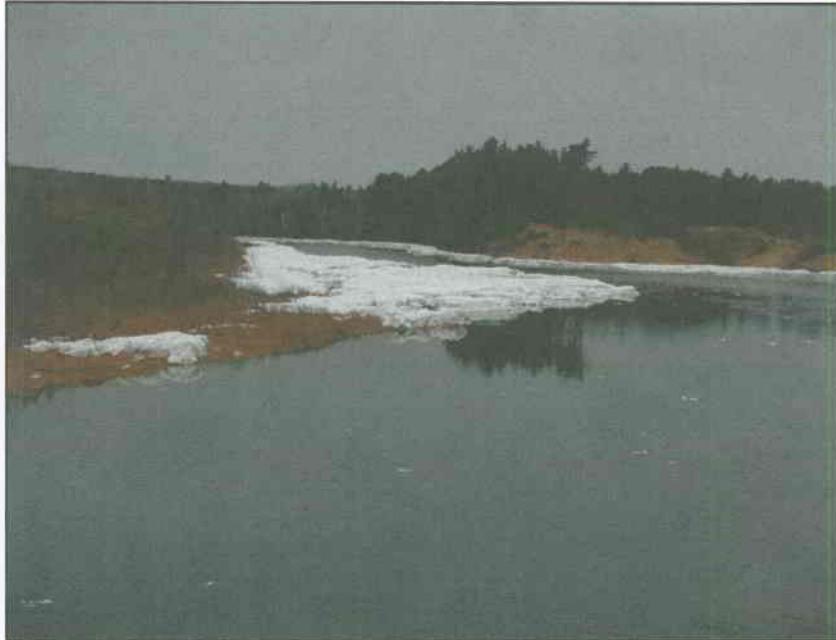
17. Downstream end of site – looking upstream towards point bar on right (south) bank (left side of photo).

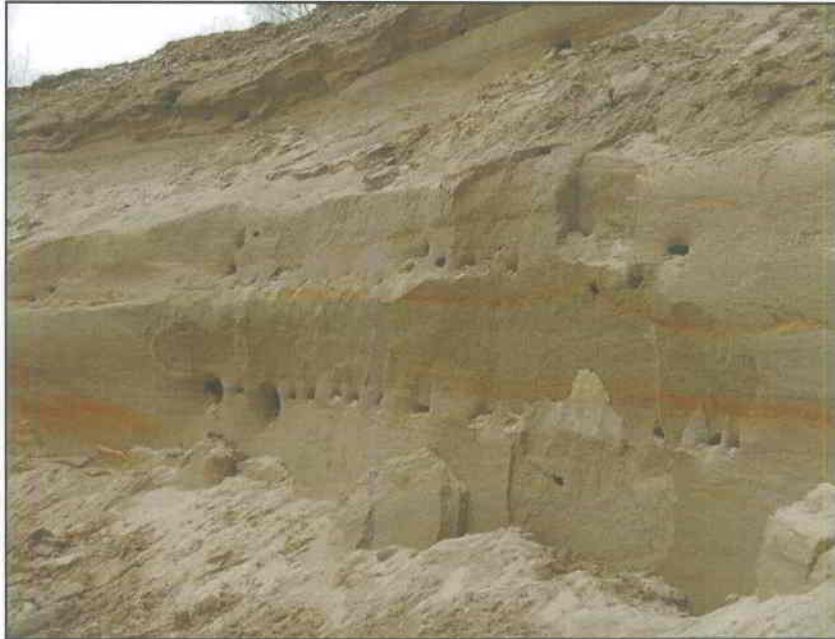
21. View looking at left (north) bank – note bank swallow nests in eroding bend

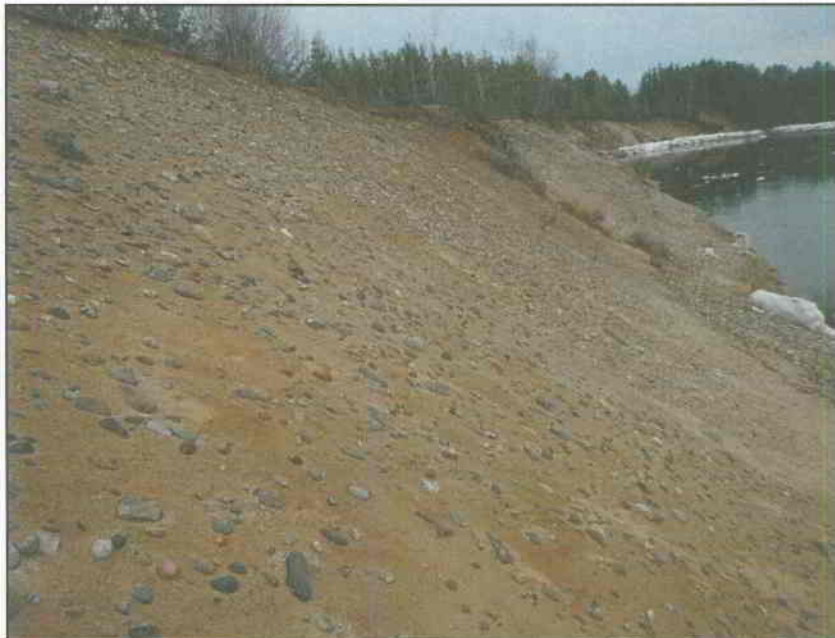
22. View looking downstream – looking at bank materials of eroding bend (left bank)
