Wildlife and Wildlife Habitat Report,
Wetland VEC & Vegetation VEC

Wildlife and Wildlife Habitat Report

The Project is a campground extension on Euclide Leger Road in Shediac, New Brunswick. The Subject Property is a linear portion of land approximately 700 m x 150 m. It is bordered by a Provincially Significant Wetland coastal saltmarsh to the west (see Figure 1).

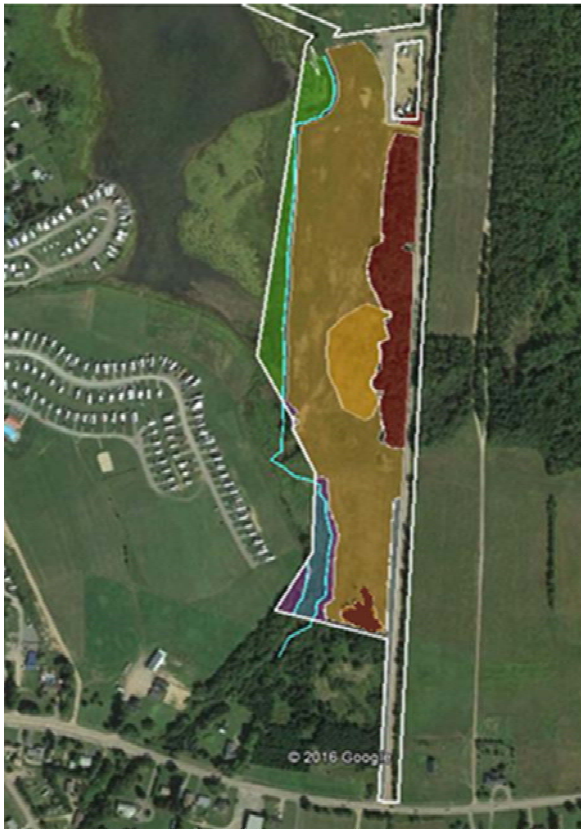
Figure 1

Habitat Map

- Red – Forest
- Green – Saltmarsh
- Oranges – Field and smaller low-lying area in field
- Blue – Fen
- Purple – Forested Bank

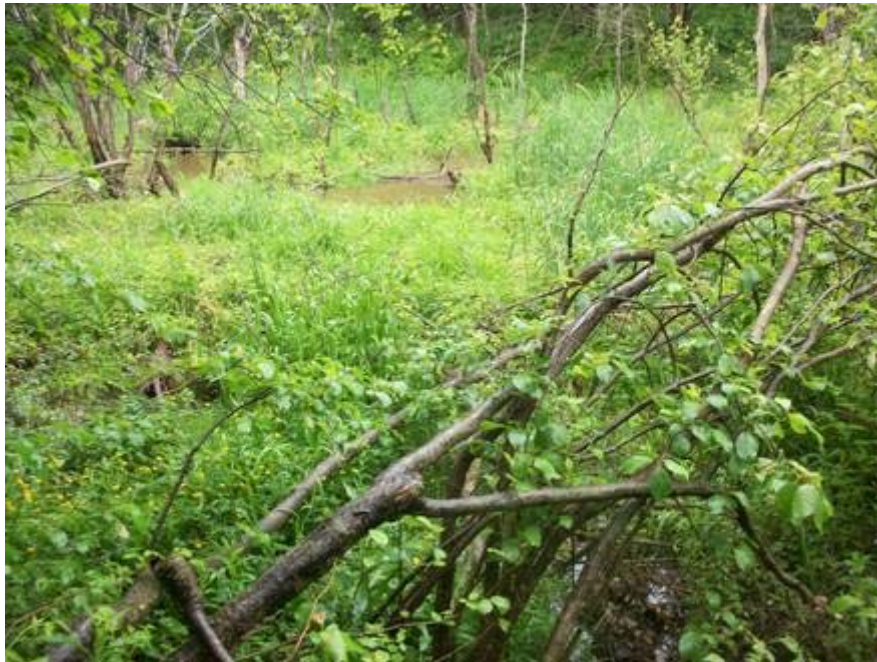
Figure 5

Within the Fen there are at least two primary channels which support small sandy floodplains. The bulk of the Fen is dominated by Reed Canary Grass and Spotted Touch-me-not. The most uncommon plants found during the survey were found here: Rough Horsetail (*Equisetum hyemale*) and Water Loosestrife (*Lysimachia thyrsiflora*).

Fen

Care should be taken during all phases of the proposed project to avoid Saltmarsh (PSW) habitat found below the Seawall. This could be achieved by clearly marking the 15-30m buffer around the wetland. The same is true for the Fen Wetland to the south.

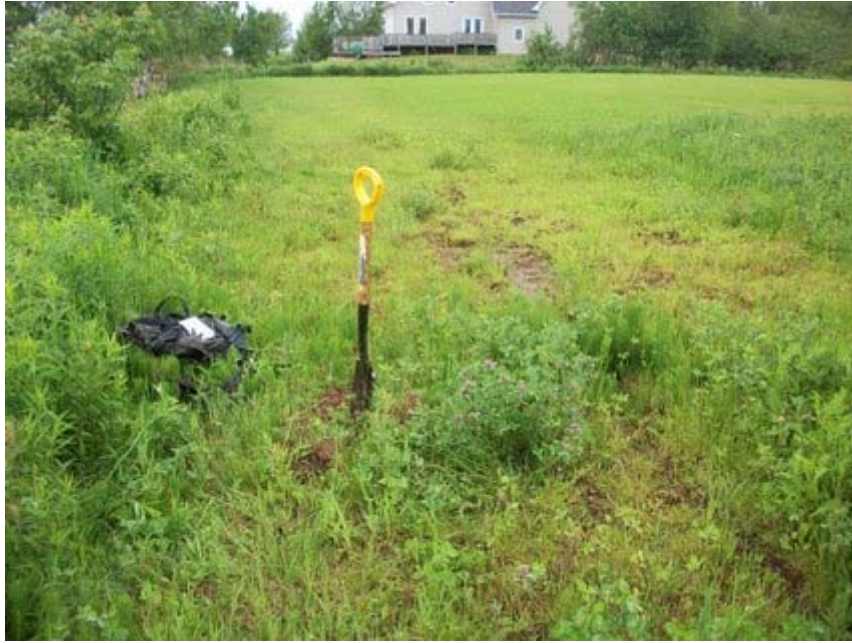
Datapoint 1 was sampled on the upland side of the seawall in the field dominated by weedy, upland plants such as Clover and Yarrow. No hydrological indicators were observed. Soils consisted of well-drained sandy-gravel substrate used for backfilling.

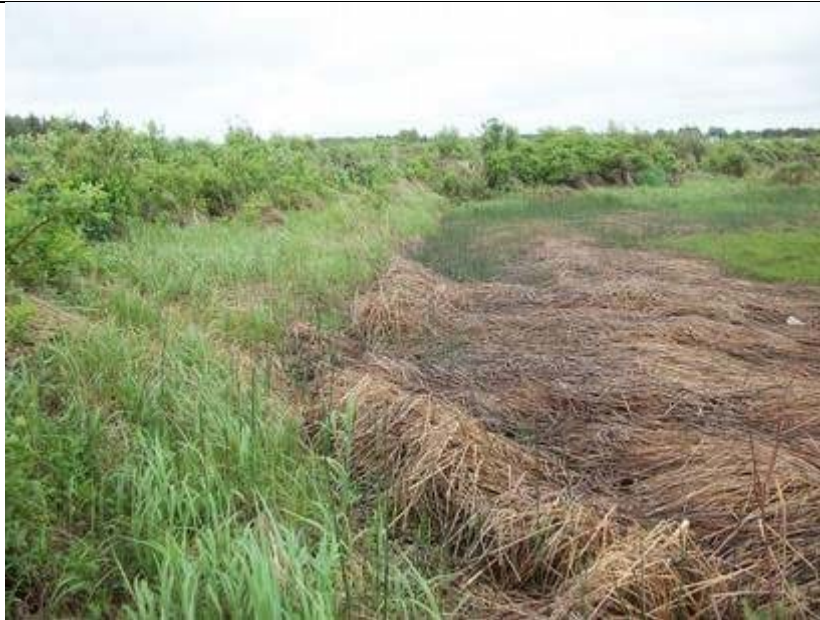
Datapoint 4 represents the only instance where habitat at the base of the seawall was found to be upland. With sedimentation and drainage affected by the wall, hydric soil and hydrology indicators were absent, although wetland indicator species of plants were still present.

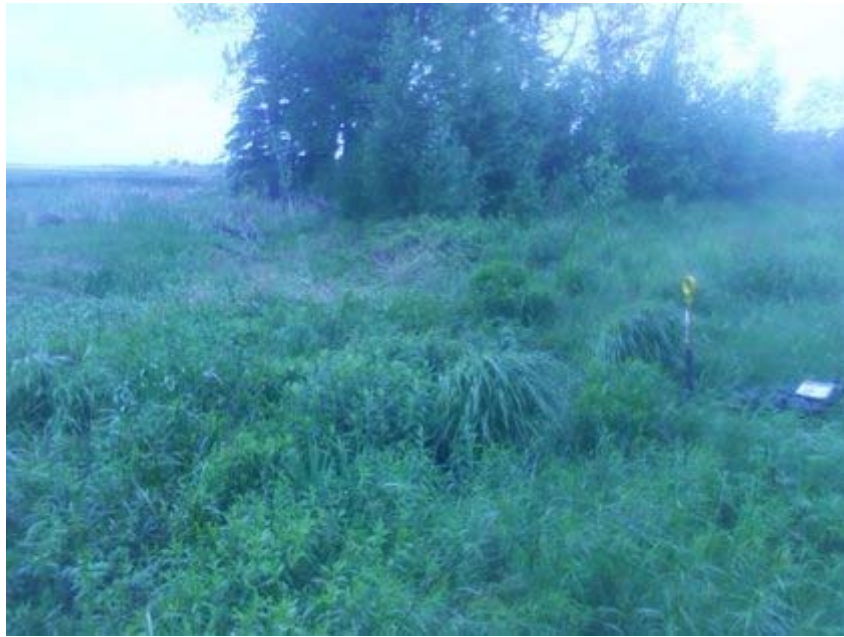
Datapoint 7

Datapoints 7, 8 and 9 represent the edge of upland meadow and forest habitats present before infilling. No hydrological or hydric soil indicators were found to be present.
