Appendix H VEC Heritage and Archaeological Resources

Project
EIA - NORTHWEST MIRAMICHI RIVER
NO.1 ANDERSON BRIDGE REPLACEMENT

**Archaeological Assessment of a Proposed Bridge Replacement in Miramichi
City, NB**

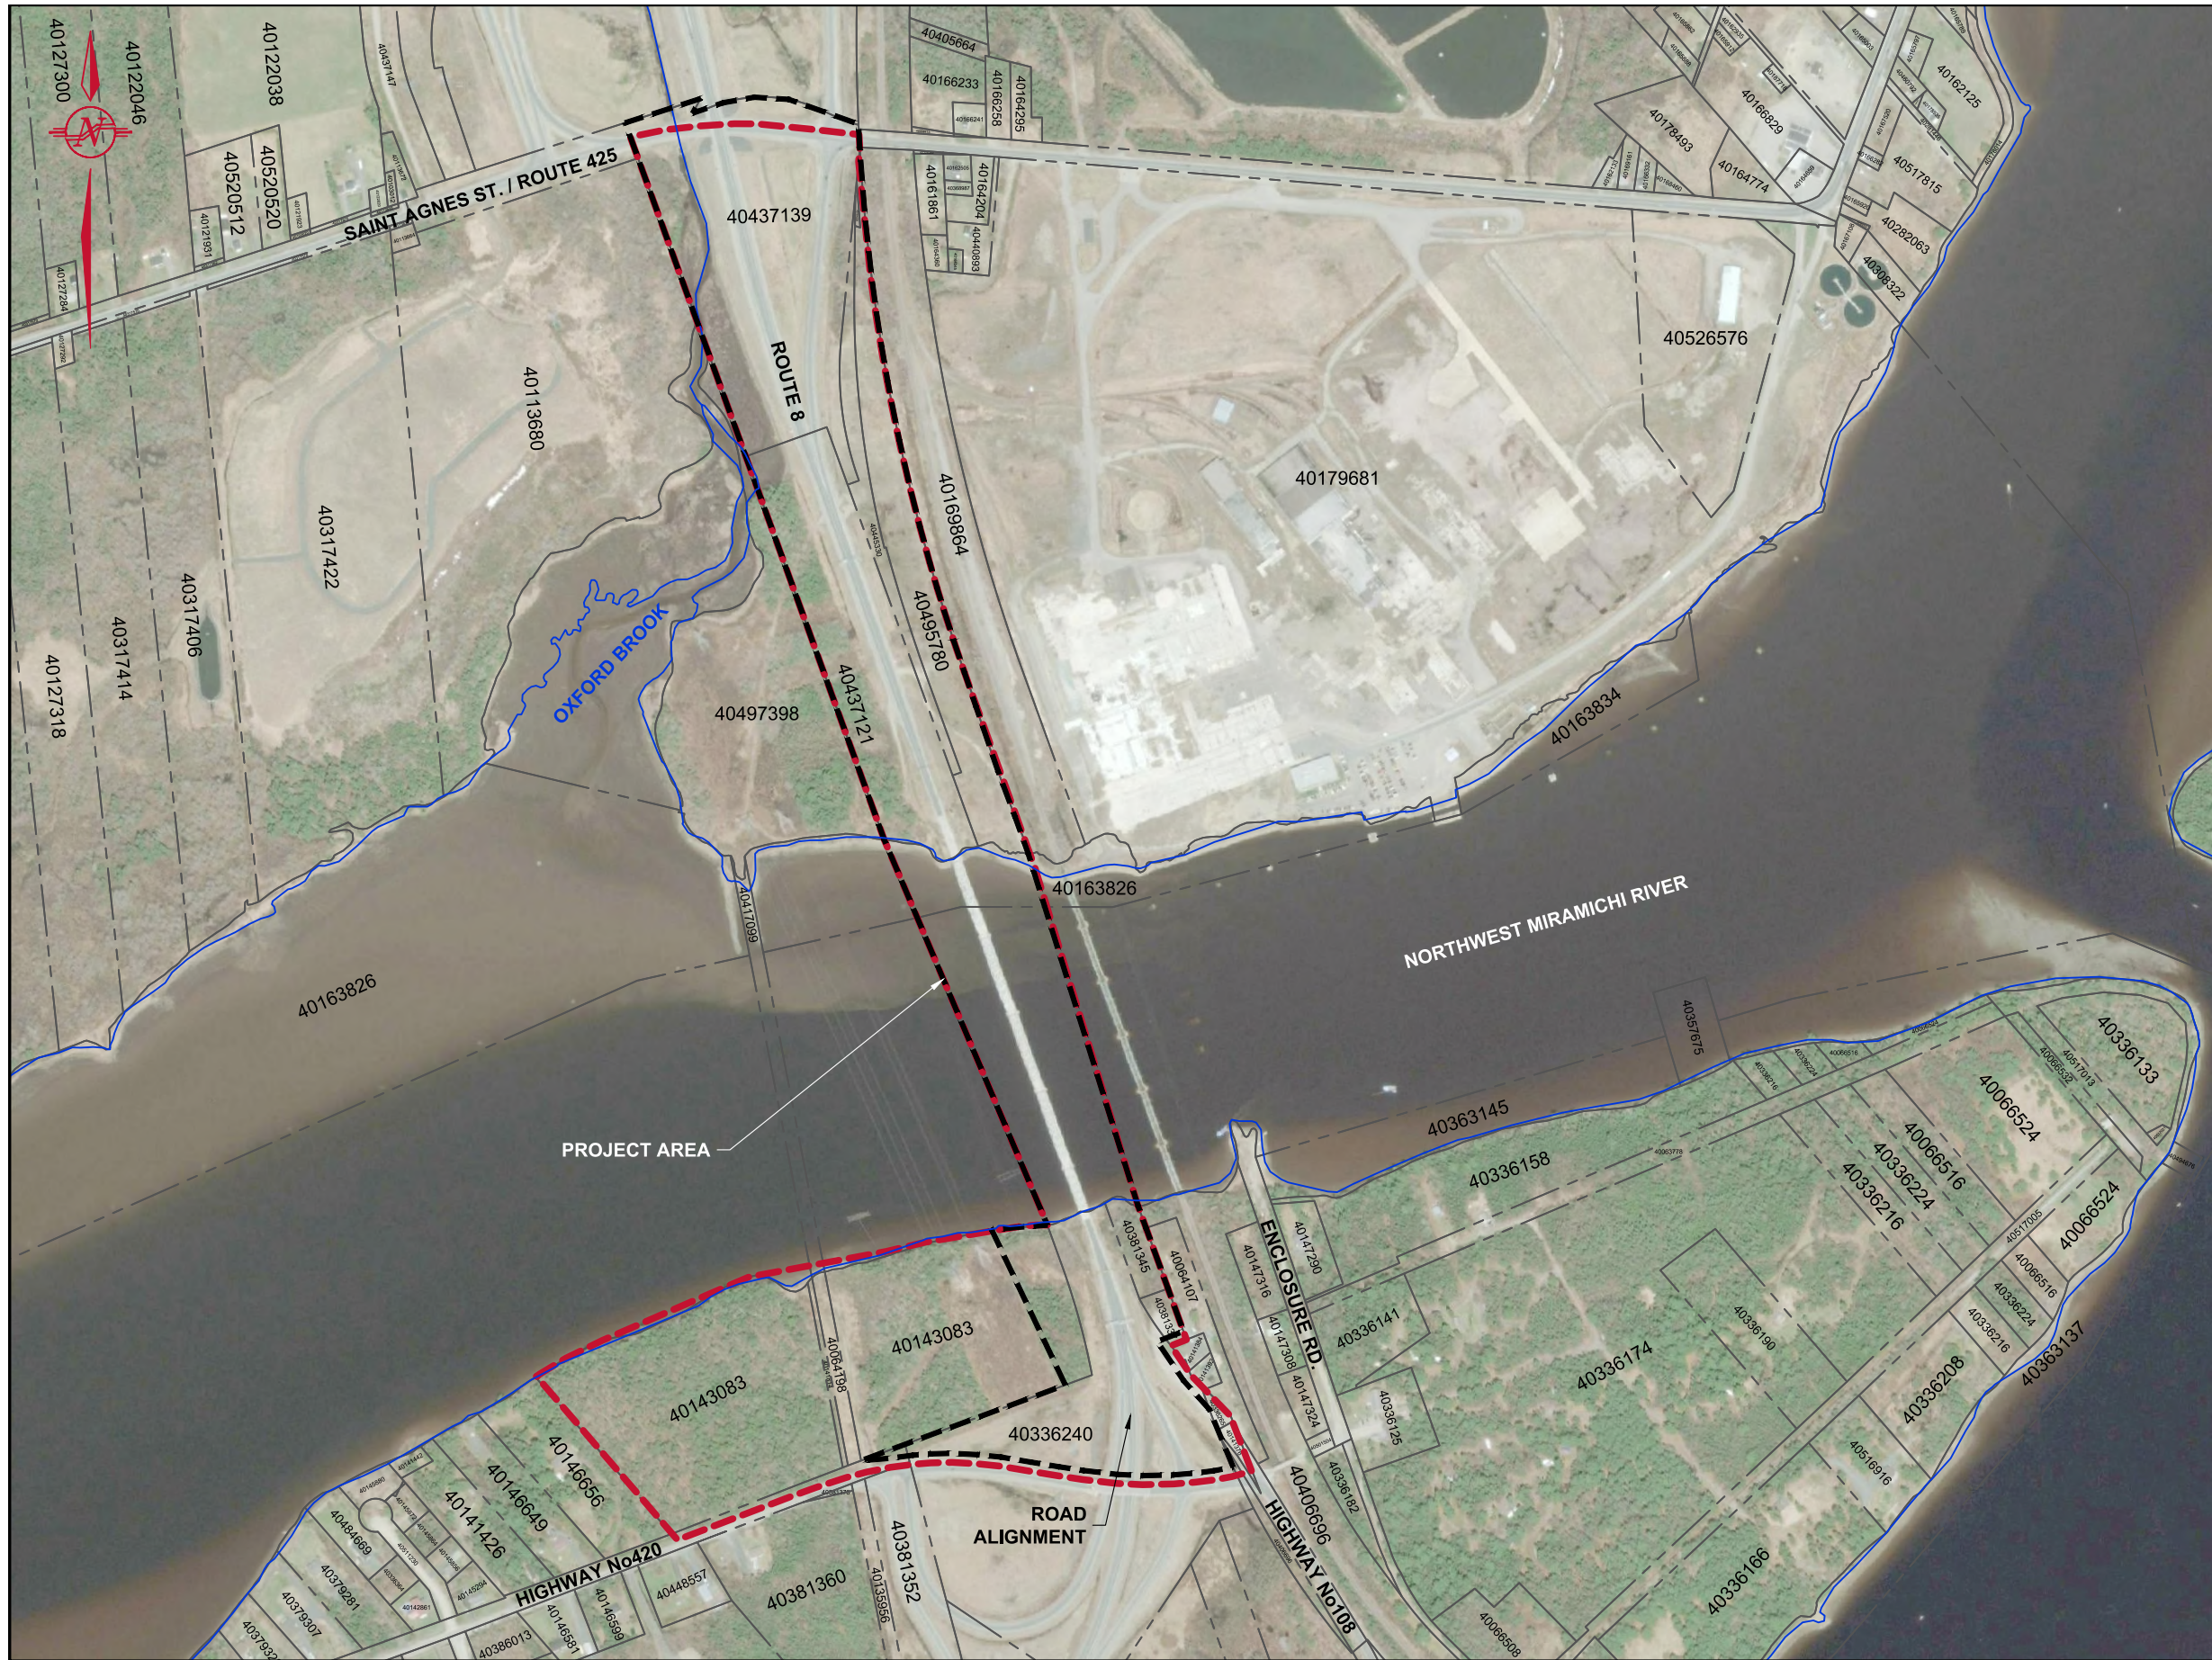
File No. 69214403	Drawing FIGURE H-1	Revision No. 0
----------------------	-----------------------	-------------------

- The Project Area is defined as footprint of ground disturbance required for the Project activities (PID 40381345, 40381337, 40437121, 40445330, 40495780, 40164808, portion of 40163826, portion of 40143083, portion of 40336240, and portion of 40437139) as presented in Figure H-1; and
- The Assessment Area which is defined as the originally envisioned project area and encompasses the Project Area and PID 40064198 and PID 40141814 and the entire footprint of PID 40143083 (Figure H-1).

Drawing
ARCHAEOLOGICAL ASSESSMENT
SPATIAL BOUNDARIES

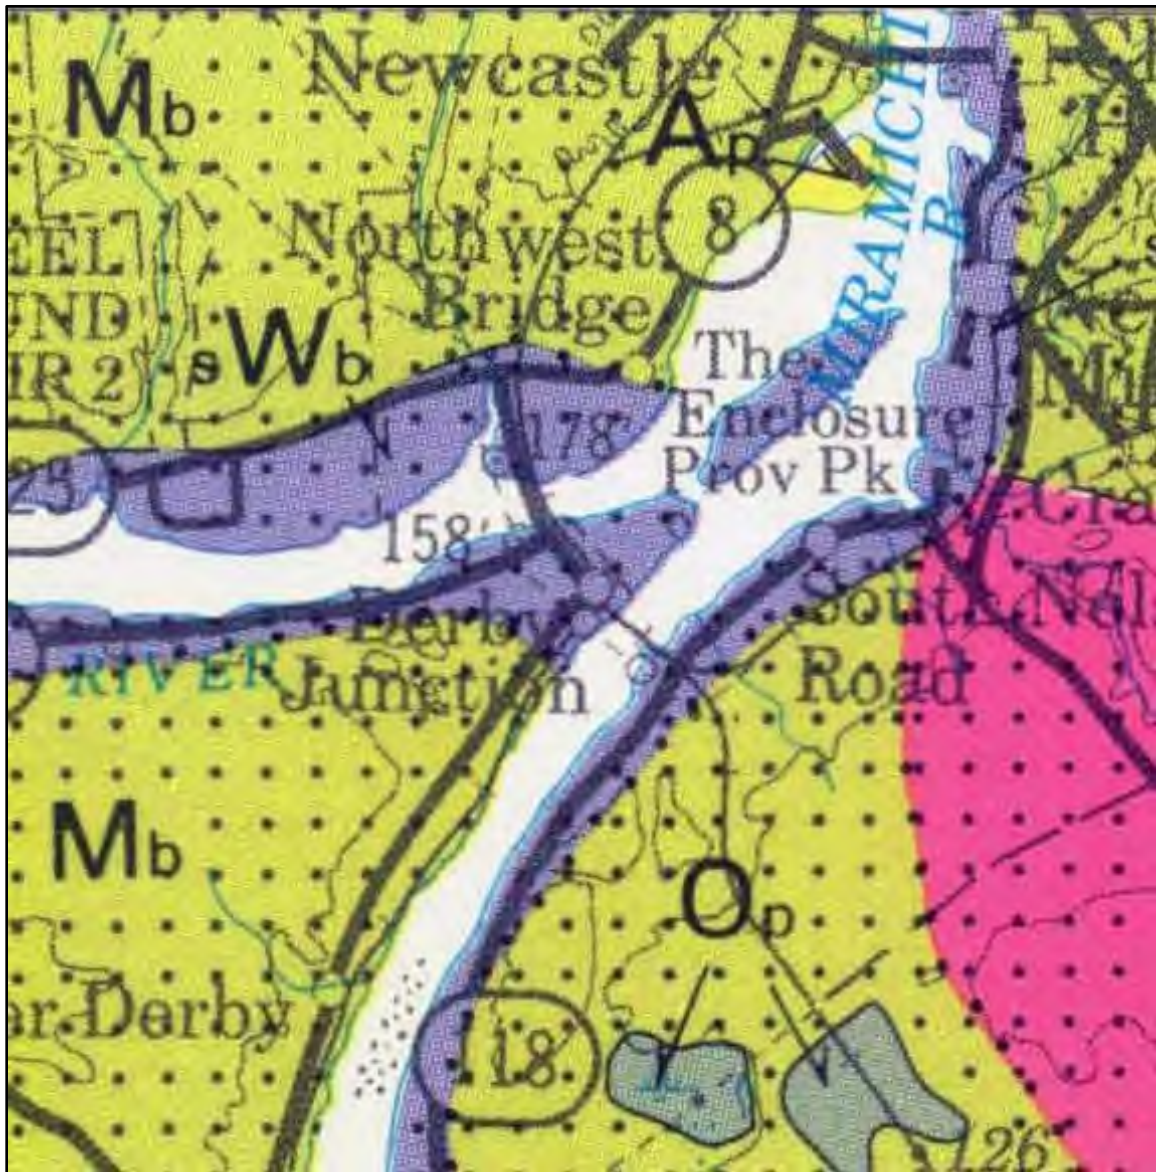
Figure 4: Surficial geology map of the region (Rampton, Paradis & Smith 1981).

A review of early aerial photographs (1944 7443/055 (snow cover), 1954 1551/029) failed to indicate any extant cultural features of interest. The air photos from 1944 reveal the area prior to the erection of the Anderson Bridge, which eventually appears in the 1954 aerial photos. Also of note from the early images is the appearance of Jones Cove prior to having much of its eastern side filled in to accommodate the new road/bridge (see Figure 3). A surficial geology map of the region from 1981 (Rampton et al.) illustrates that the entire project area was inundated by marine high water at the end of the last glaciation (see Figure 4). The purple area labelled 'sWb' is described as mainly sand marine deposits usually as a blanket over bedrock (0.5-1.5 m thick), which is how it appeared during the pedestrian survey.

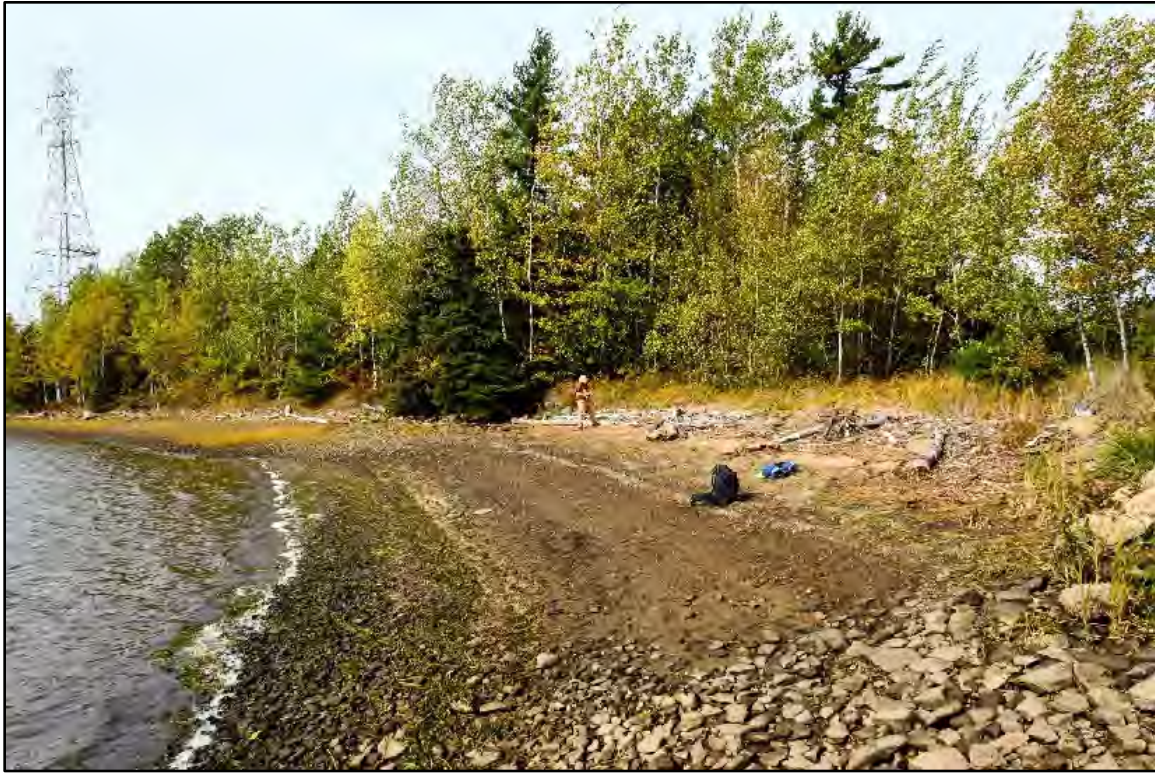
Figure 8: Archaeological site identified on north side of river, west of bridge.

The eastern side of the bridge and Route 8, on the north side of the Northwest Miramichi River is exceptionally flat and level – most likely the result of a laydown area for the construction of the bridge or other large-scale activity. On the western side of the road/bridge, the landscape on the southern half of Jones Cove appears to have had many dump trucks drop fill (not leveled) on portions of it. The project area west of the road/bridge (north side of river) is generally flat and suitable for habitation. On the north side shoreline, a large sandy beach is present, along with tabular bedrock fragments. A likely quartz core was recovered on the eastern side of the bridge, and 18 quartz flakes were collected on the sandy beach west of the bridge – along the entire width of the project right-of-way (see Figures 8, 12 & 14). The core and flakes are the result of Indigenous flintknapping in the prehistoric period and may indicate the presence of a habitation site nearby.

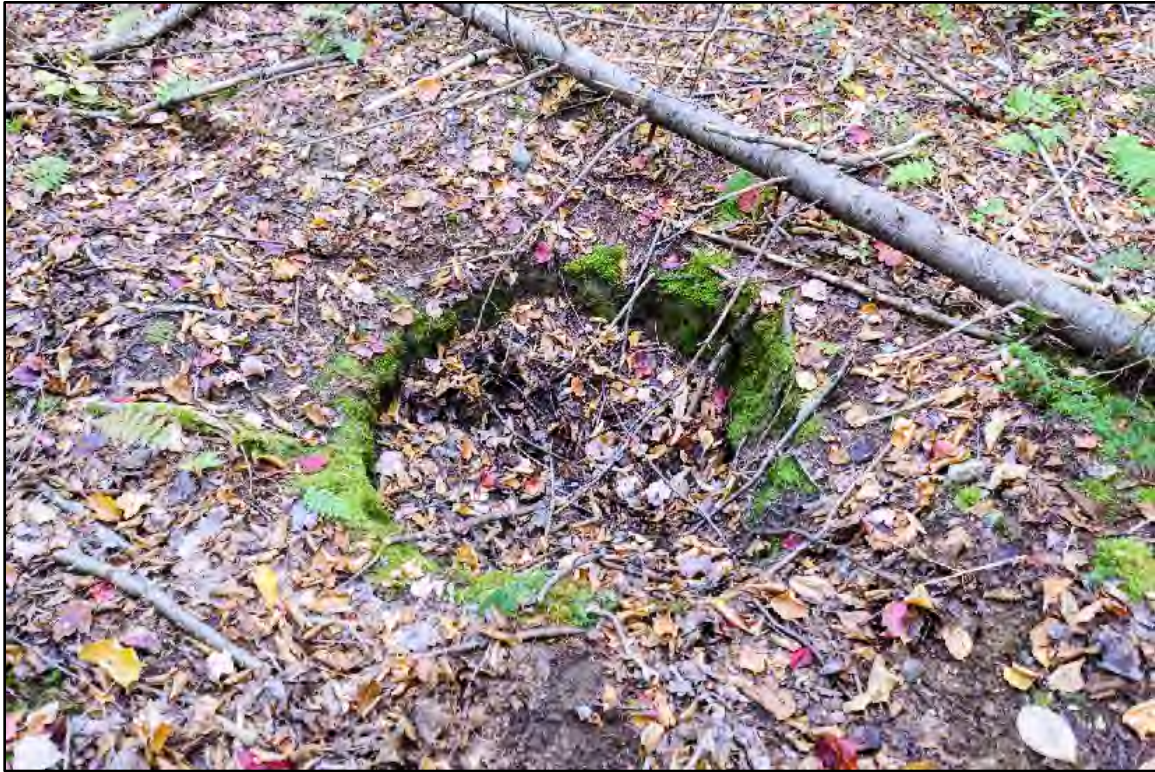
Figure 10: Circular depression (former well?) on the south side of river, west of bridge.

No evidence of significant extant structures was visible during the desktop survey or in the field. Some fairly modern garbage adjacent to the property line on the western edge of the wooded area, south of river was noticed. This garbage included numerous galvanized steel buckets that may have been used to collect maple sap. The road that runs through the centre of this wooded area was likely created as a result of the pipe that runs under it and empties into the river.

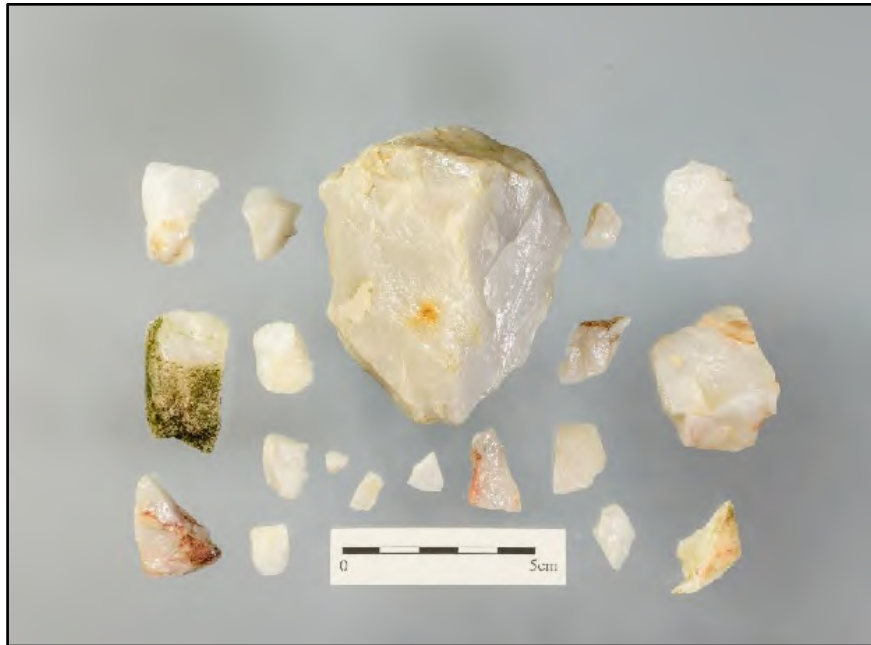
Figure 12: Artifacts recovered from the north side of the Northwest Miramichi River.

On October 7th, 2017, an archaeological pedestrian survey took place at a proposed bridge replacement in Miramichi City, NB. The assessment of these properties resulted in the recovery of 22 quartz artifacts from at least two different Indigenous archaeological sites.

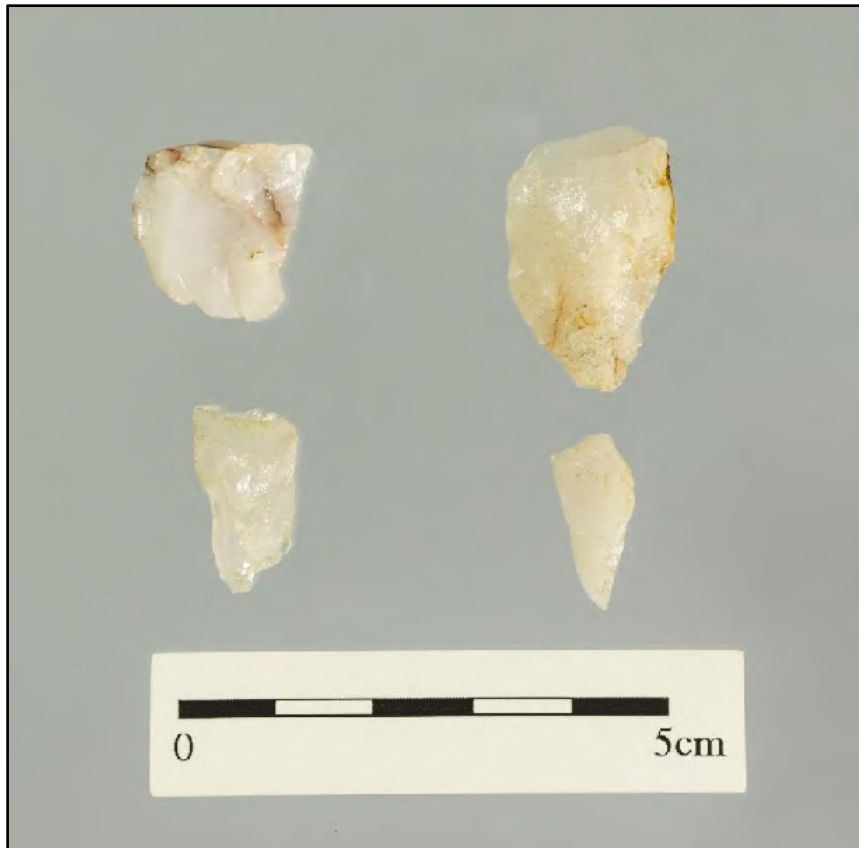
Figure 13: Artifacts recovered from the south side of the Northwest Miramichi River.

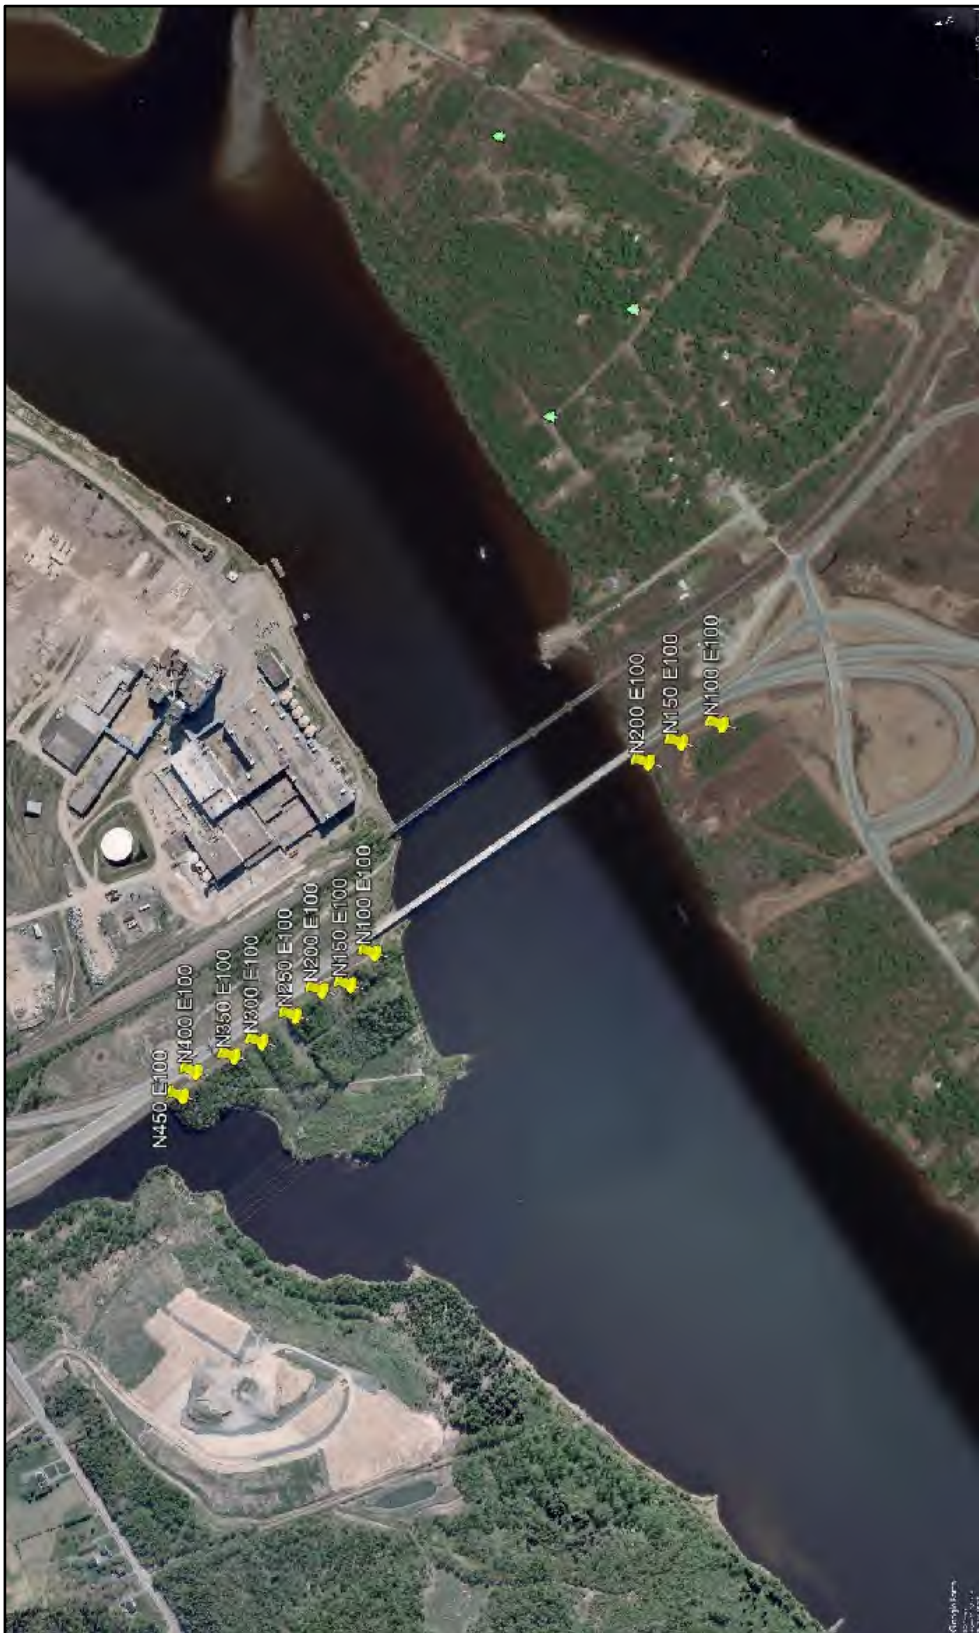
Figure 2: Approximate location of test pits.

The subsurface testing portion was performed by digging square, standardised test pits (STPs) measuring 50 cm a side and up to the maximum depth that is practical with hand shovels (~1 m). Test pits were excavated with round-nose shovel and trowel and all material passed through a bipedal screen with 6 mm mesh. Both the locations and the stratigraphy of the STPs were recorded (see Figures 16-18) and one wall of each test pit was photographed (see Figures 6-15).

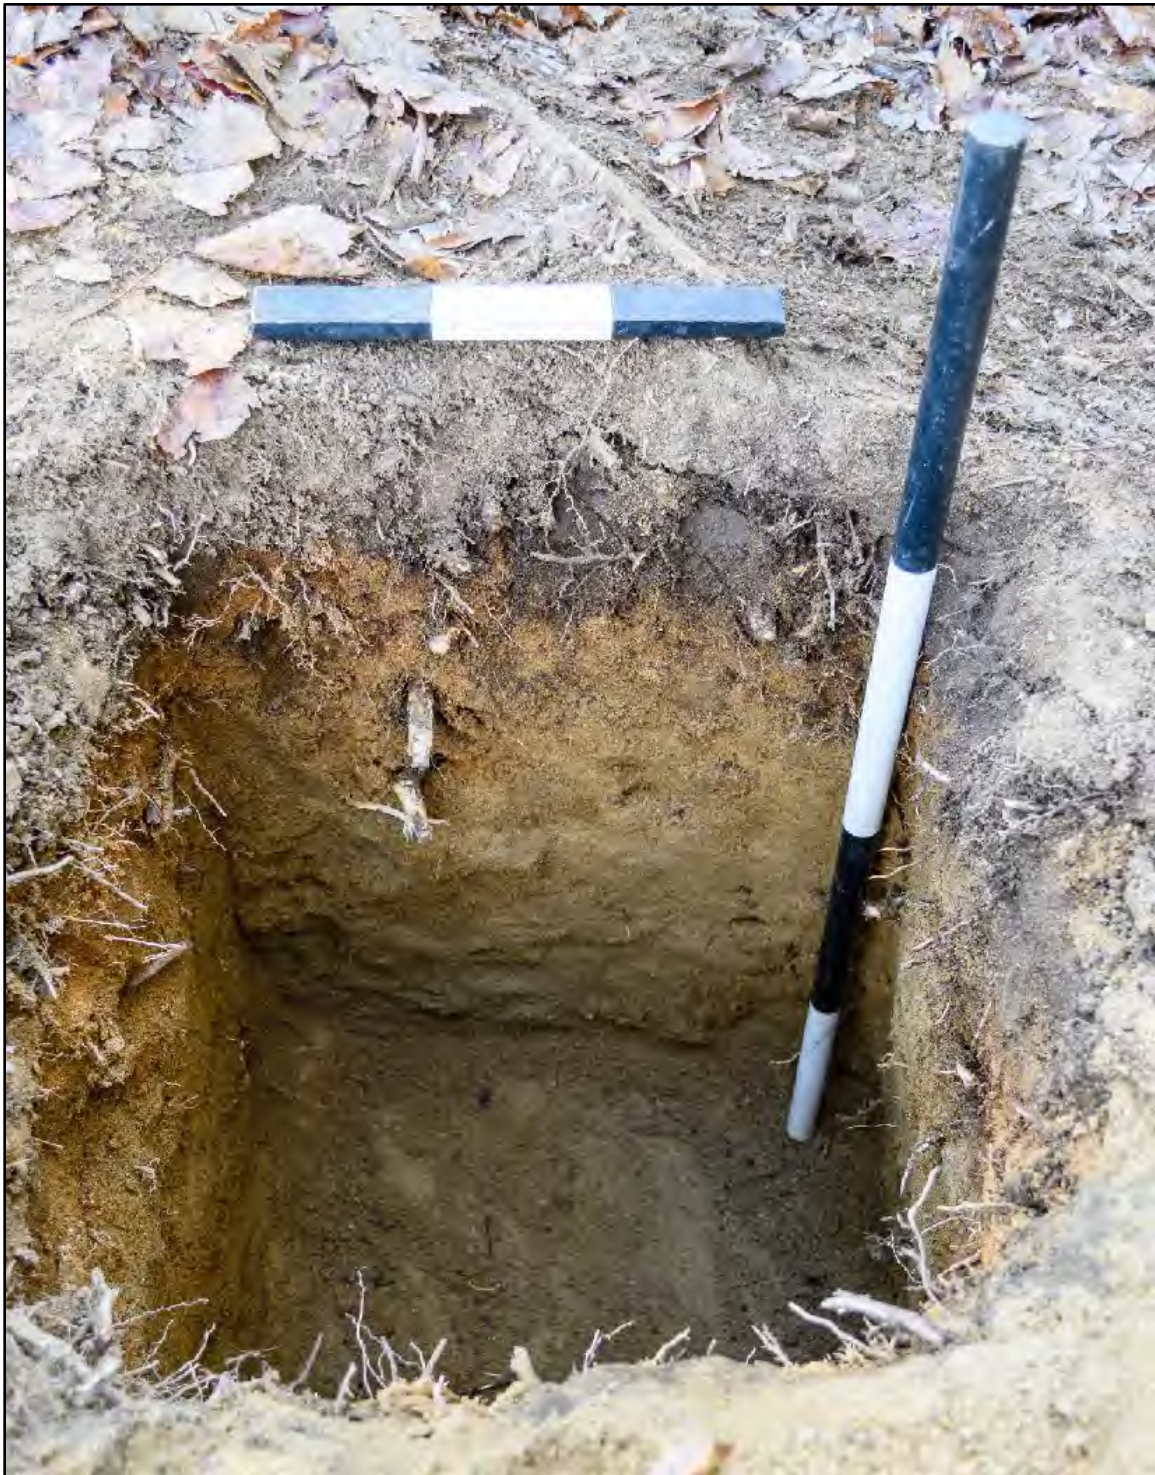
On the south side of the river, the two southern-most STPs revealed a similar stratigraphy of sand to a depth of 78 cm dbs (depth below surface). The STP (N200 E100) closest to the river (~25 m south of edge) also consisted of sand as its major sediment constituent but also included an elevated amount of gravel, pebbles and cobbles (often tabular) and likely ended very close to bedrock.

Figure 6: South wall of STP N100 E100 – South side.

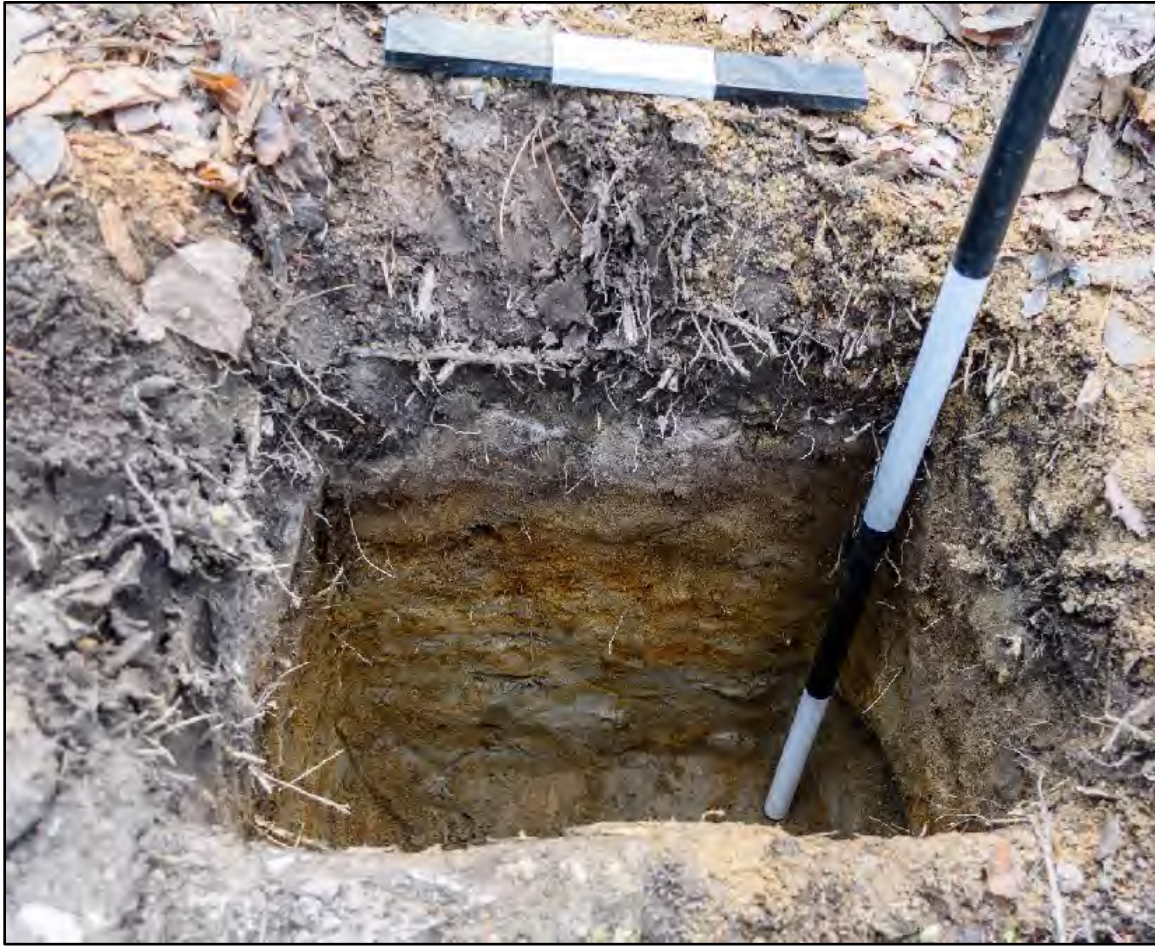
Figure 7: South wall of STP N150 E100 – South side.

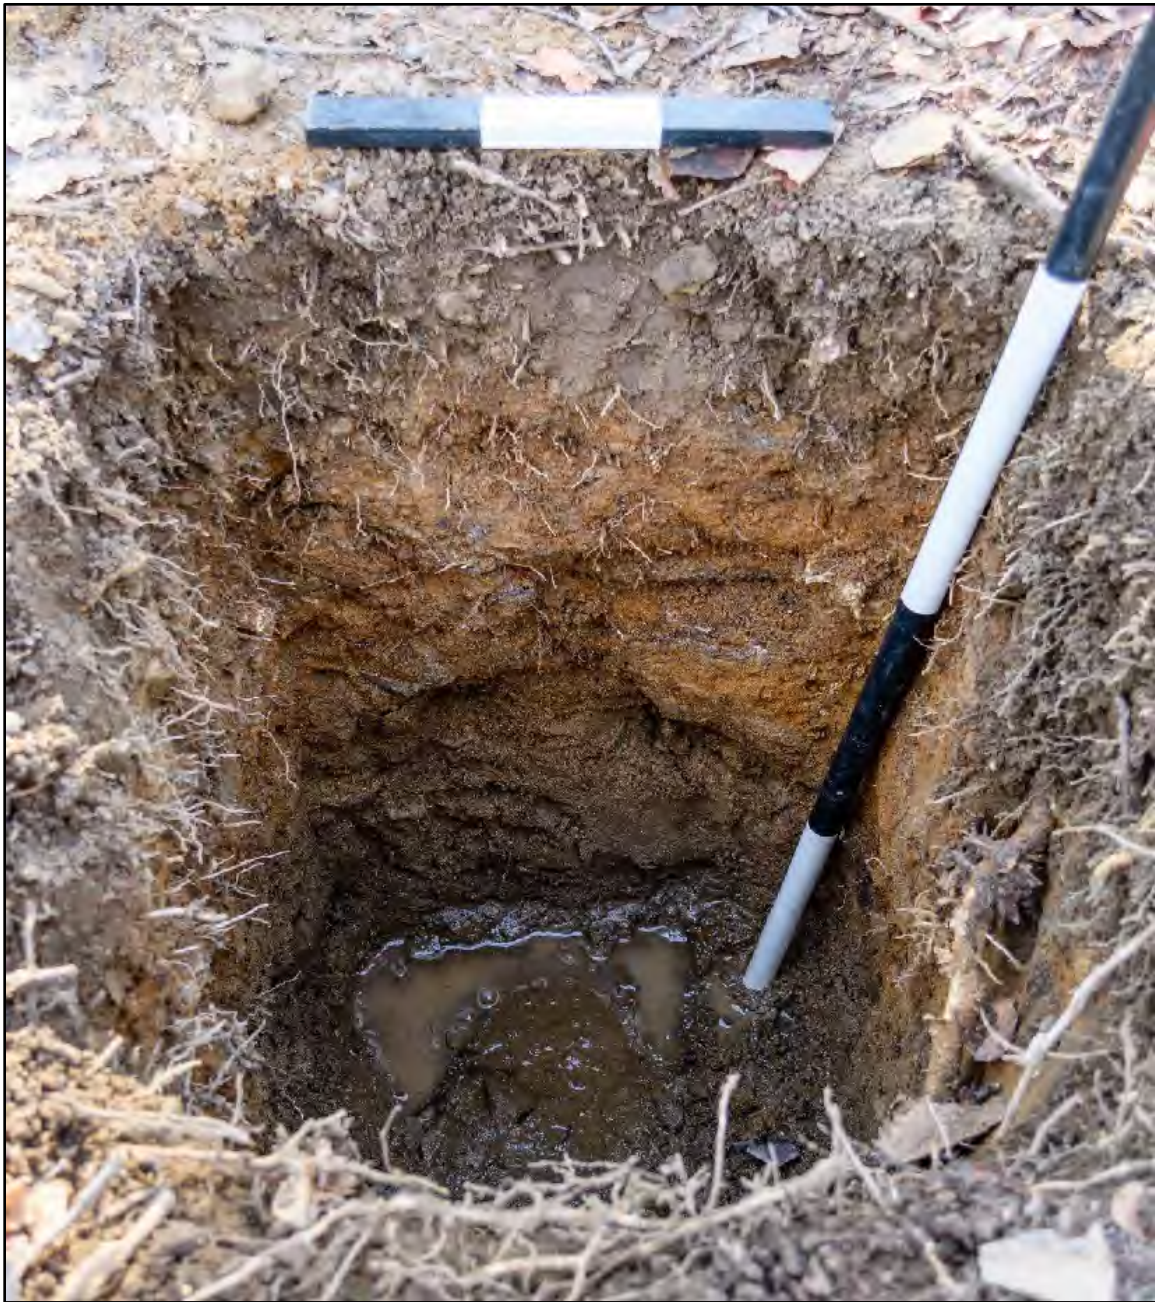
Figure 8: South wall of STP N200 E100 – South side.

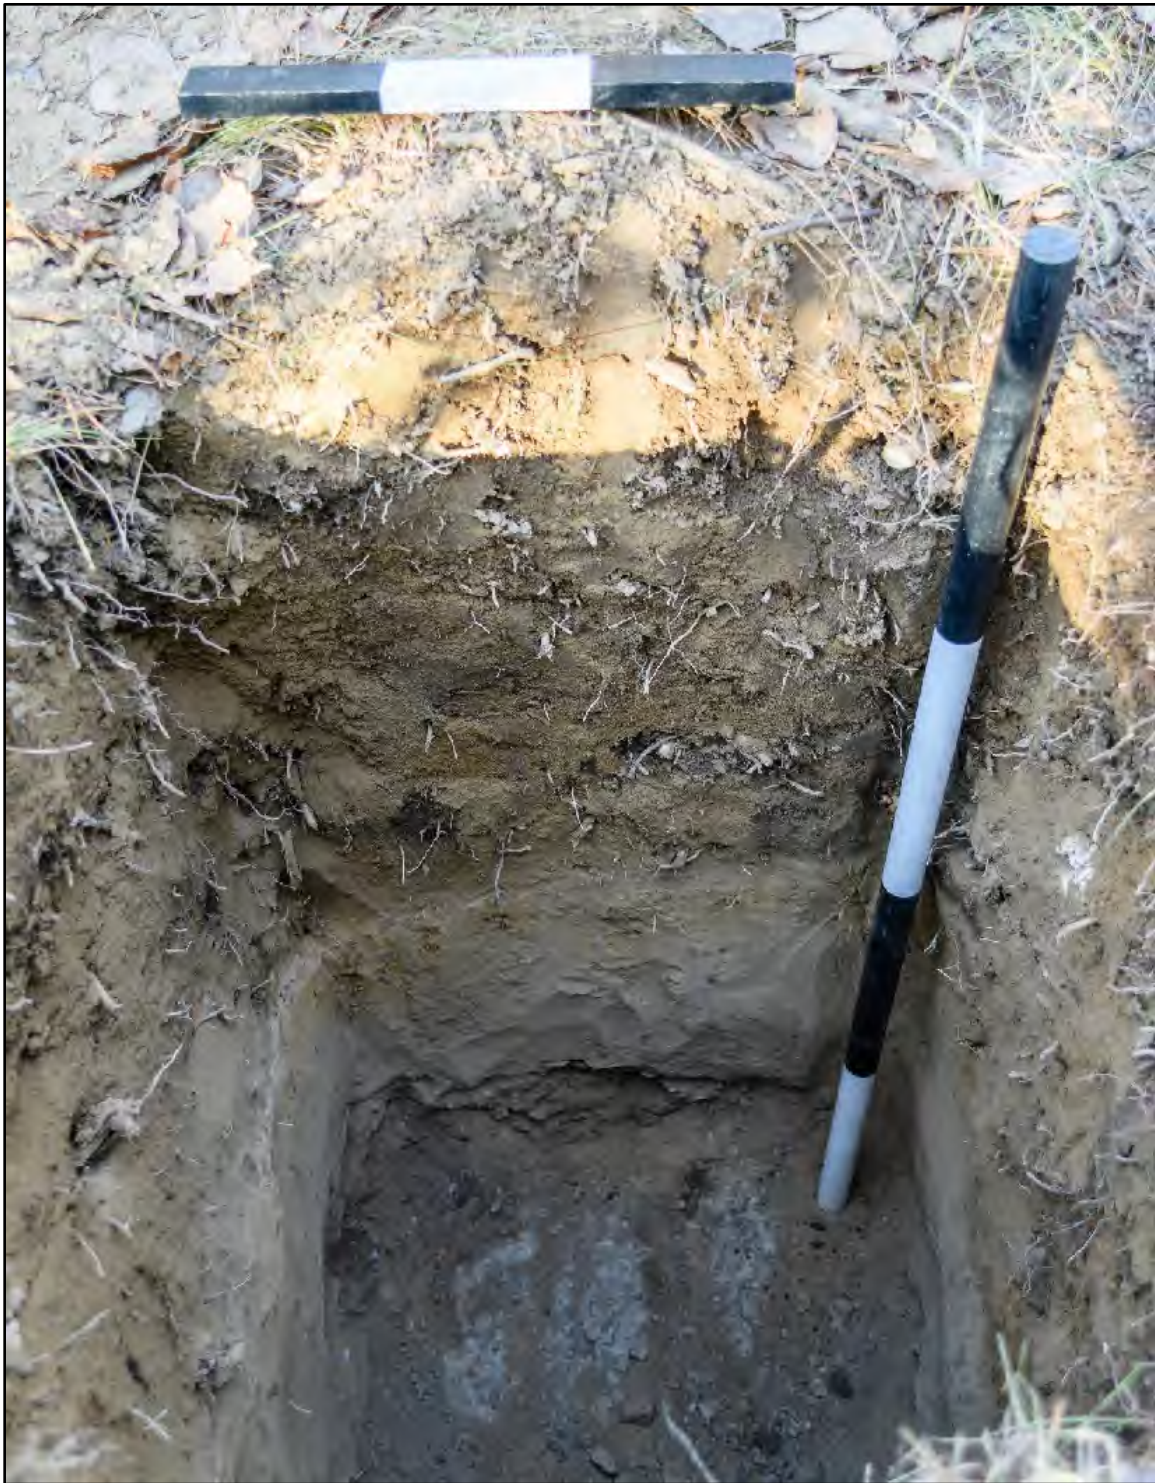
A total of seven STPs were excavated on the north side of the river, beginning with N100 E100 placed ~25 m from the river's edge and each one after at ~50 m apart. STP N100 E100 had ~33 cm of local fill over the original surface. Once the original "A" horizon was removed, a single quartz flake was recovered in screen, at ~50 cm dbs. A fragment of brown bottle glass and white refined earthenware was recovered from the upper disturbed layer (not retained). Numerous quartz flakes were recovered from the shoreline, nearest this test pit on the October 7th pedestrian survey. Moving north, the majority of the STPs were similar with a couple of exceptions; STP N250 E100 exhibited ~38 cm of sand over silty-clay. All of the excavated portion of STP N300 E100 was also silty-clay. It is likely that much of the original surface here was altered through construction activity associated with the nearby power line. One test pit (N200 E100) was skipped as it was in the middle of a 'wetland'.

Figure 9: North wall of STP N100 E100 – North side.

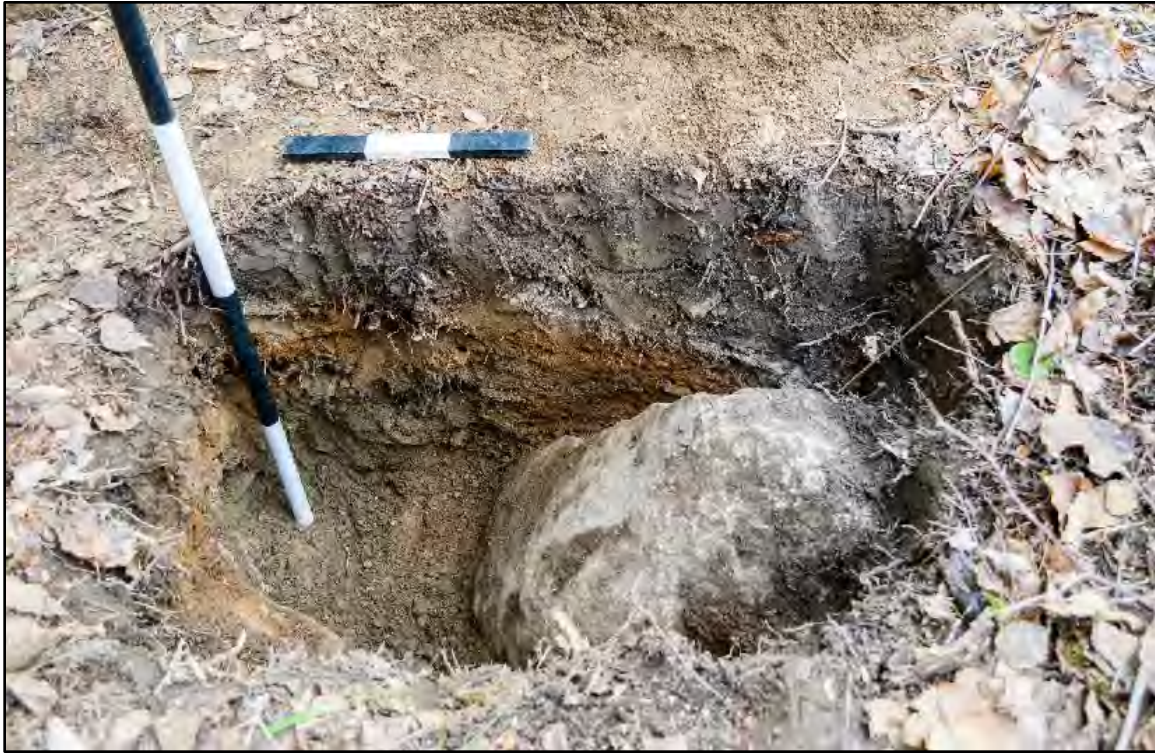
Figure 10: South wall of STP N150 E100 – North side.

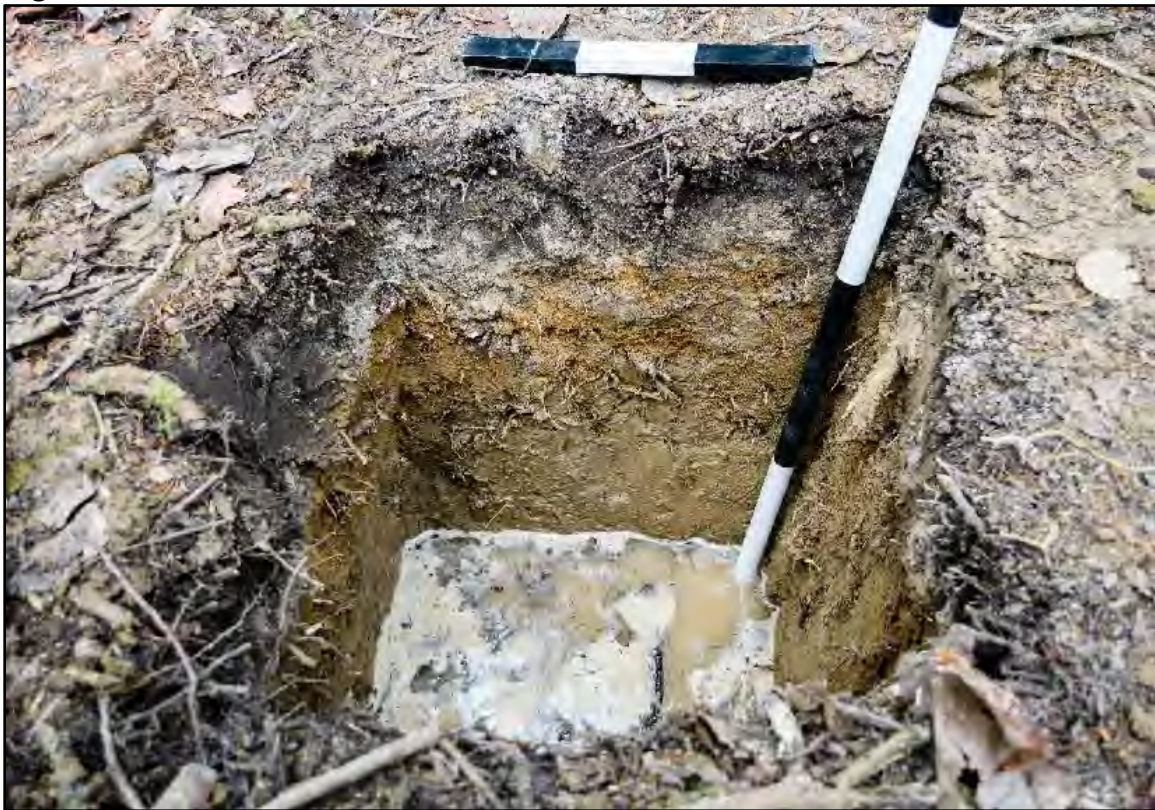
Figure 11: West wall of STP N250 E100 – North side.

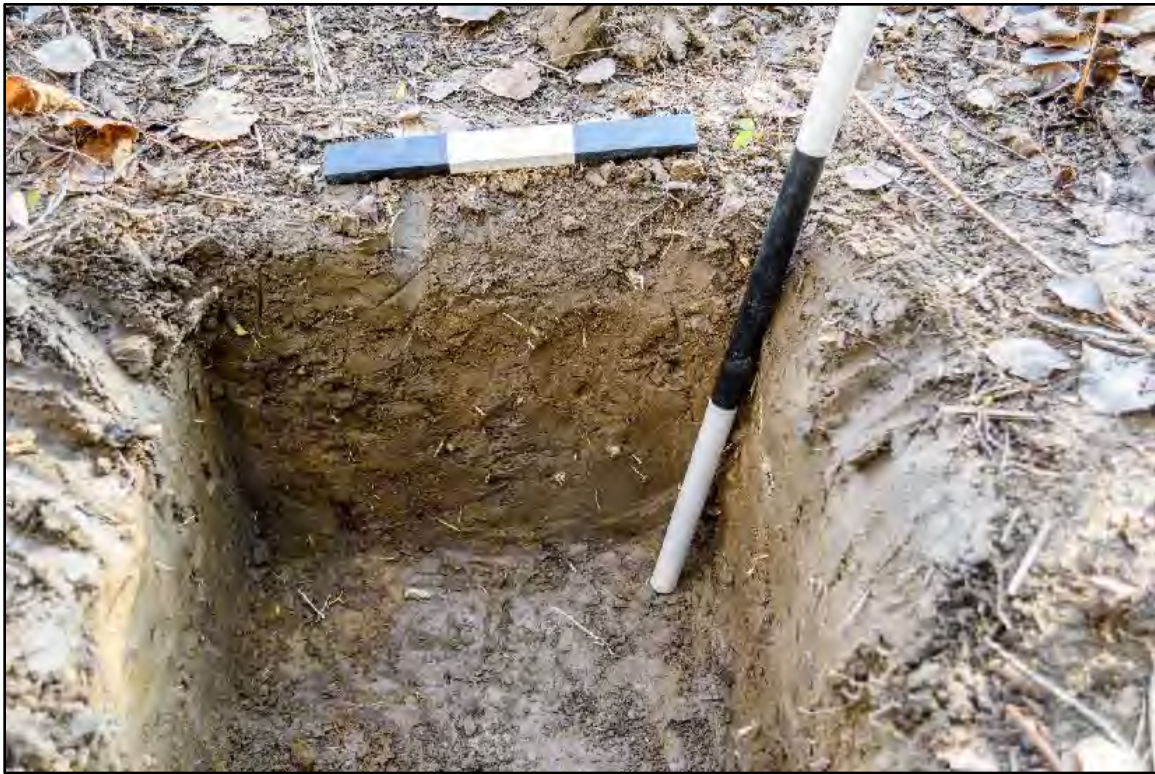
Figure 12: South wall of STP N300 E100 – North side.

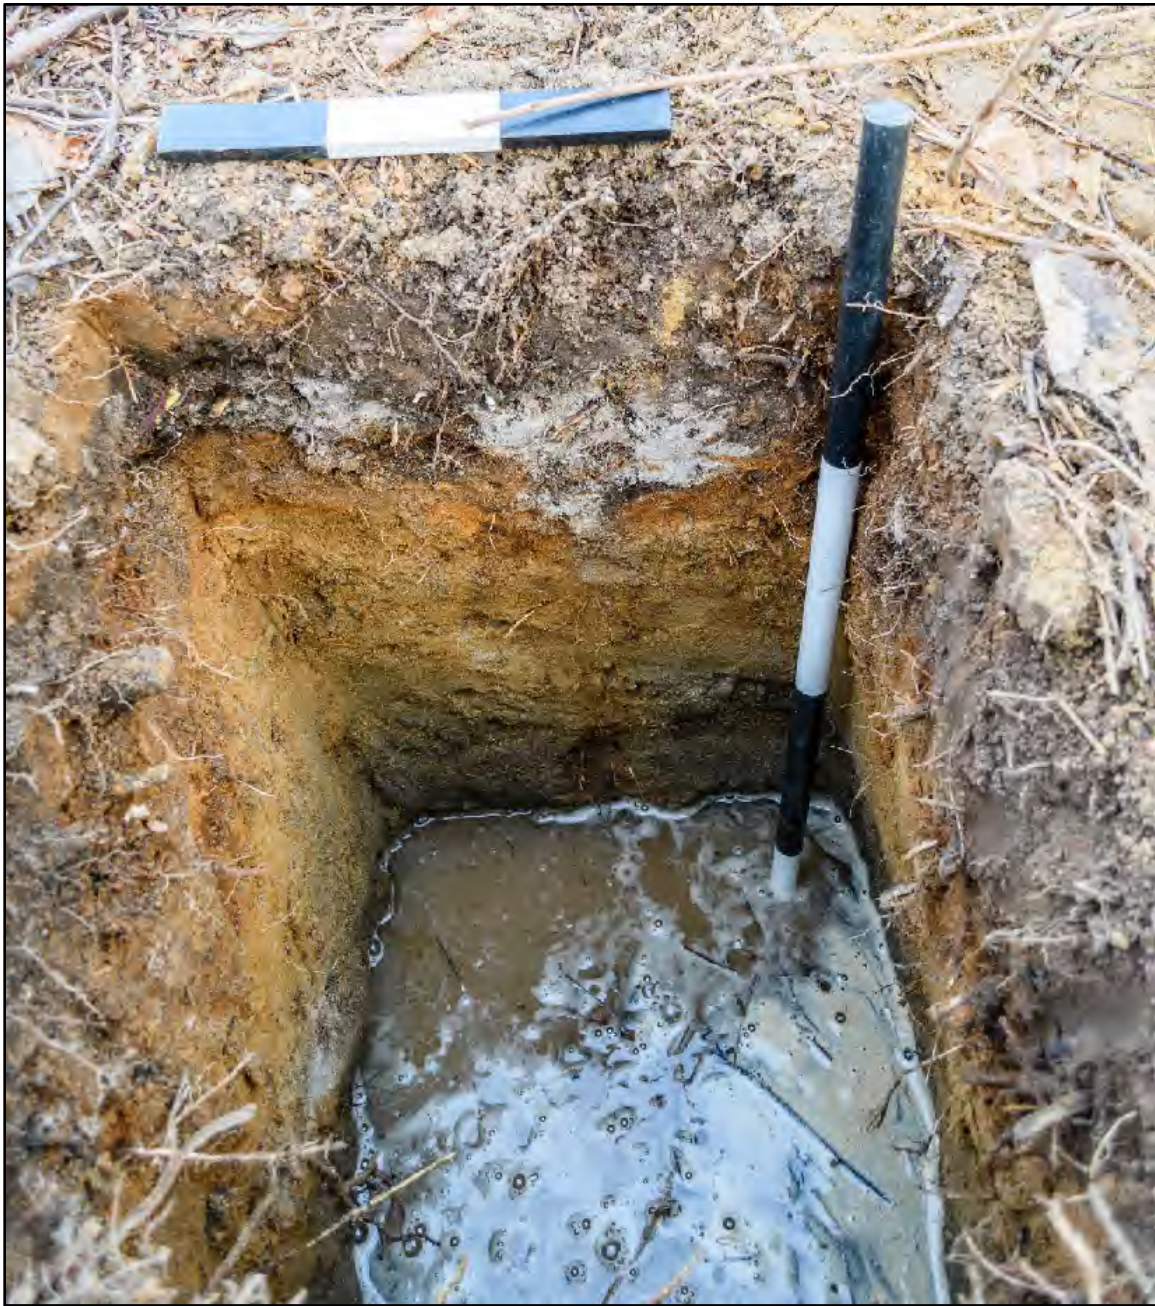
Figure 13: East wall of STP N350 E100 – North side.
