Appendix H VEC Heritage and Archaeological Resources

Project
EIA - NORTHWEST MIRAMICHI RIVER
NO.1 ANDERSON BRIDGE REPLACEMENT

**Archaeological Assessment of a Proposed Bridge Replacement in Miramichi
City, NB**

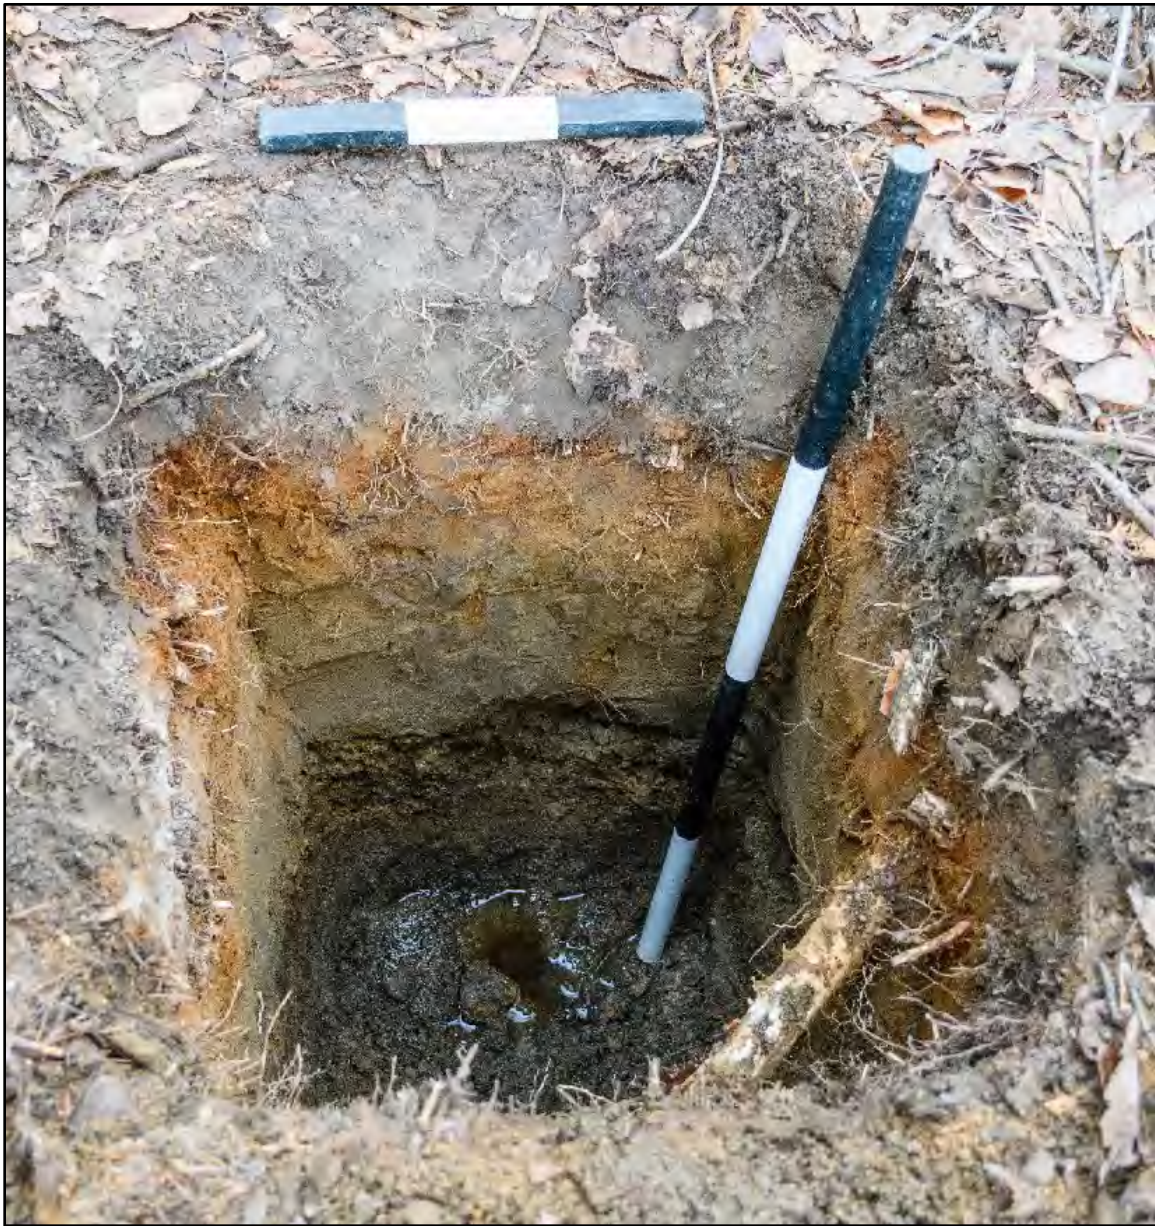
A total of seven STPs were excavated on the north side of the river, beginning with N100 E100 placed ~25 m from the river's edge and each one after at ~50 m apart. STP N100 E100 had ~33 cm of local fill over the original surface. Once the original "A" horizon was removed, a single quartz flake was recovered in screen, at ~50 cm dbs. A fragment of brown bottle glass and white refined earthenware was recovered from the upper disturbed layer (not retained). Numerous quartz flakes were recovered from the shoreline, nearest this test pit on the October 7th pedestrian survey. Moving north, the majority of the STPs were similar with a couple of exceptions; STP N250 E100 exhibited ~38 cm of sand over silty-clay. All of the excavated portion of STP N300 E100 was also silty-clay. It is likely that much of the original surface here was altered through construction activity associated with the nearby power line. One test pit (N200 E100) was skipped as it was in the middle of a 'wetland'.

Figure 14: West wall of STP N400 E100 – North side.

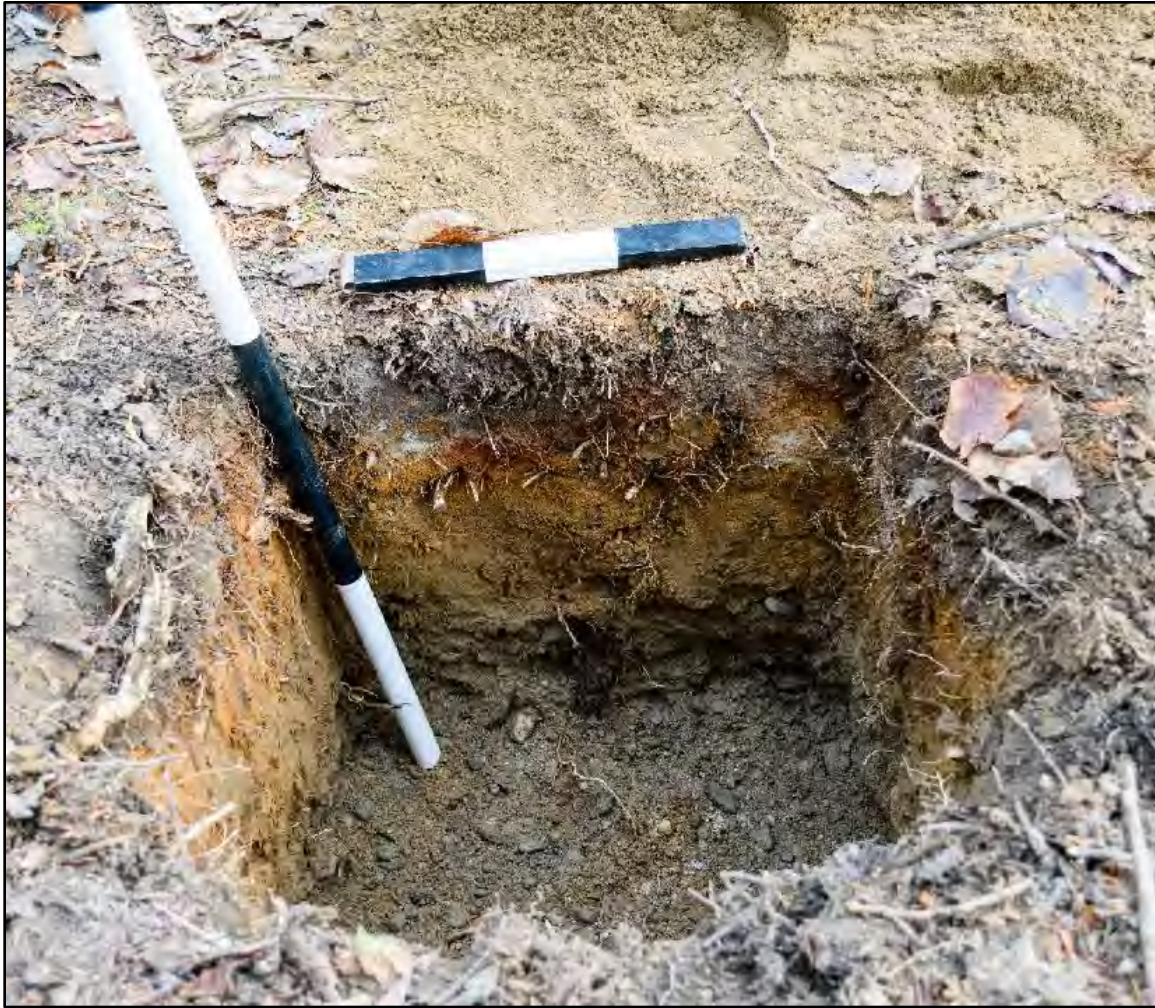
Figure 15: South wall of STP N450 E100 – North side.
