Environmental Assessment Report for EIA:

**Repairs to Retaining Wall at 11 Southers Road (Summerville)
Adjacent to Wetland**

October 22, 2018

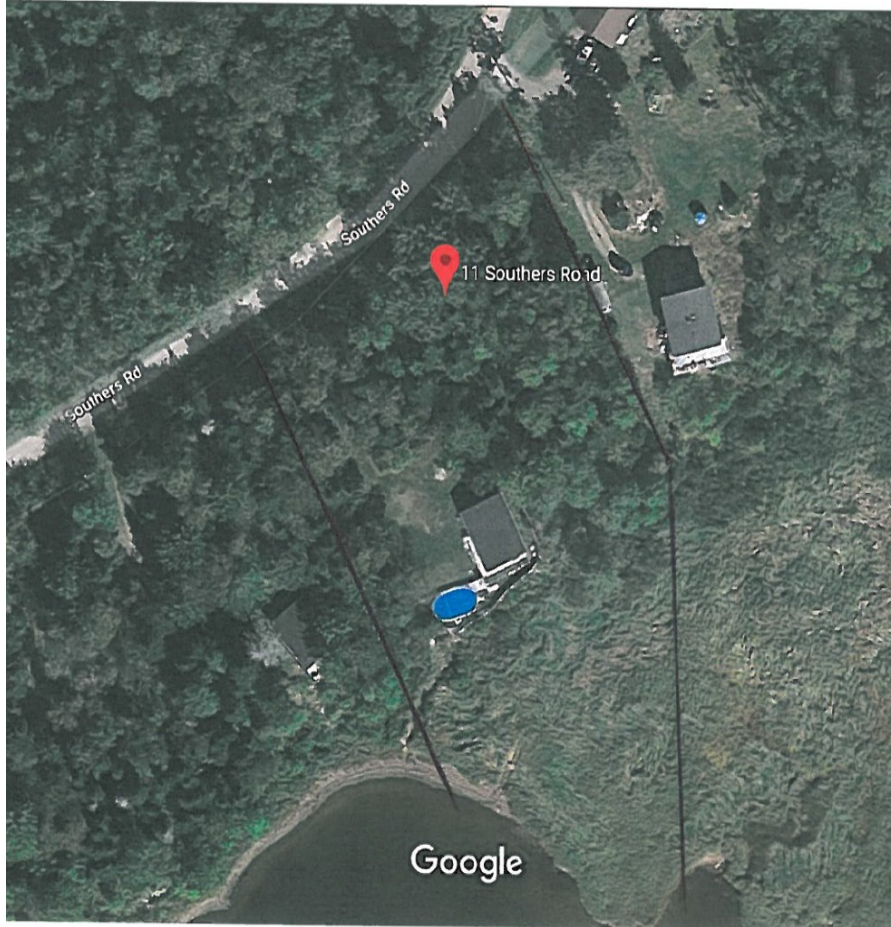
Figure 1. Aerial View of 11 Southers Road.

The project involves the construction of a retaining wall adjacent to the failing crib worked wall on a private residential property (11 Southers Road, PID 30036008; see Figure 1). The existing wall was impacted by the historic floods of 2018 and now the embankment is eroding and falling into the protected wetland (See Figure 2). The existing fence at the edge of the embankment will need to be removed during the construction of the retaining wall. The fence will be re-installed using as much of the original fence that is possible and replacing any portions that have not survived the erosion or dismantling. The stairs to the beach were detached this spring (caused by the flood of 2018). They will be re-attached and reused after the wall is completed. Any instability around the pool will be reinforced once the wall is in place. Once constructed, the wall will need little maintenance and there will be no future modifications or extensions needed. This new wall will help protect further erosion into the wetland and provide support and security to keep the house in its existing location.

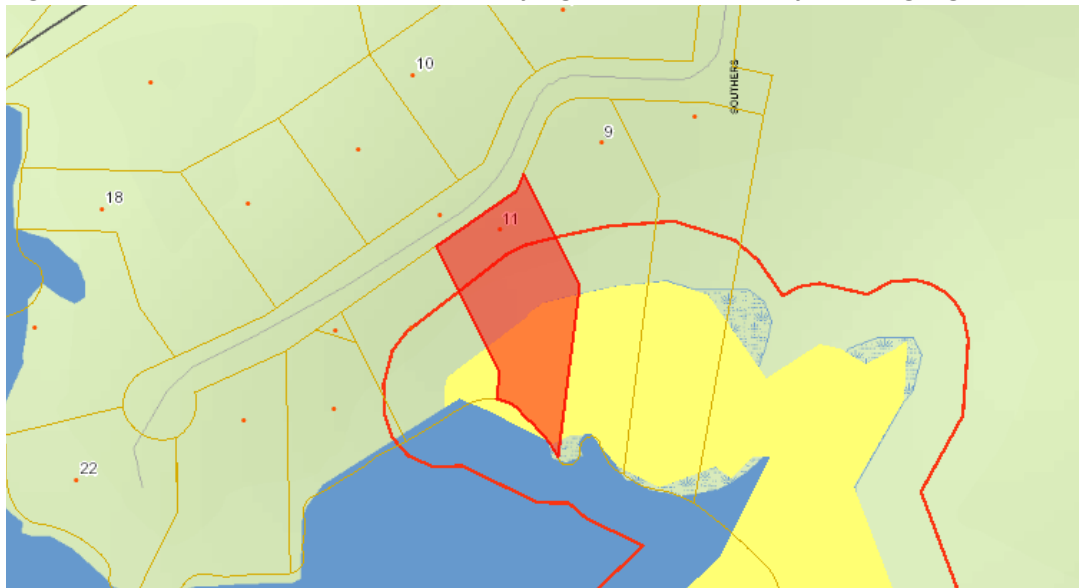
Figure 2: 11 Southers Road and Provincially Significant Wetland (yellow highlight).

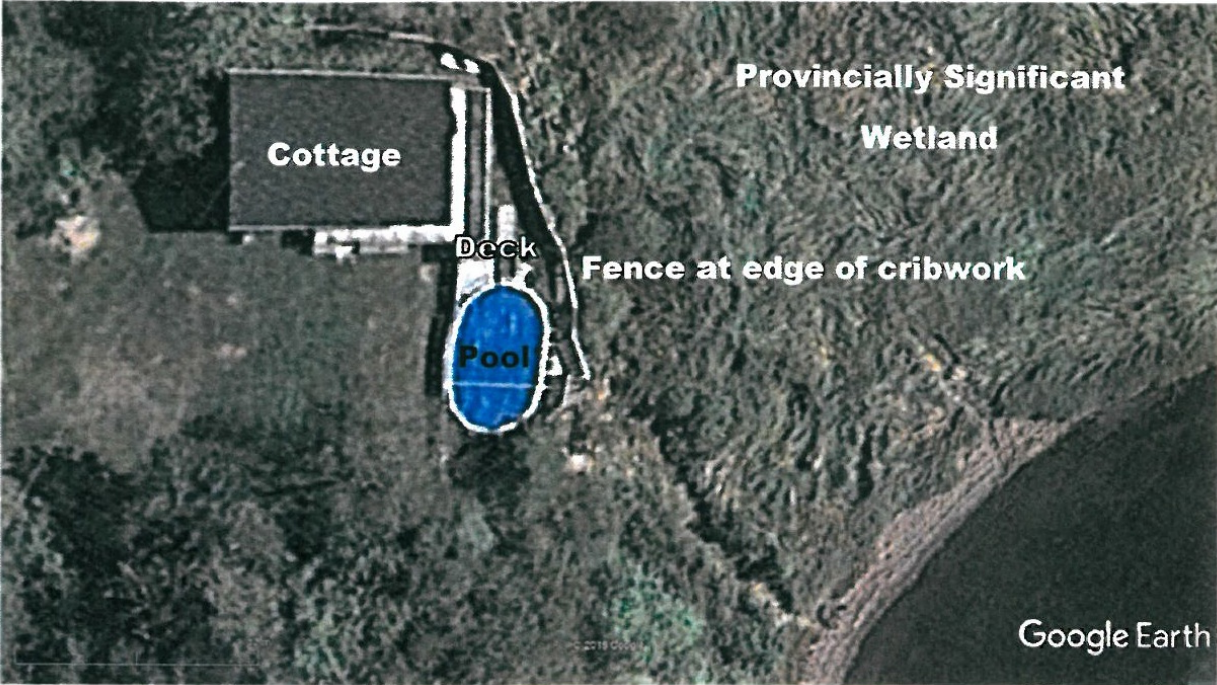
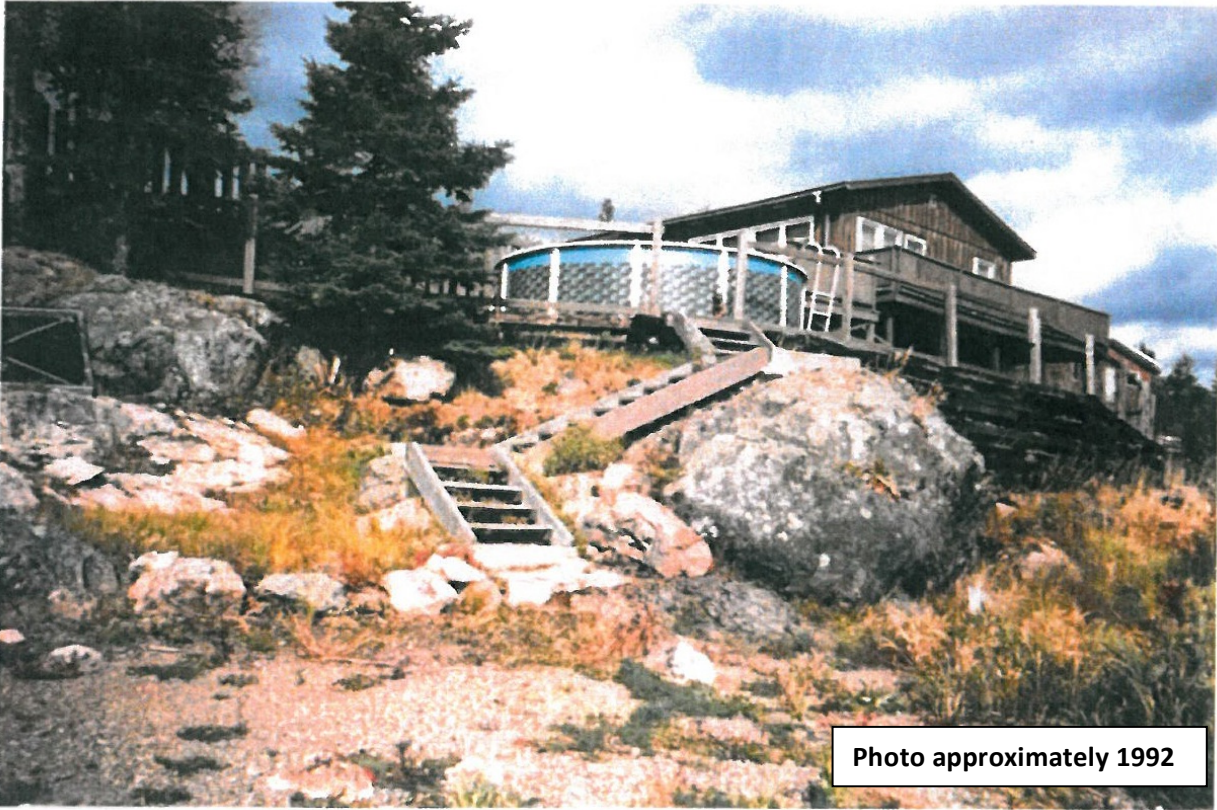
Figure 3. Aerial Photo showing location of existing cribwork retaining wall in relation to the house/cottage and lower photo of the property from the wetland.

Due to spring flooding of 2018, the edge of the property is eroding and has weakened or impacted the existing retaining (cribwork) wall (Figure 3). The house is at risk of falling over the embankment and into the protected wetland as the house /pool/fence are protected with cribwork which consists of “railway tie” type cribs of wood that are coated in creosote. This existing cribwork has been damaged from the 2018 flood and is no longer properly supporting the property and its infrastructure. The integrity of the cribwork is failing and the soils and fill are being washed away (See Figure 4 and 5). The house/pool and fence are at risk of going over the bank. The high water and winds in the spring has caused whatever material was stabilizing the cribwork to be washed away. The Engineering Report (Appendix 1) does not recommend touching the existing wall as this could cause imminent failure and damage to the house, as well as the wetlands. The original rationale for this project is summed up in the letter from Fundy Engineering (Appendix 2) and the enclosed final design of the wall (Appendix 3).

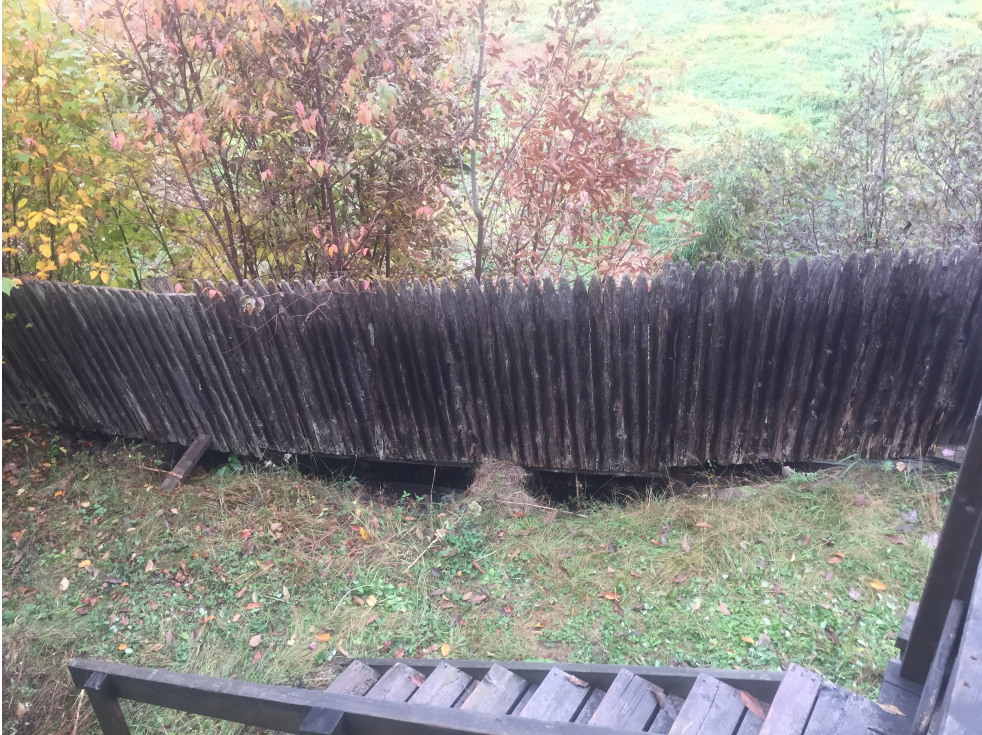
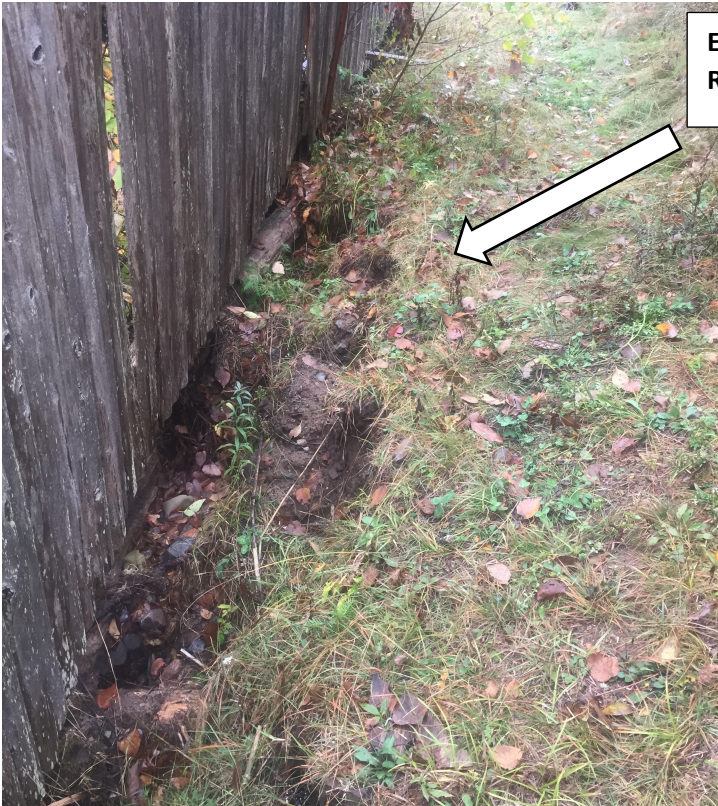
Figure 4: Two Photos of Erosion at Base of Fence. Retaining Wall on Opposite Side.

Erosion of Fence due to Weakening of Retaining Wall. Fence side.

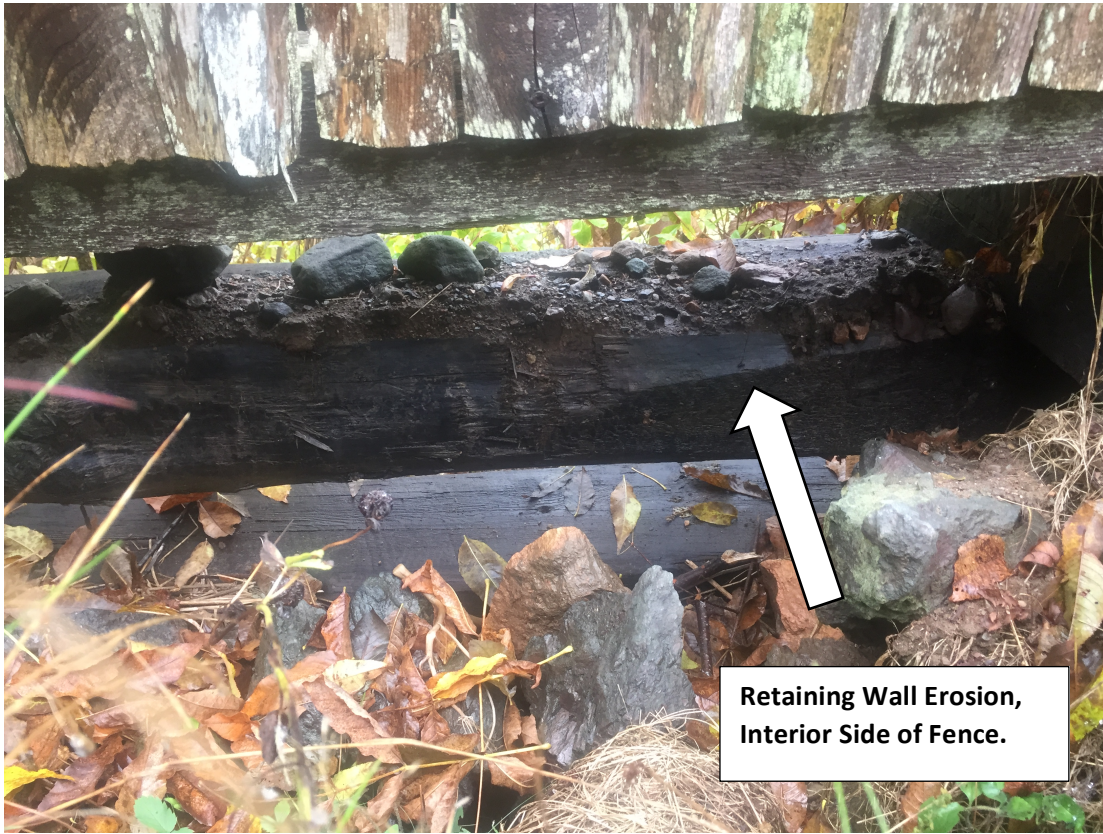
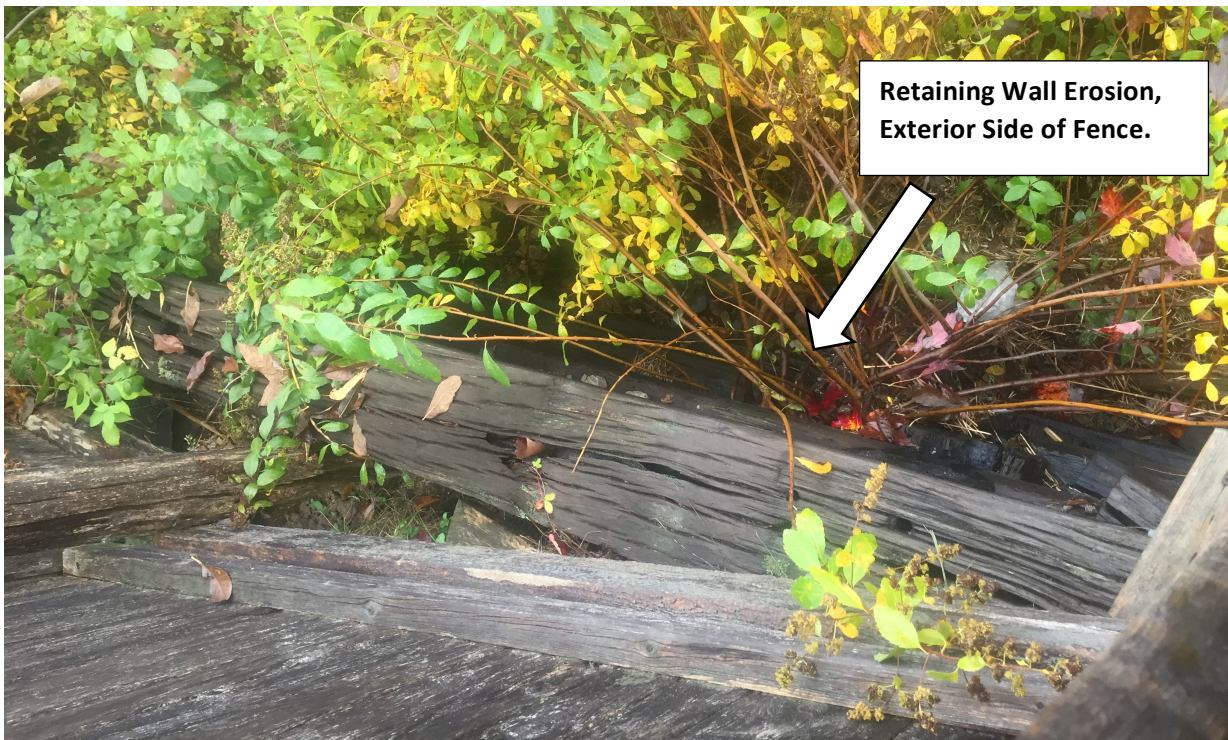
Figure 5: Existing Retaining Wall at Base of Fence Damaged by Spring 2018 Flood

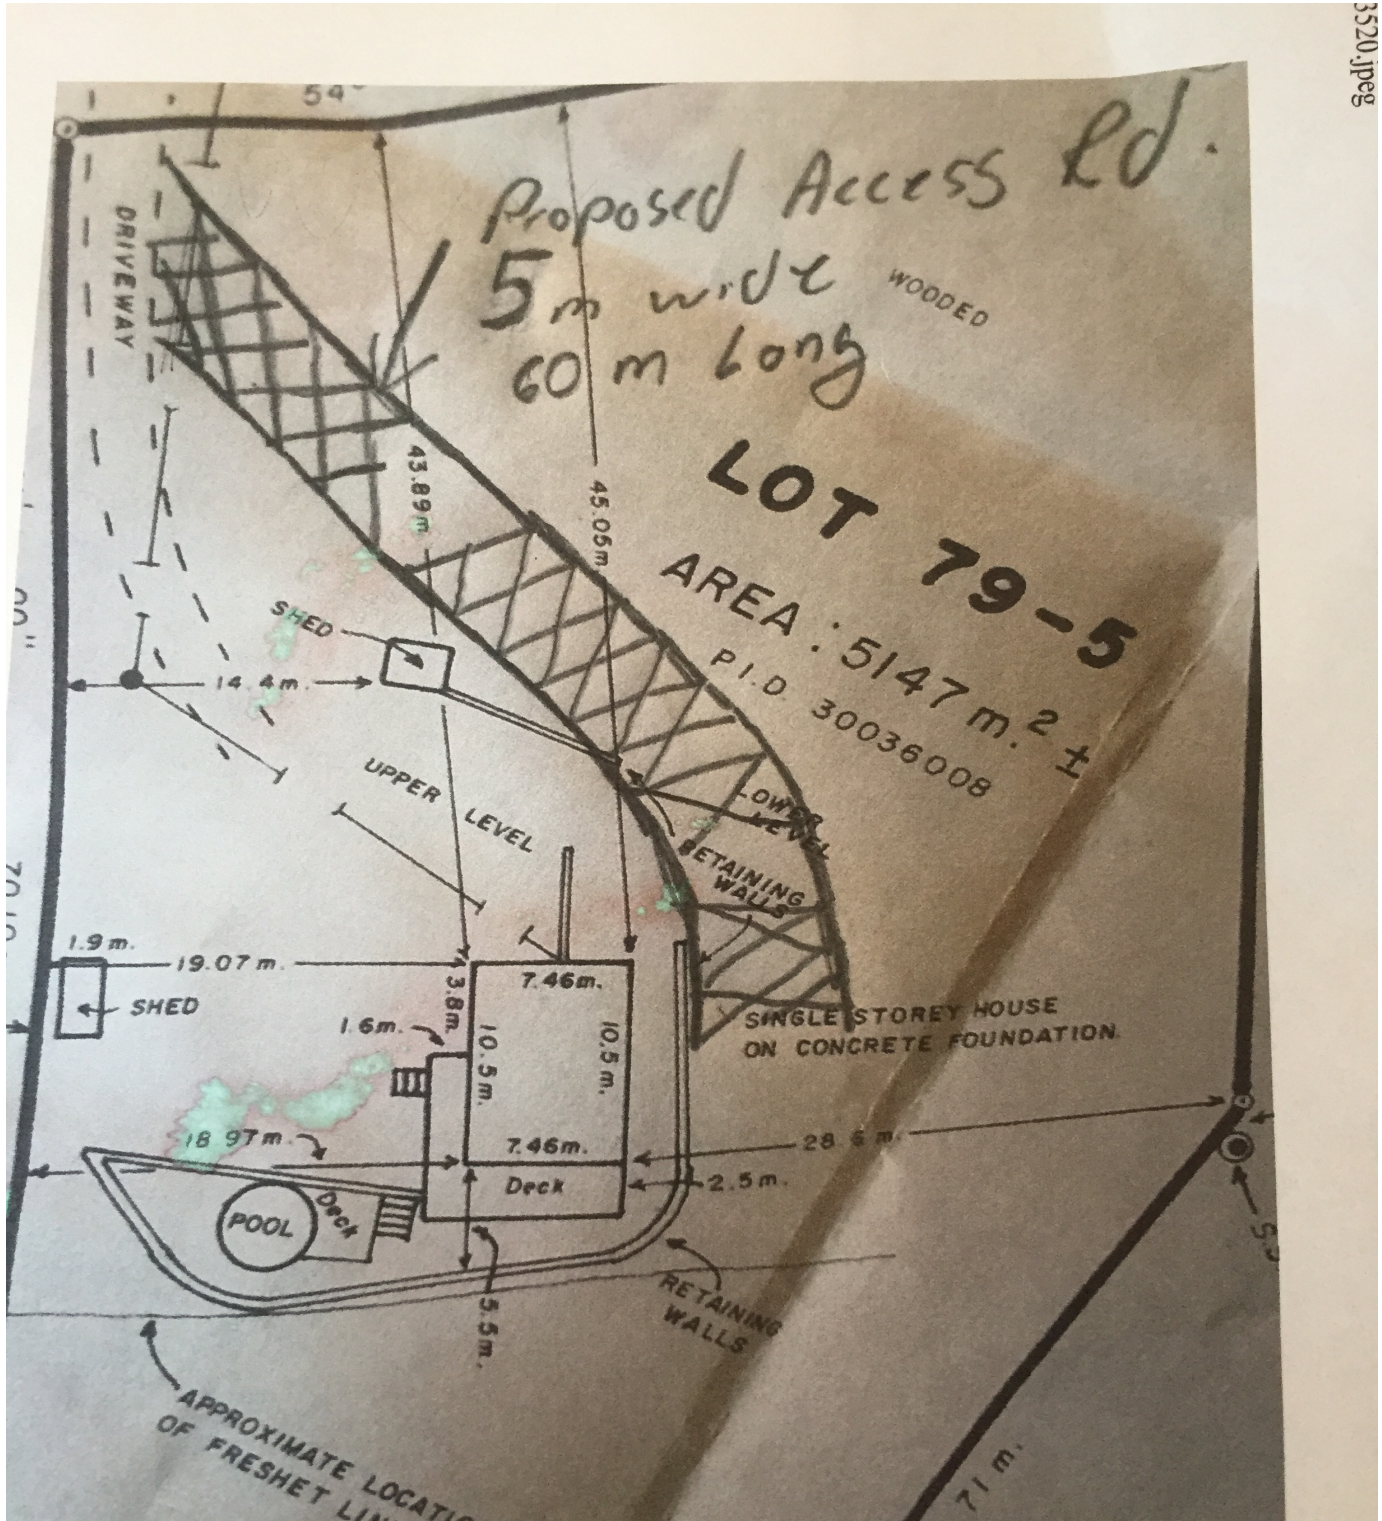
Appendix 8: Sketch Showing the Access Road.

Approximately 3 feet of mud will be dislocated for the base of the wall to be constructed. This material will be re-used on the top of the base and to create the slope. The access road will be constructed off the main private driveway on the property (see Appendix 8).

Sketch of Temporary Access Road can be found in Appendix 8.

The construction is thought to take approximately 4 weeks. Stage 1 will be building the access road shown in Appendix 8 will take approximately 4 days. Step 2 of removing the overburden will take approximately 3 days and the final Step will take approximately 2-3 weeks and consist of layering the rock and fill.
