**Underwater Benthic Habitat
Survey and Marine Sediment
Sampling Program (Final)
Anse-Bleue Small Craft Harbour,
Gloucester County, New
Brunswick**

**DFRP No. 04898
RPIS No. MS 02502
SCH No. 02502**

**PUBLIC SERVICES AND
PROCUREMENT CANADA FOR
FISHERIES AND OCEANS CANADA**

October 2018

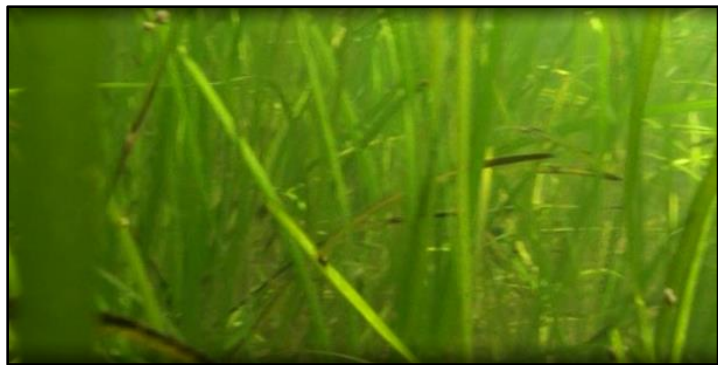
The proposed containment cell area is comprised primarily of eelgrass beds (10 to 100% cover) overlying sandy substrate (between <5% and 60% cover). The eelgrass appears to be in good health and due to the thickness of the beds in this zone the observation of macrofaunal species was limited; however, Atlantic rock crab (*Cancer irroratus*); Periwinkle

Typical condition of the eelgrass beds observed within the proposed containment cell area.

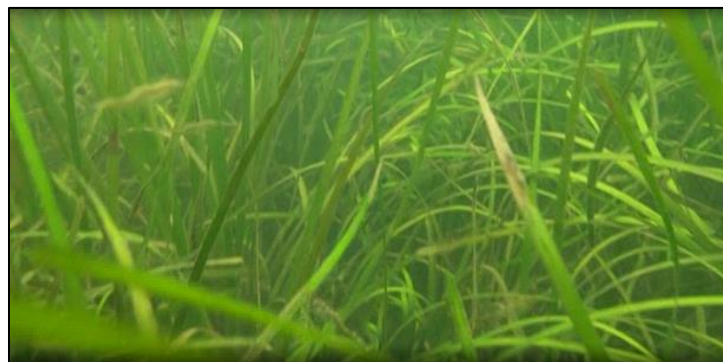
Typical condition of the eelgrass beds observed within the proposed dredge area.

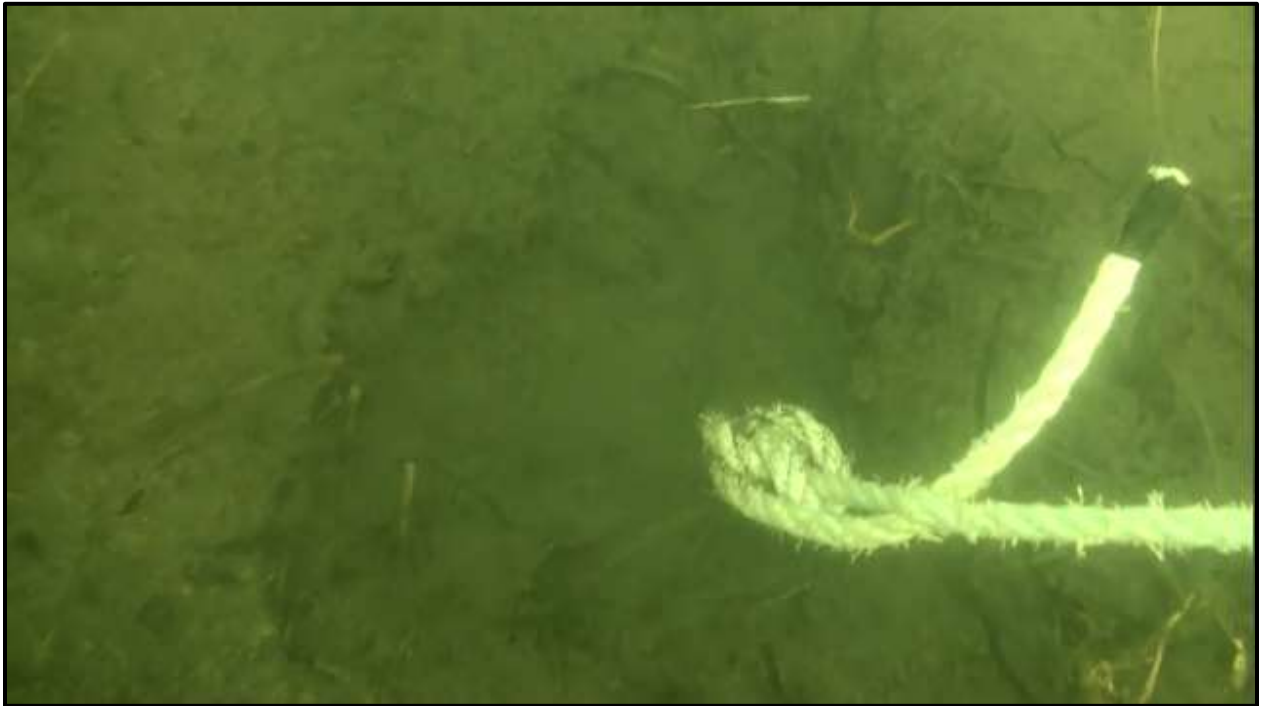
Photo 1: SS18-1 – Cover is primarily decaying seaweed and woody debris (July 18, 2018).

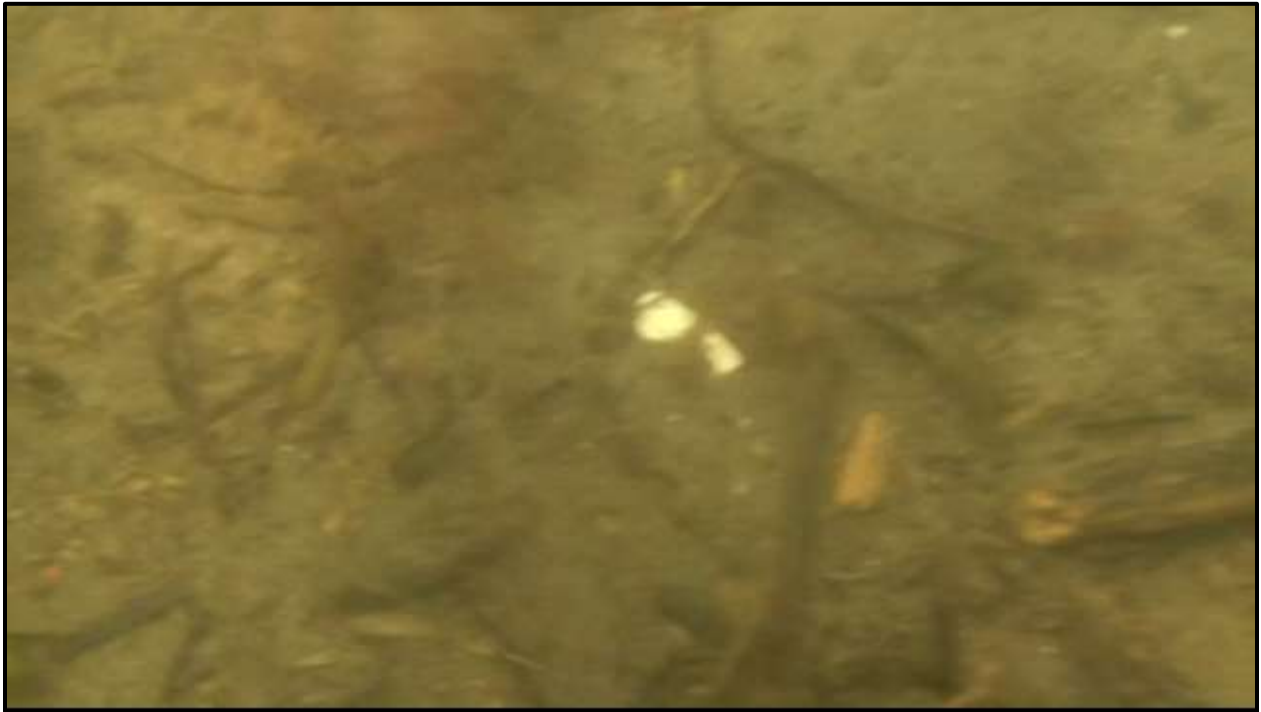
Photo 3: SS18-3 – Sandy substrate with some shell hash and woody debris (July 18, 2018).

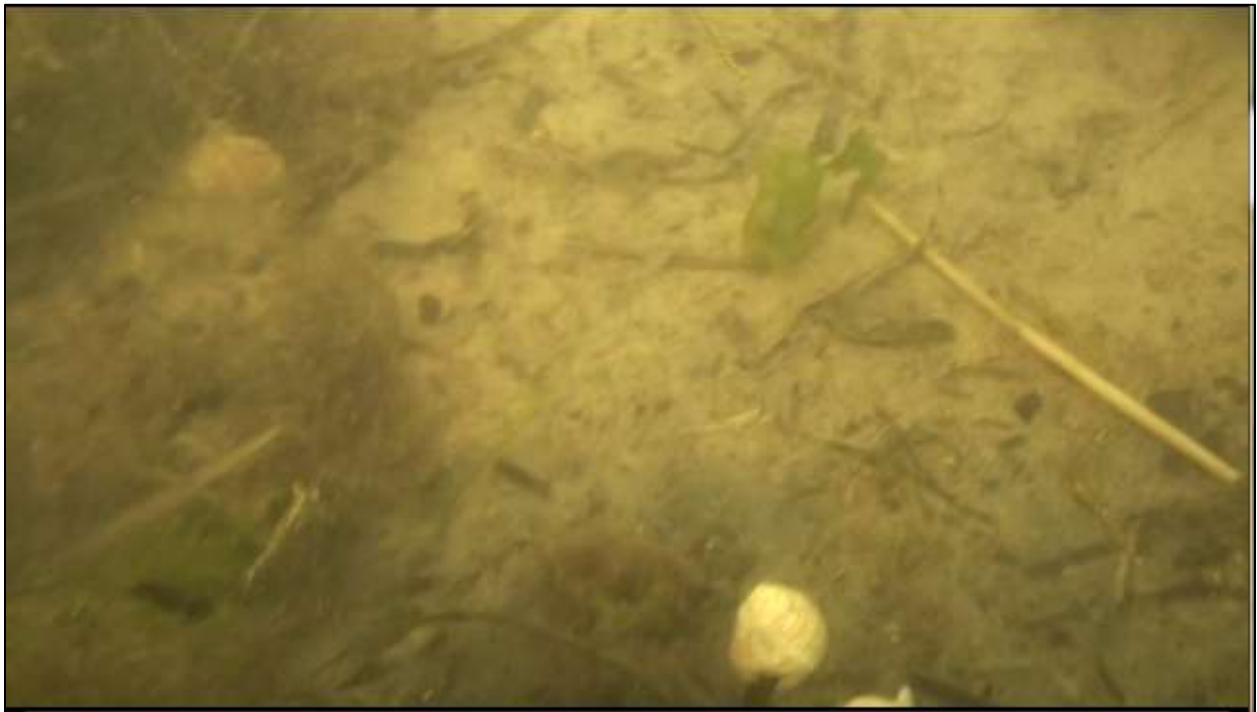
Photo 5: SS18-5 – Sandy silt substrate with decayed eelgrass and woody debris (July 18, 2018).

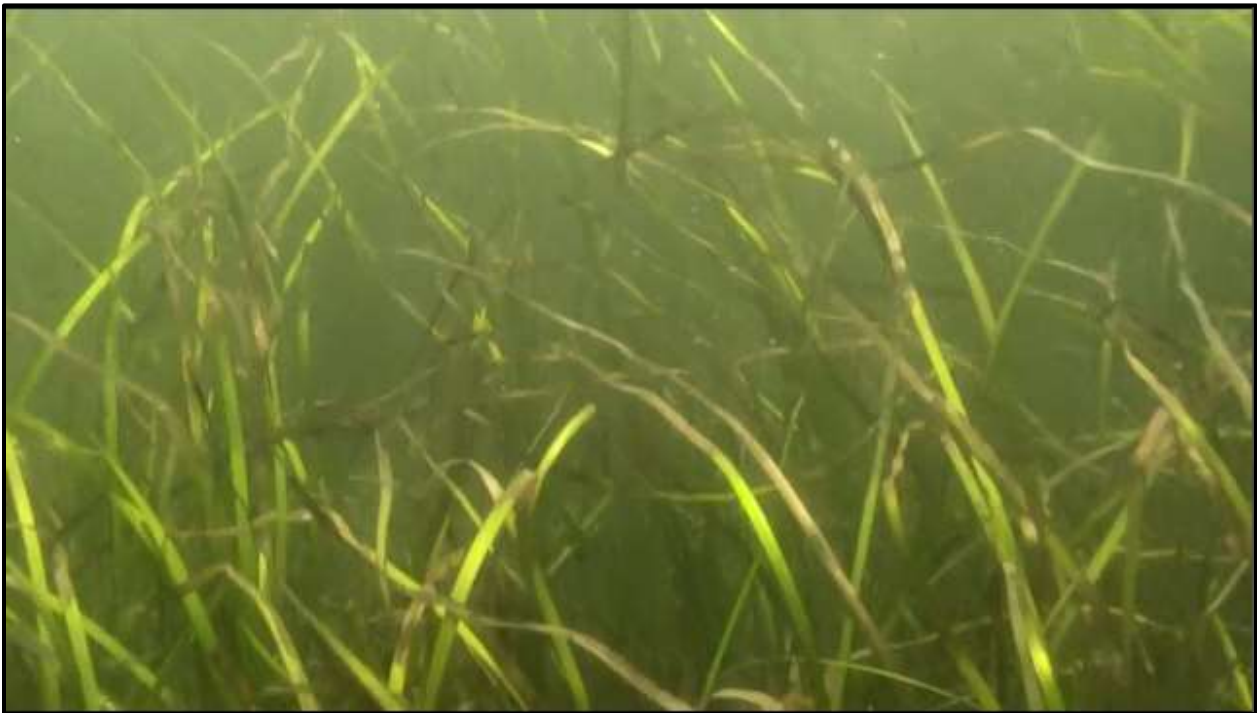
Photo 6: Eelgrass in the vicinity of SS18-6 (July 18, 2018).

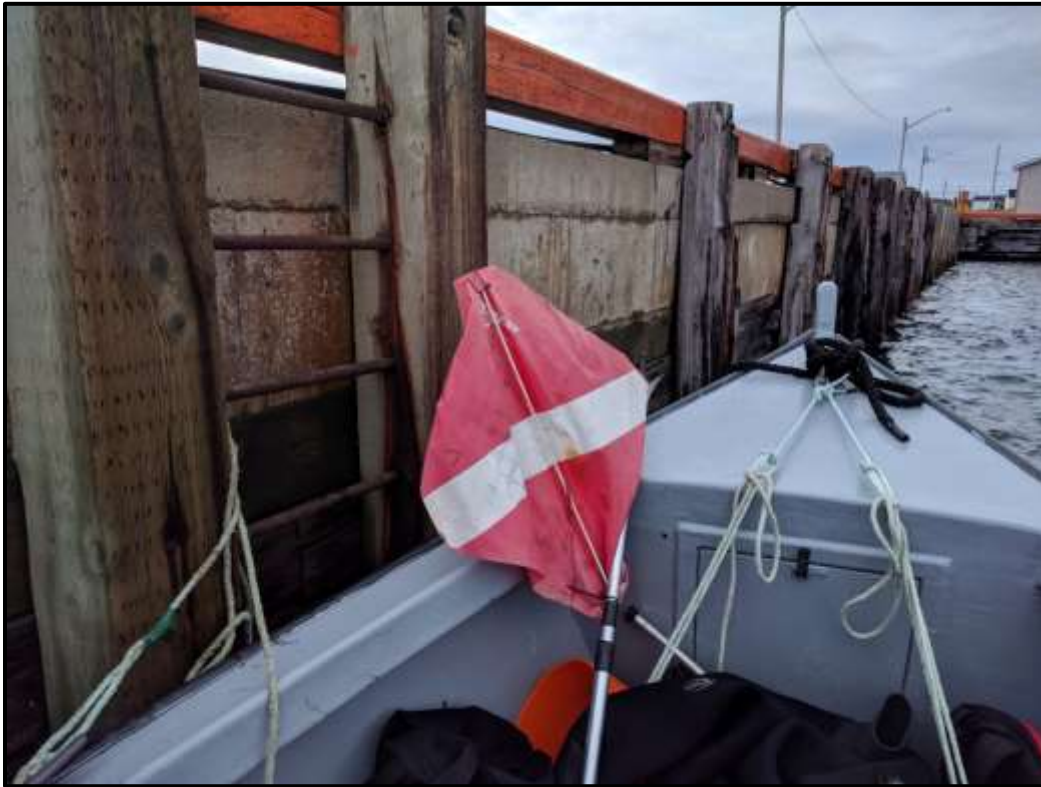
Photo 7: Demonstrating the depth from the top of the water to the top of the wharf (approximately 2 meters) at the time of sediment sample collection (July 17, 2018).

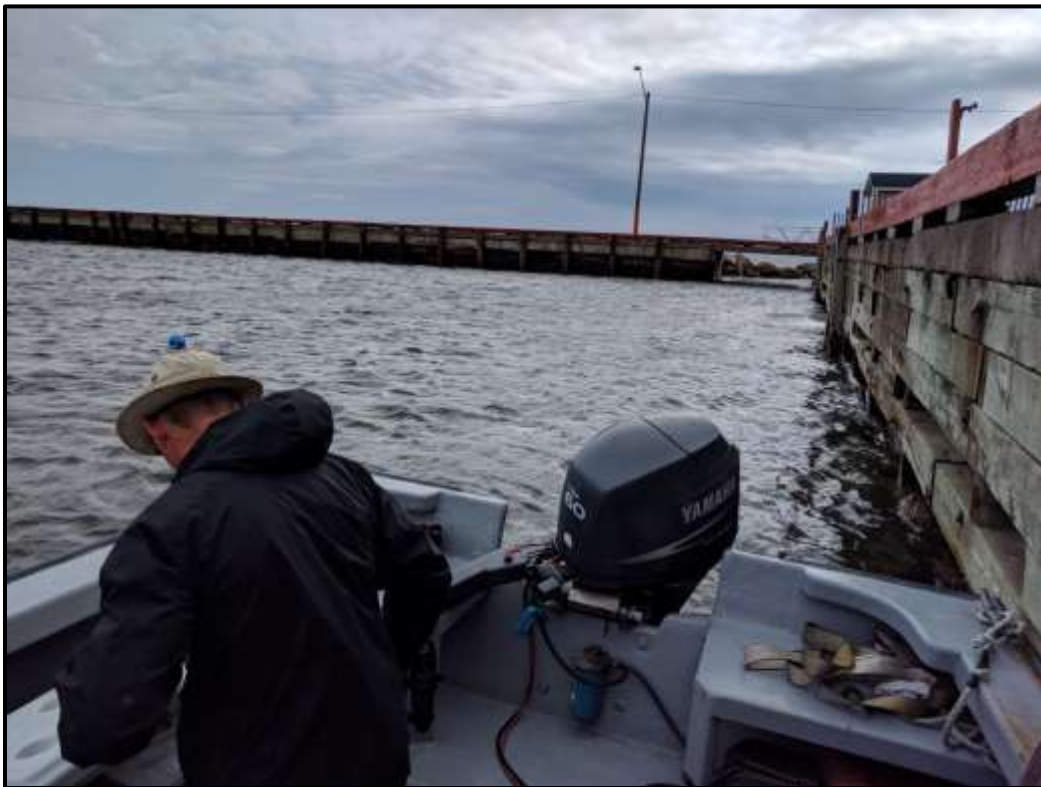
Photo 8: Demonstrating the depth from the top of the water to the top of the wharf (approximately 2 meters) at the time of sediment sample collection (July 17, 2018).

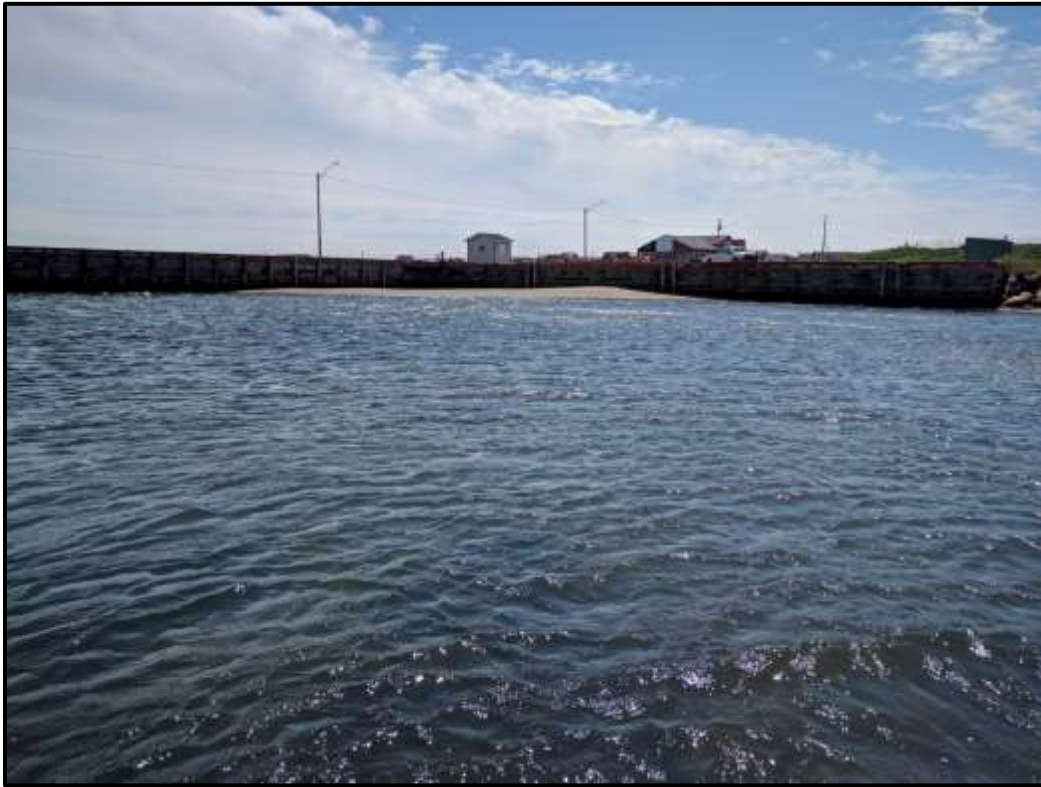
Photo 9: Looking southeast across the waterlot at the timber wharf and ice shed (July 17, 2018).

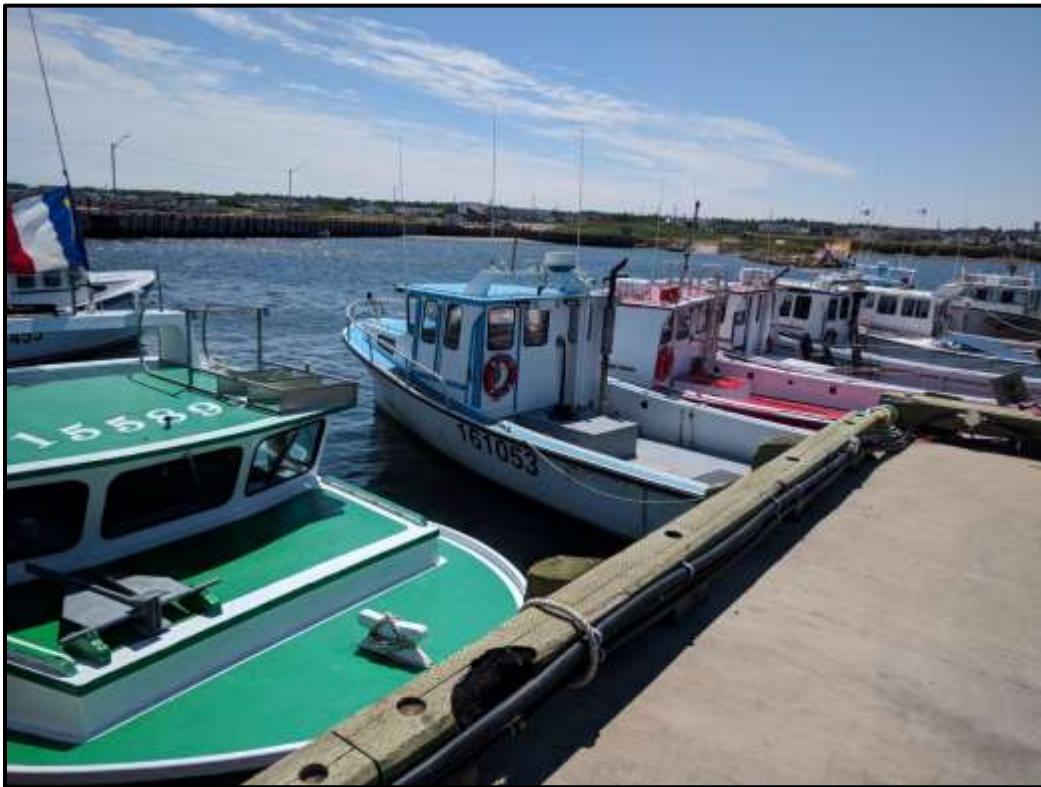
Photo 10: Looking northwest across the waterlot at the docked fishing boats and the breakwater (July 17, 2018).

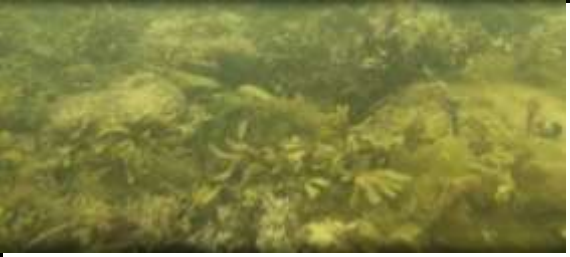
5-10	Sandy substrate with scattering of macroalgae debris.	Patches of anchored macroalgae dominated by eelgrass (<i>Zostera marina</i>), with a minimal amount of bladderwrack (<i>Fucus</i> sp.) mixed in, were observed along the ocean floor. One Atlantic Rock Crab (<i>Cancer irroratus</i>) was observed.

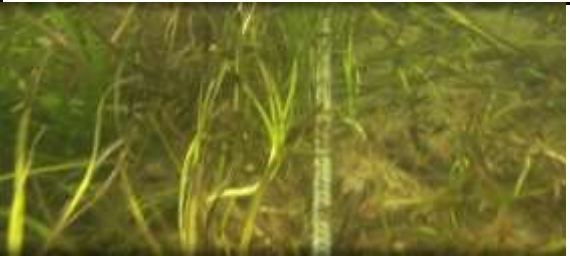
10-15	Sandy substrate with scattering of macroalgae debris.	Dense patches of eelgrass (<i>Zostera marina</i>) were observed along the ocean floor.

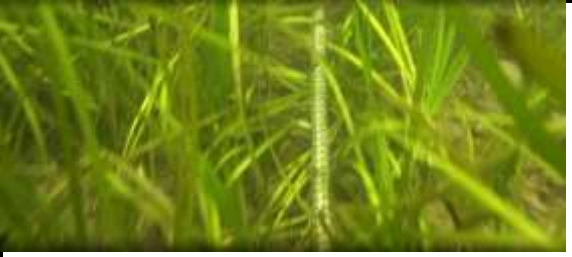
Transect 1			
Area Distance (m)	Substrate Observation	Macroflora/fauna Observations	Representative bottom camera images captured from the diver video camera
20-25	Sandy substrate.	Dense, healthy live eelgrass bed (<i>Zostera marina</i>) with Periwinkle (<i>Littorina</i> sp.) and Stickleback species (<i>Gasterosteus</i> sp.) living within the eelgrass bed.

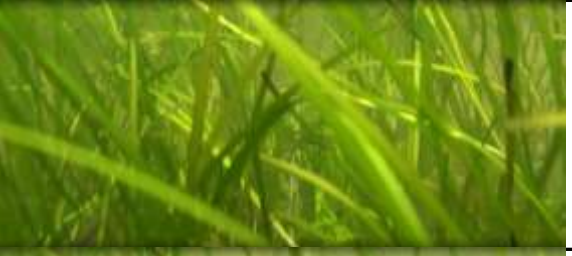
25-30	Sandy substrate.	Dense, healthy live eelgrass bed (<i>Zostera marina</i>) with Periwinkle (<i>Littorina</i> sp.) and Stickleback species (<i>Gasterosteus</i> sp.) living within the eelgrass bed.

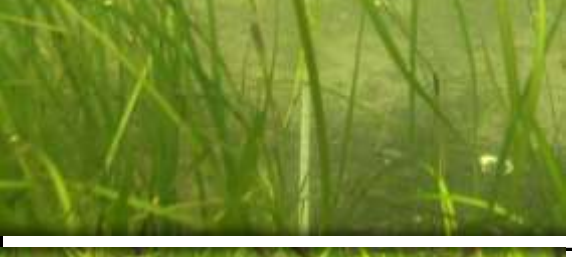
30-35	Sandy substrate.	Dense, healthy live eelgrass bed (<i>Zostera marina</i>) with Periwinkle (<i>Littorina</i> sp.) and Stickleback species (<i>Gasterosteus</i> sp.) living within the eelgrass bed.

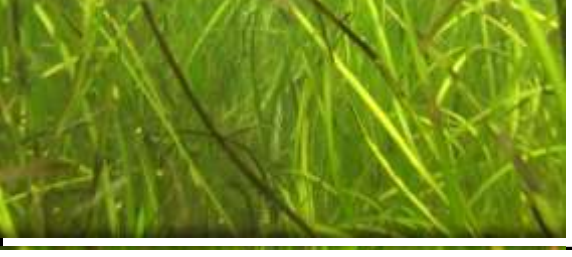
35-40	Sandy substrate.	Dense, healthy live eelgrass bed (<i>Zostera marina</i>) with Periwinkle (<i>Littorina</i> sp.) and Stickleback species (<i>Gasterosteus</i> sp.) living within the eelgrass bed.

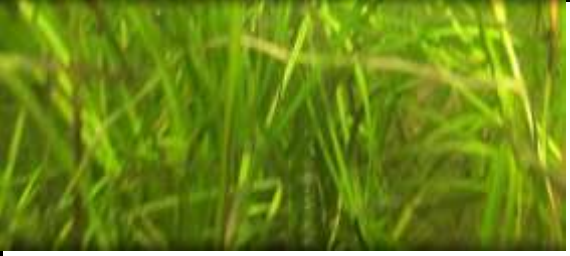
Transect 1			
Area Distance (m)	Substrate Observation	Macroflora/fauna Observations	Representative bottom camera images captured from the diver video camera
40-45	Sandy substrate.	Dense, healthy live eelgrass bed (<i>Zostera marina</i>) with Periwinkle (<i>Littorina</i> sp.) and Stickleback species (<i>Gasterosteus</i> sp.) living within the eelgrass bed.

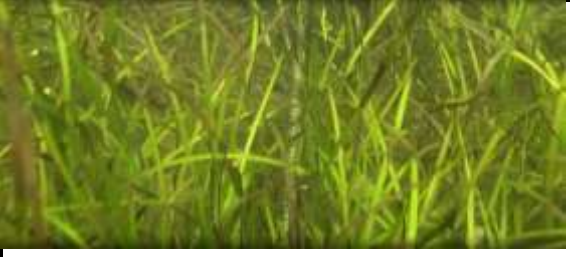
45-50	Sandy substrate.	Dense, healthy live eelgrass bed (<i>Zostera marina</i>) with Periwinkle (<i>Littorina</i> sp.) and Stickleback species (<i>Gasterosteus</i> sp.) living within the eelgrass bed.

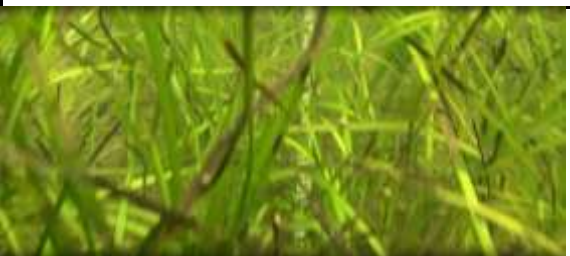
50-55	Sandy substrate.	Dense, healthy live eelgrass bed (<i>Zostera marina</i>) with Periwinkle (<i>Littorina</i> sp.) and Stickleback species (<i>Gasterosteus</i> sp.) living within the eelgrass bed.

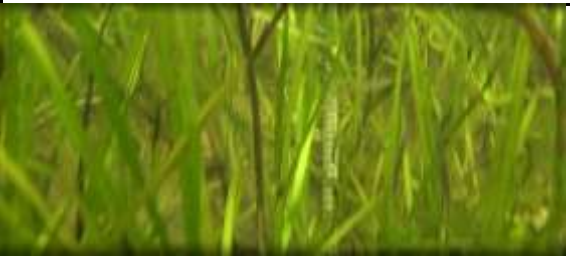
55-60	Sandy substrate.	Dense, healthy live eelgrass bed (<i>Zostera marina</i>) with Periwinkle (<i>Littorina</i> sp.) and Stickleback species (<i>Gasterosteus</i> sp.) living within the eelgrass bed.

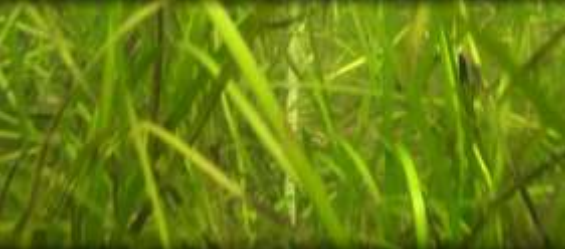
Transect 1			
Area Distance (m)	Substrate Observation	Macroflora/fauna Observations	Representative bottom camera images captured from the diver video camera
60-65	Sandy substrate.	Dense, healthy live eelgrass bed (<i>Zostera marina</i>) with Periwinkle (<i>Littorina</i> sp.) and Stickleback species (<i>Gasterosteus</i> sp.) living within the eelgrass bed.

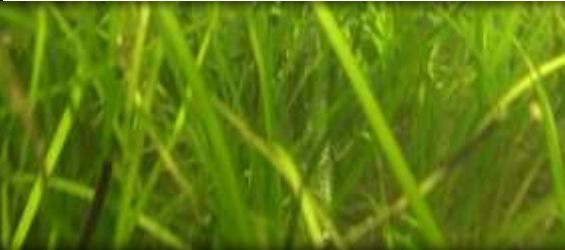
65-70	Sandy substrate.	Dense, healthy live eelgrass bed (<i>Zostera marina</i>) with Periwinkle (<i>Littorina</i> sp.) and Stickleback species (<i>Gasterosteus</i> sp.) living within the eelgrass bed.

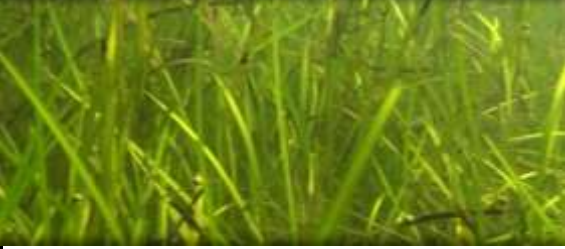
70-75	Sandy substrate.	Dense, healthy live eelgrass bed (<i>Zostera marina</i>) with Periwinkle (<i>Littorina</i> sp.) and Stickleback species (<i>Gasterosteus</i> sp.) living within the eelgrass bed.

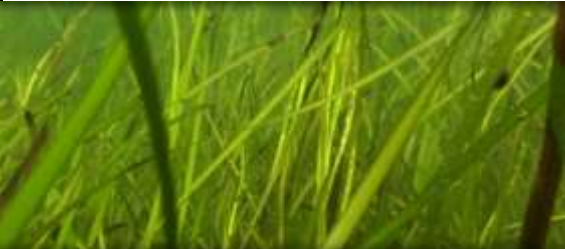
75-80	Sandy substrate.	Dense, healthy live eelgrass bed (<i>Zostera marina</i>) with Periwinkle (<i>Littorina</i> sp.) and Stickleback species (<i>Gasterosteus</i> sp.) living within the eelgrass bed.

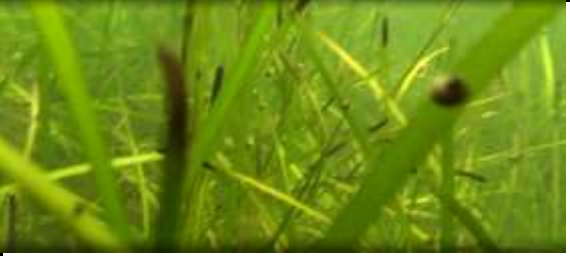
Transect 1			
Area Distance (m)	Substrate Observation	Macroflora/fauna Observations	Representative bottom camera images captured from the diver video camera
80-85	Sandy substrate.	Dense, healthy live eelgrass bed (<i>Zostera marina</i>) with Periwinkle (<i>Littorina</i> sp.) and Stickleback species (<i>Gasterosteus</i> sp.) living within the eelgrass bed.

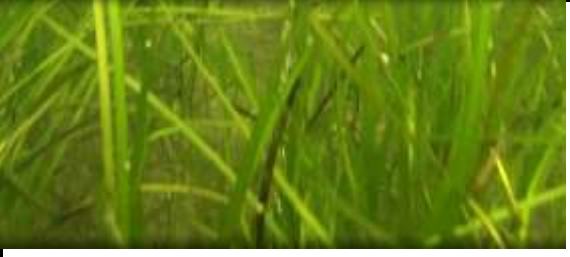
85-90	Sandy substrate.	Dense, healthy live eelgrass bed (<i>Zostera marina</i>) with Periwinkle (<i>Littorina</i> sp.) and Stickleback species (<i>Gasterosteus</i> sp.) living within the eelgrass bed.

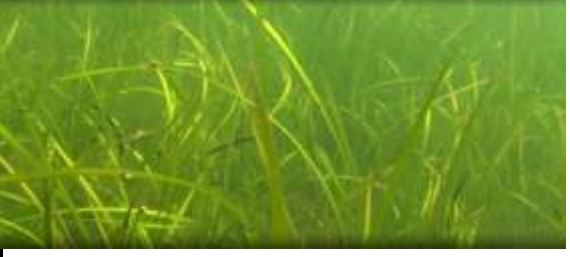
90-95	Sandy substrate.	Dense, healthy live eelgrass bed (<i>Zostera marina</i>) with Periwinkle (<i>Littorina</i> sp.) and Stickleback species (<i>Gasterosteus</i> sp.) living within the eelgrass bed.

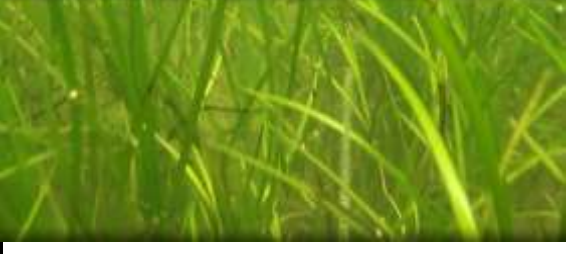
95-100	Sandy substrate.	Dense, healthy live eelgrass bed (<i>Zostera marina</i>) with Periwinkle (<i>Littorina</i> sp.) and Stickleback species (<i>Gasterosteus</i> sp.) living within the eelgrass bed.

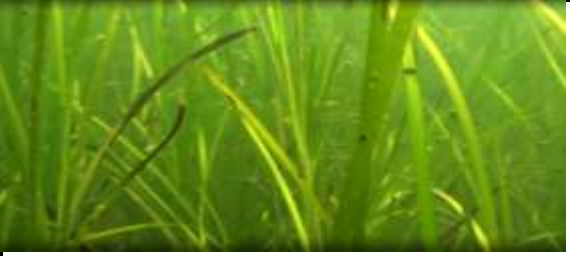
Transect 1			
Area Distance (m)	Substrate Observation	Macroflora/fauna Observations	Representative bottom camera images captured from the diver video camera
100-105	Sandy substrate.	Dense, healthy live eelgrass bed (<i>Zostera marina</i>) with Periwinkle (<i>Littorina</i> sp.) and Stickleback species (<i>Gasterosteus</i> sp.) living within the eelgrass bed.

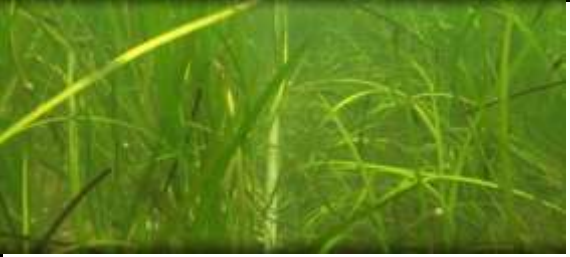
105-110	Sandy substrate.	Dense, healthy live eelgrass bed (<i>Zostera marina</i>) with Periwinkle (<i>Littorina</i> sp.) and Stickleback species (<i>Gasterosteus</i> sp.) living within the eelgrass bed.

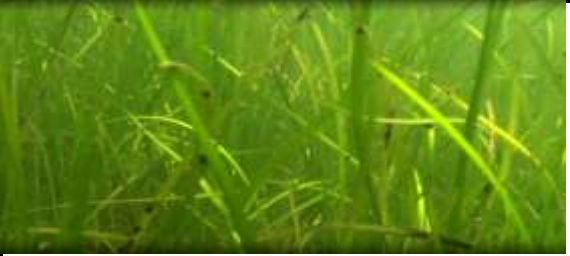
110-115	Sandy substrate.	Dense, healthy live eelgrass bed (<i>Zostera marina</i>) with Periwinkle (<i>Littorina</i> sp.) and Stickleback species (<i>Gasterosteus</i> sp.) living within the eelgrass bed.

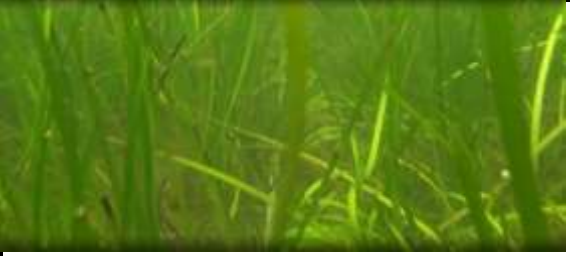
115-120	Sandy substrate.	Dense, healthy live eelgrass bed (<i>Zostera marina</i>) with Periwinkle (<i>Littorina</i> sp.) and Stickleback species (<i>Gasterosteus</i> sp.) living within the eelgrass bed.

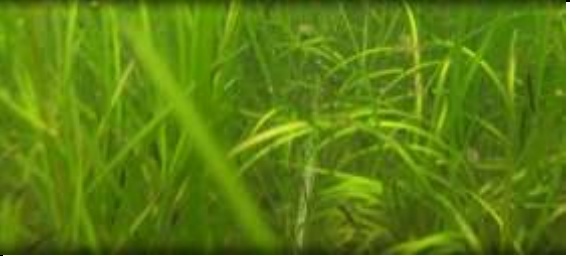
Transect 1			
Area Distance (m)	Substrate Observation	Macroflora/fauna Observations	Representative bottom camera images captured from the diver video camera
120-125	Sandy substrate.	Dense, healthy live eelgrass bed (<i>Zostera marina</i>) with Periwinkle (<i>Littorina</i> sp.) and Stickleback species (<i>Gasterosteus</i> sp.) living within the eelgrass bed.

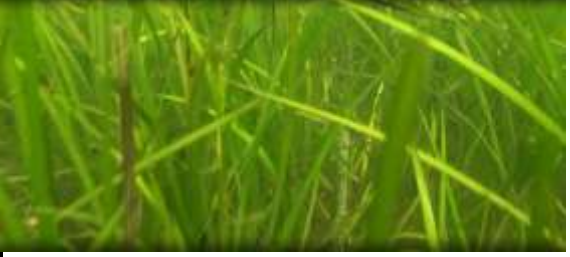
125-130	Sandy substrate.	Dense, healthy live eelgrass bed (<i>Zostera marina</i>) with Periwinkle (<i>Littorina</i> sp.) and Stickleback species (<i>Gasterosteus</i> sp.) living within the eelgrass bed.

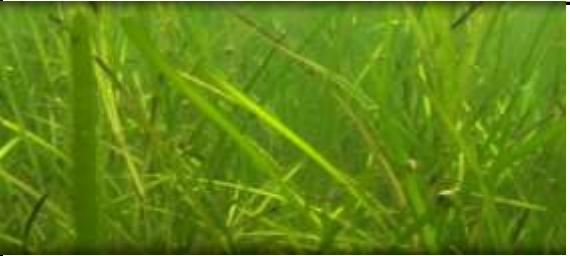
130-135	Sandy substrate.	Dense, healthy live eelgrass bed (<i>Zostera marina</i>) with Periwinkle (<i>Littorina</i> sp.) and Stickleback species (<i>Gasterosteus</i> sp.) living within the eelgrass bed.

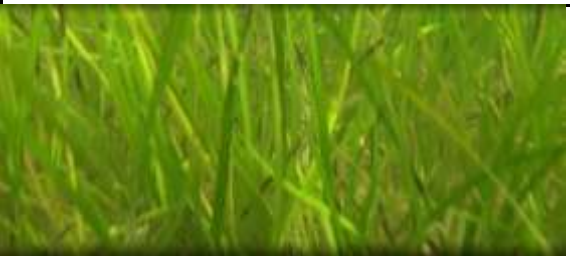
135-140	Sandy substrate.	Dense, healthy live eelgrass bed (<i>Zostera marina</i>) with Periwinkle (<i>Littorina</i> sp.) and Stickleback species (<i>Gasterosteus</i> sp.) living within the eelgrass bed.

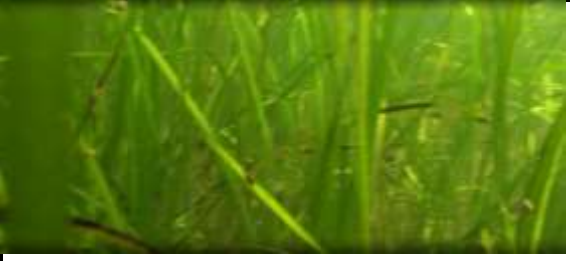
Transect 1			
Area Distance (m)	Substrate Observation	Macroflora/fauna Observations	Representative bottom camera images captured from the diver video camera
140-145	Sandy substrate.	Dense, healthy live eelgrass bed (<i>Zostera marina</i>) with Periwinkle (<i>Littorina</i> sp.) and Stickleback species (<i>Gasterosteus</i> sp.) living within the eelgrass bed.

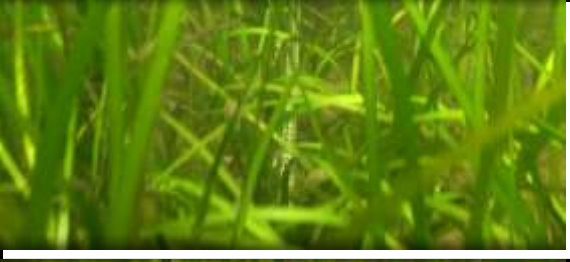
145-150	Sandy substrate.	Dense, healthy live eelgrass bed (<i>Zostera marina</i>) with Periwinkle (<i>Littorina</i> sp.) and Stickleback species (<i>Gasterosteus</i> sp.) living within the eelgrass bed.

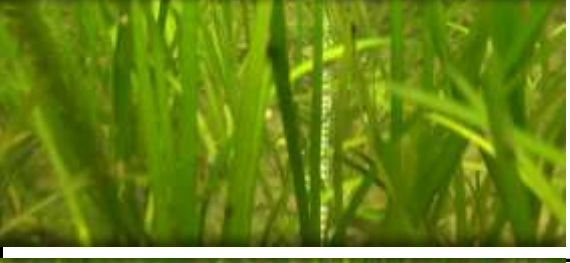
150-155	Sandy substrate.	Dense, healthy live eelgrass bed (<i>Zostera marina</i>) with Periwinkle (<i>Littorina</i> sp.) and Stickleback species (<i>Gasterosteus</i> sp.) living within the eelgrass bed.

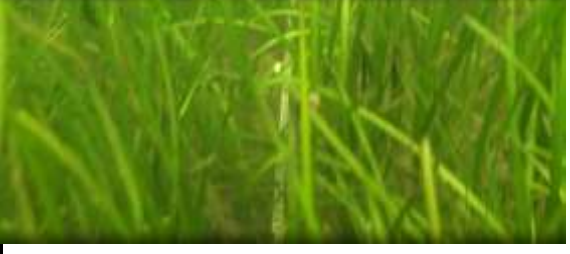
155-160	Sandy substrate.	Dense, healthy live eelgrass bed (<i>Zostera marina</i>) with Periwinkle (<i>Littorina</i> sp.) and Stickleback species (<i>Gasterosteus</i> sp.) living within the eelgrass bed.

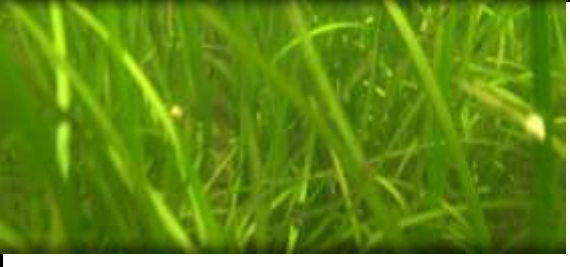
Transect 1			
Area Distance (m)	Substrate Observation	Macroflora/fauna Observations	Representative bottom camera images captured from the diver video camera
160-165	Sandy substrate.	Dense, healthy live eelgrass bed (<i>Zostera marina</i>) with Periwinkle (<i>Littorina</i> sp.) and Stickleback species (<i>Gasterosteus</i> sp.) living within the eelgrass bed.

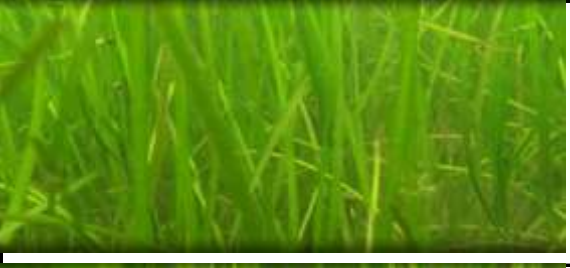
165-170	Sandy substrate.	Dense, healthy live eelgrass bed (<i>Zostera marina</i>) with Periwinkle (<i>Littorina</i> sp.) and Stickleback species (<i>Gasterosteus</i> sp.) living within the eelgrass bed.

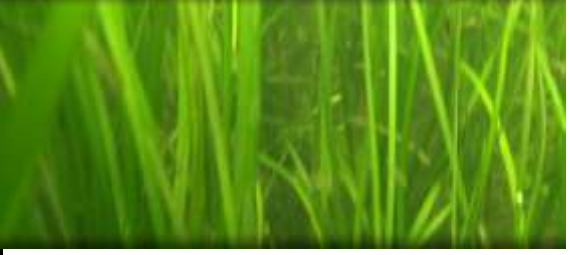
170-175	Sandy substrate.	Dense, healthy live eelgrass bed (<i>Zostera marina</i>) with Periwinkle (<i>Littorina</i> sp.) and Stickleback species (<i>Gasterosteus</i> sp.) living within the eelgrass bed.

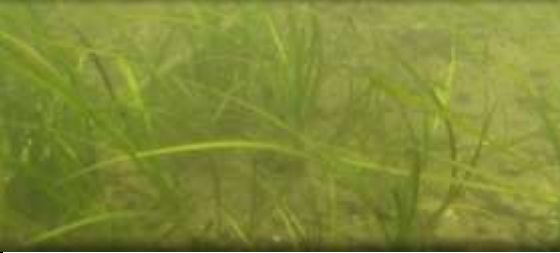
Transect 2			
Area Distance (m)	Substrate Observation	Macroflora/fauna Observations	Representative bottom camera images captured from the diver video camera
0-5	Sandy substrate with scattering of macrofloral debris.	Dense, healthy live eelgrass bed (<i>Zostera marina</i>) with Periwinkle (<i>Littorina</i> sp.) and Stickleback species (<i>Gasterosteus</i> sp.) living within the eelgrass bed.

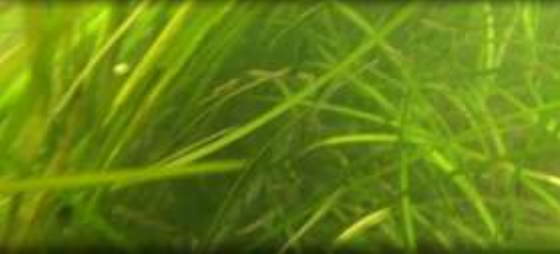
5-10	Sandy substrate.	Dense, healthy live eelgrass bed (<i>Zostera marina</i>) with Periwinkle (<i>Littorina</i> sp.) and Stickleback species (<i>Gasterosteus</i> sp.) living within the eelgrass bed.

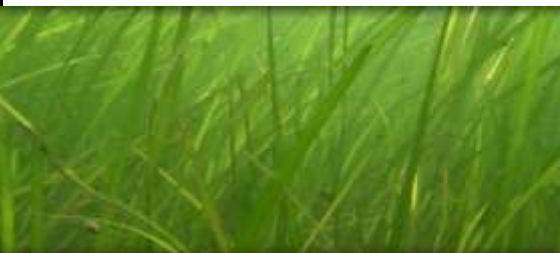
10-15	Sandy substrate.	Dense, healthy live eelgrass bed (<i>Zostera marina</i>) with Periwinkle (<i>Littorina</i> sp.) and Stickleback species (<i>Gasterosteus</i> sp.) living within the eelgrass bed.

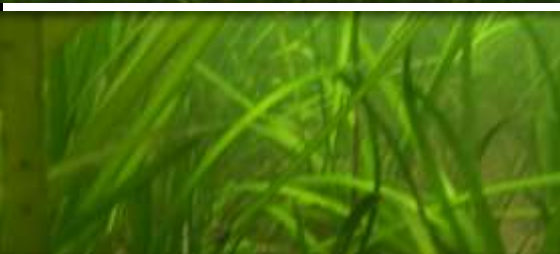
15-20	Sandy substrate.	Dense, healthy live eelgrass bed (<i>Zostera marina</i>) with Periwinkle (<i>Littorina</i> sp.) and Stickleback species (<i>Gasterosteus</i> sp.) living within the eelgrass bed.

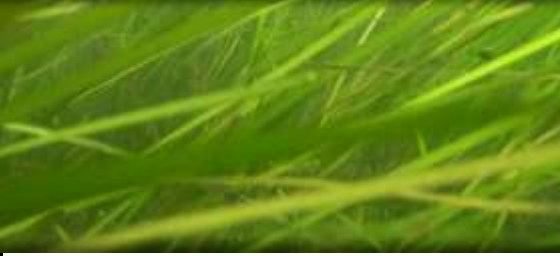
Transect 2			
Area Distance (m)	Substrate Observation	Macroflora/fauna Observations	Representative bottom camera images captured from the diver video camera
20-25	Sandy substrate.	Dense, healthy live eelgrass bed (<i>Zostera marina</i>) with Periwinkle (<i>Littorina</i> sp.) and Stickleback species (<i>Gasterosteus</i> sp.) living within the eelgrass bed.

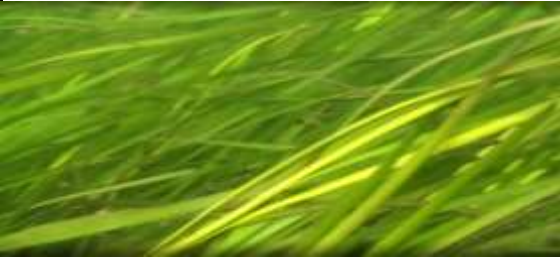
25-30	Sandy substrate.	Dense, healthy live eelgrass bed (<i>Zostera marina</i>) with Periwinkle (<i>Littorina</i> sp.) and Stickleback species (<i>Gasterosteus</i> sp.) living within the eelgrass bed.

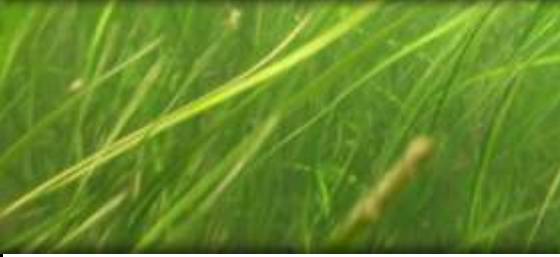
30-35	Sandy substrate.	Dense, healthy live eelgrass bed (<i>Zostera marina</i>) with Periwinkle (<i>Littorina</i> sp.) and Stickleback species (<i>Gasterosteus</i> sp.) living within the eelgrass bed.

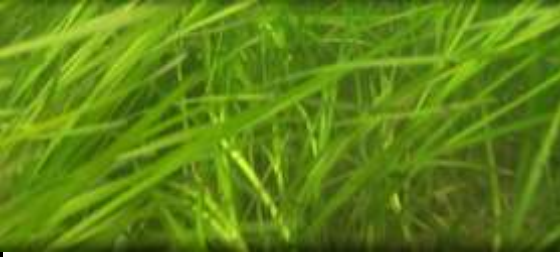
35-40	Sandy substrate.	Dense, healthy live eelgrass bed (<i>Zostera marina</i>) with Periwinkle (<i>Littorina</i> sp.) and Stickleback species (<i>Gasterosteus</i> sp.) living within the eelgrass bed.

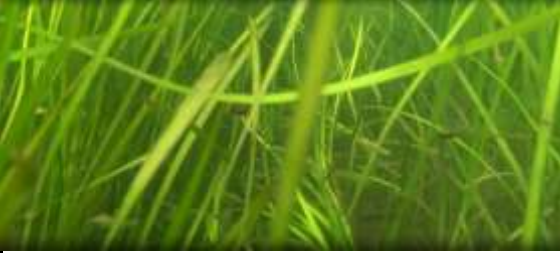
Transect 2			
Area Distance (m)	Substrate Observation	Macroflora/fauna Observations	Representative bottom camera images captured from the diver video camera
40-45	Sandy substrate.	Dense, healthy live eelgrass bed (<i>Zostera marina</i>) with Periwinkle (<i>Littorina</i> sp.) and Stickleback species (<i>Gasterosteus</i> sp.) living within the eelgrass bed.

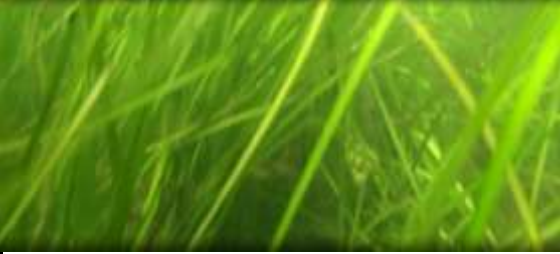
45-50	Sandy substrate.	Dense, healthy live eelgrass bed (<i>Zostera marina</i>) with Periwinkle (<i>Littorina</i> sp.) and Stickleback species (<i>Gasterosteus</i> sp.) living within the eelgrass bed.

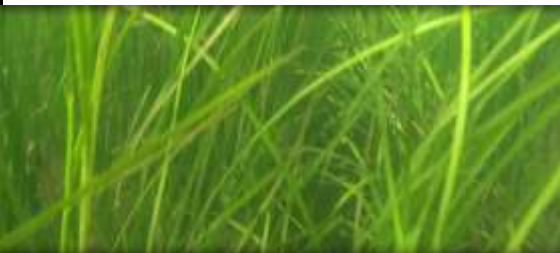
50-55	Sandy substrate.	Dense, healthy live eelgrass bed (<i>Zostera marina</i>) with Periwinkle (<i>Littorina</i> sp.) and Stickleback species (<i>Gasterosteus</i> sp.) living within the eelgrass bed.

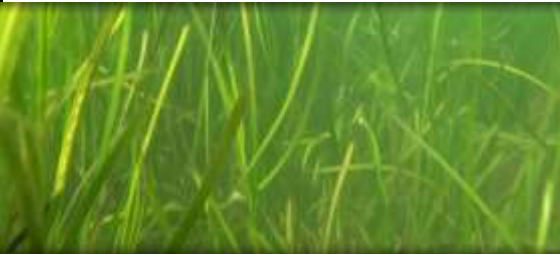
55-60	Sandy substrate.	Dense, healthy live eelgrass bed (<i>Zostera marina</i>) with Periwinkle (<i>Littorina</i> sp.) and Stickleback species (<i>Gasterosteus</i> sp.) living within the eelgrass bed.

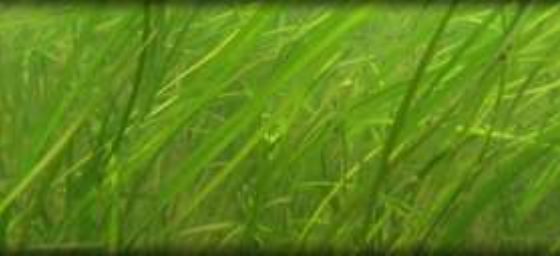
Transect 2			
Area Distance (m)	Substrate Observation	Macroflora/fauna Observations	Representative bottom camera images captured from the diver video camera
60-65	Sandy substrate.	Dense, healthy live eelgrass bed (<i>Zostera marina</i>) with Periwinkle (<i>Littorina</i> sp.) and Stickleback species (<i>Gasterosteus</i> sp.) living within the eelgrass bed.

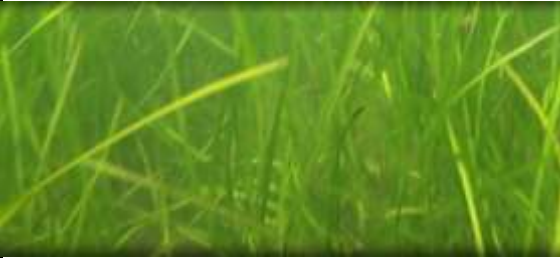
65-70	Sandy substrate.	Dense, healthy live eelgrass bed (<i>Zostera marina</i>) with Periwinkle (<i>Littorina</i> sp.) and Stickleback species (<i>Gasterosteus</i> sp.) living within the eelgrass bed.

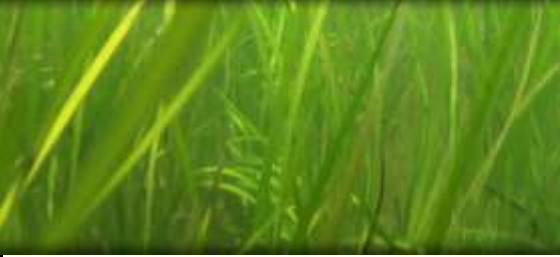
70-75	Sandy substrate.	Dense, healthy live eelgrass bed (<i>Zostera marina</i>) with Periwinkle (<i>Littorina</i> sp.) and Stickleback species (<i>Gasterosteus</i> sp.) living within the eelgrass bed.

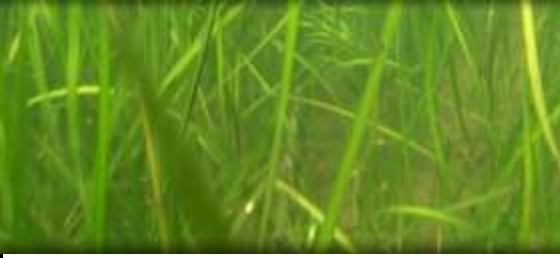
75-80	Sandy substrate.	Dense, healthy live eelgrass bed (<i>Zostera marina</i>) with Periwinkle (<i>Littorina</i> sp.) and Stickleback species (<i>Gasterosteus</i> sp.) living within the eelgrass bed.

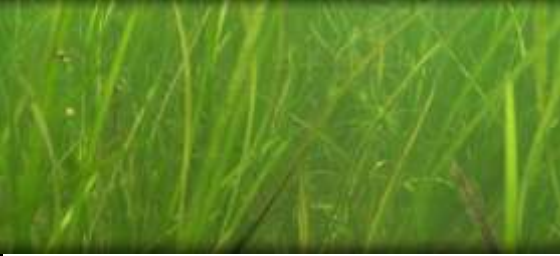
Transect 2			
Area Distance (m)	Substrate Observation	Macroflora/fauna Observations	Representative bottom camera images captured from the diver video camera
80-85	Sandy substrate.	Dense, healthy live eelgrass bed (<i>Zostera marina</i>) with Periwinkle (<i>Littorina</i> sp.) and Stickleback species (<i>Gasterosteus</i> sp.) living within the eelgrass bed.

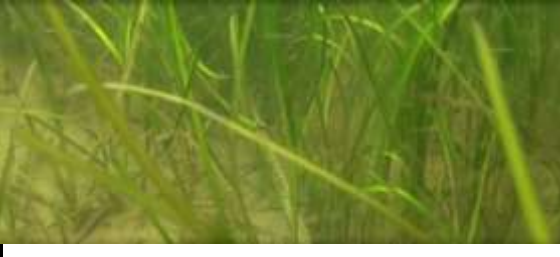
85-90	Sandy substrate with scattering of macrofloral debris.	Dense, healthy live eelgrass bed (<i>Zostera marina</i>) with Periwinkle (<i>Littorina</i> sp.) and Stickleback species (<i>Gasterosteus</i> sp.) living within the eelgrass bed.

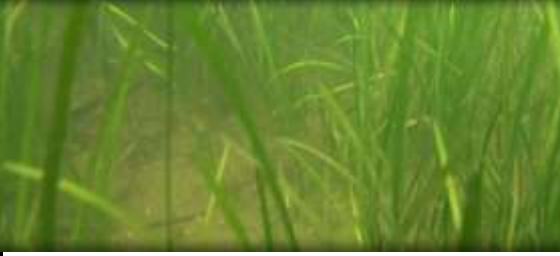
90-95	Sandy substrate with scattering of macrofloral debris.	Dense, healthy live eelgrass bed (<i>Zostera marina</i>) with Periwinkle (<i>Littorina</i> sp.) and Stickleback species (<i>Gasterosteus</i> sp.) living within the eelgrass bed.

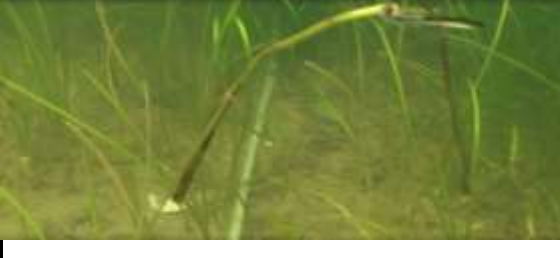
95-100	Sandy substrate with scattering of macrofloral debris.	Dense, healthy live eelgrass bed (<i>Zostera marina</i>) with Periwinkle (<i>Littorina</i> sp.) and Stickleback species (<i>Gasterosteus</i> sp.) living within the eelgrass bed. One American Lobster (<i>Homarus americanus</i>) observed.

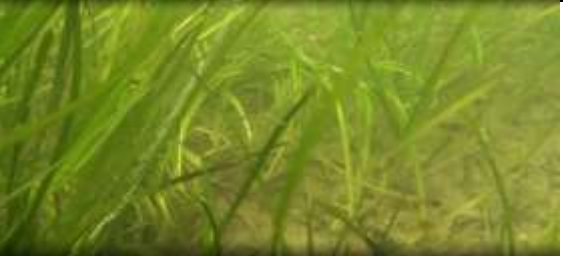
Transect 3			
Area Distance (m)	Substrate Observation	Macroflora/fauna Observations	Representative bottom camera images captured from the diver video camera
0-5	Sandy substrate with scattering of macroalgae debris.	Dense, healthy live eelgrass bed (<i>Zostera marina</i>) with Periwinkle (<i>Littorina</i> sp.) living within the eelgrass bed.

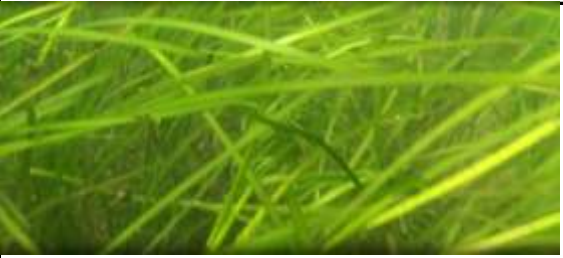
5-10	Sandy substrate.	Dense, healthy live eelgrass bed (<i>Zostera marina</i>) with Periwinkle (<i>Littorina</i> sp.) living within the eelgrass bed.

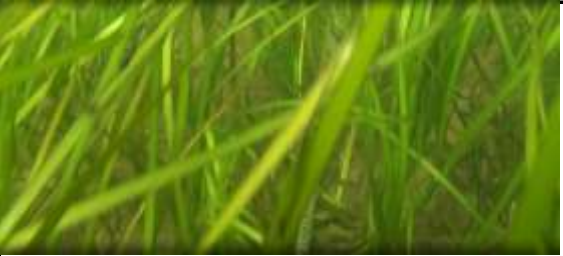
10-15	Sandy substrate.	Dense, healthy live eelgrass bed (<i>Zostera marina</i>) with Periwinkle (<i>Littorina</i> sp.) living within the eelgrass bed.

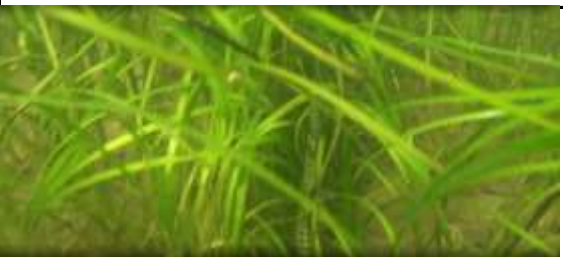
15-20	Sandy substrate.	Dense, healthy live eelgrass bed (<i>Zostera marina</i>) with Periwinkle (<i>Littorina</i> sp.) living within the eelgrass bed.

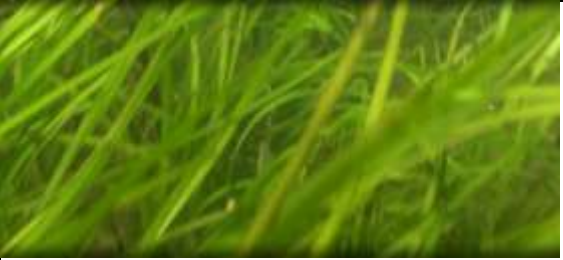
Transect 3			
Area Distance (m)	Substrate Observation	Macroflora/fauna Observations	Representative bottom camera images captured from the diver video camera
20-25	Sandy substrate.	Dense, healthy live eelgrass bed (<i>Zostera marina</i>) with Periwinkle (<i>Littorina</i> sp.) living within the eelgrass bed.

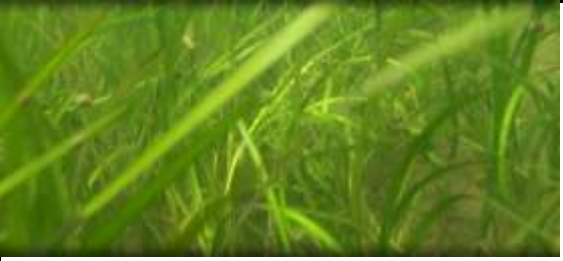
25-30	Sandy substrate.	Dense, healthy live eelgrass bed (<i>Zostera marina</i>) with Periwinkle (<i>Littorina</i> sp.) living within the eelgrass bed.

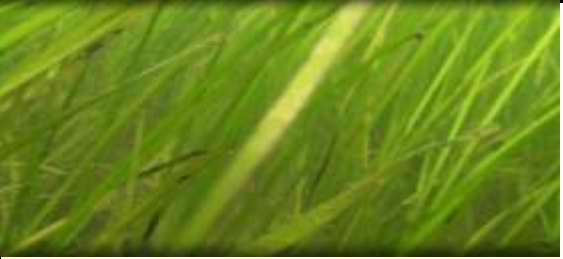
30-35	Sandy substrate.	Dense, healthy live eelgrass bed (<i>Zostera marina</i>) with Periwinkle (<i>Littorina</i> sp.) living within the eelgrass bed.

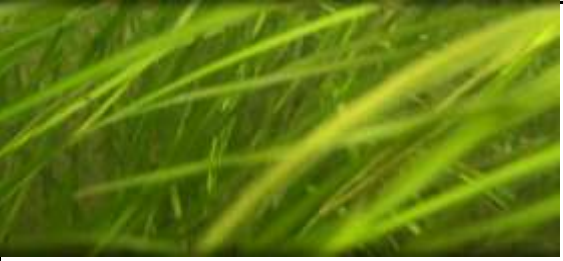
35-40	Sandy substrate.	Dense, healthy live eelgrass bed (<i>Zostera marina</i>) with Periwinkle (<i>Littorina</i> sp.) living within the eelgrass bed.

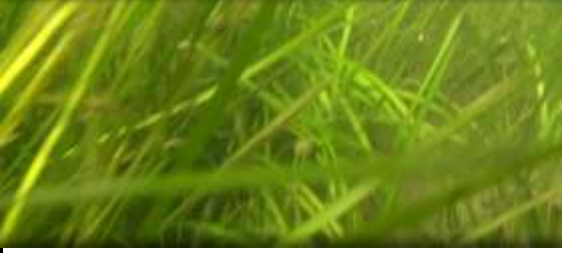
Transect 3			
Area Distance (m)	Substrate Observation	Macroflora/fauna Observations	Representative bottom camera images captured from the diver video camera
40-45	Sandy substrate.	Dense, healthy live eelgrass bed (<i>Zostera marina</i>) with Periwinkle (<i>Littorina</i> sp.) living within the eelgrass bed.

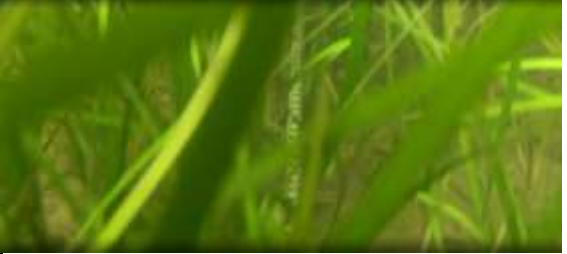
45-50	Sandy substrate.	Dense, healthy live eelgrass bed (<i>Zostera marina</i>) with Periwinkle (<i>Littorina</i> sp.) living within the eelgrass bed.

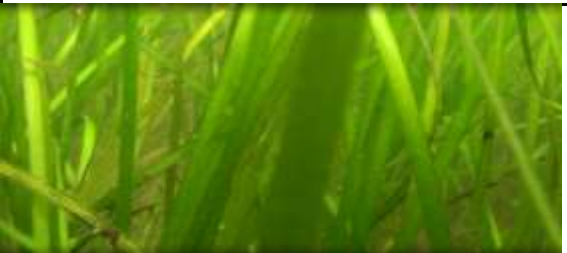
50-55	Sandy substrate.	Dense, healthy live eelgrass bed (<i>Zostera marina</i>) with Periwinkle (<i>Littorina</i> sp.) living within the eelgrass bed.

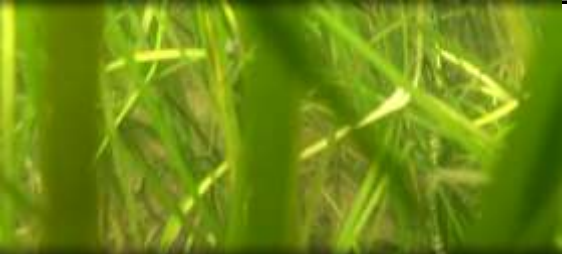
55-60	Sandy substrate.	Dense, healthy live eelgrass bed (<i>Zostera marina</i>) with Periwinkle (<i>Littorina</i> sp.) living within the eelgrass bed.

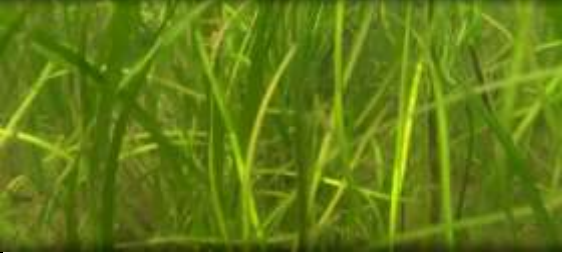
Transect 3			
Area Distance (m)	Substrate Observation	Macroflora/fauna Observations	Representative bottom camera images captured from the diver video camera
60-65	Sandy substrate.	Dense, healthy live eelgrass bed (<i>Zostera marina</i>) with Periwinkle (<i>Littorina</i> sp.) living within the eelgrass bed.

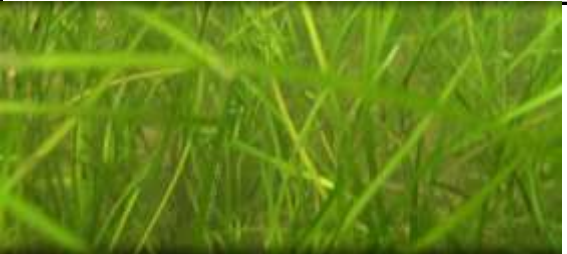
65-70	Sandy substrate.	Dense, healthy live eelgrass bed (<i>Zostera marina</i>) with Periwinkle (<i>Littorina</i> sp.) living within the eelgrass bed.

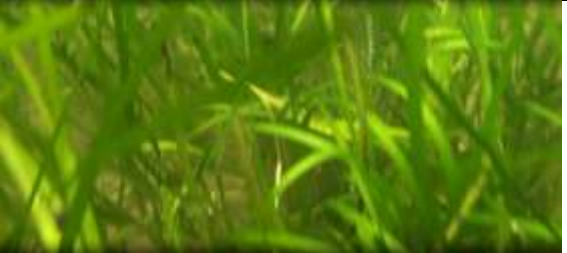
70-75	Sandy substrate.	Dense, healthy live eelgrass bed (<i>Zostera marina</i>) with Periwinkle (<i>Littorina</i> sp.) living within the eelgrass bed.

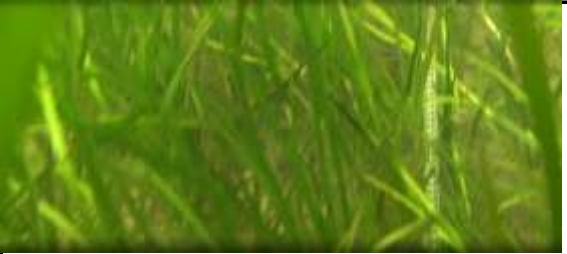
75-80	Sandy substrate.	Dense, healthy live eelgrass bed (<i>Zostera marina</i>) with Periwinkle (<i>Littorina</i> sp.) living within the eelgrass bed.

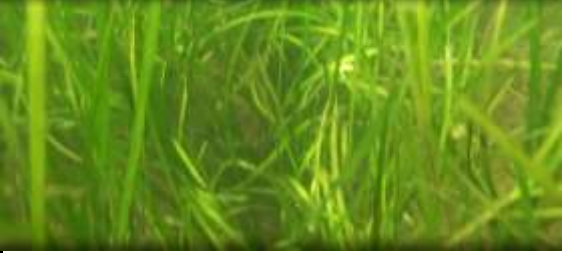
Transect 3			
Area Distance (m)	Substrate Observation	Macroflora/fauna Observations	Representative bottom camera images captured from the diver video camera
80-85	Sandy substrate.	Dense, healthy live eelgrass bed (<i>Zostera marina</i>) with Periwinkle (<i>Littorina</i> sp.) living within the eelgrass bed.

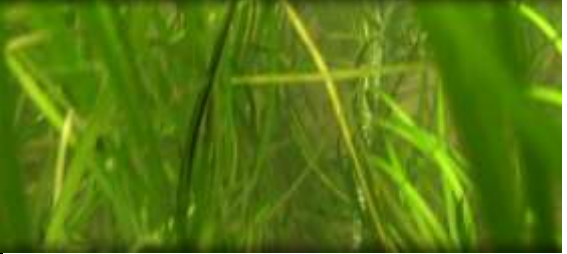
85-90	Sandy substrate.	Dense, healthy live eelgrass bed (<i>Zostera marina</i>) with Periwinkle (<i>Littorina</i> sp.) living within the eelgrass bed.
