**Underwater Benthic Habitat
Survey and Marine Sediment
Sampling Program (Final)
Anse-Bleue Small Craft Harbour,
Gloucester County, New
Brunswick**

**DFRP No. 04898
RPIS No. MS 02502
SCH No. 02502**

**PUBLIC SERVICES AND
PROCUREMENT CANADA FOR
FISHERIES AND OCEANS CANADA**

October 2018

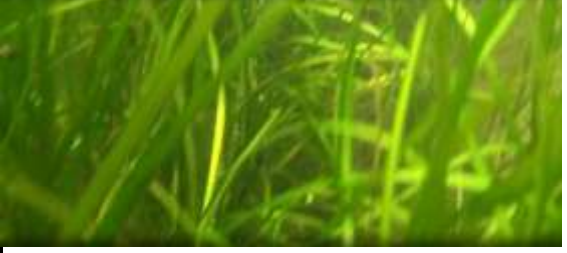
90-95	Sandy substrate.	Dense, healthy live eelgrass bed (<i>Zostera marina</i>) with Periwinkle (<i>Littorina</i> sp.) living within the eelgrass bed.

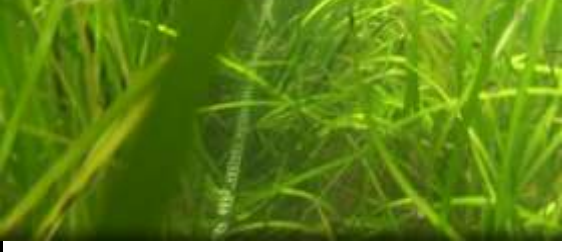
95-100	Sandy substrate.	Dense, healthy live eelgrass bed (<i>Zostera marina</i>) with Periwinkle (<i>Littorina</i> sp.) living within the eelgrass bed.

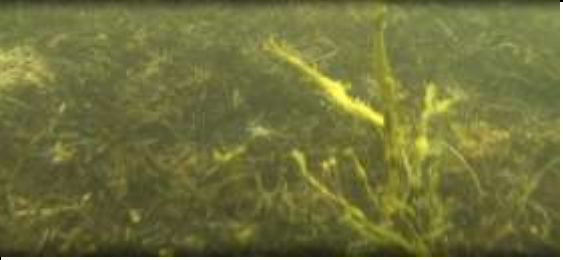
5-10	Sandy substrate with scattering of macroalgae debris.	Intermittent patches of anchored bladderwrack (<i>Fucus</i> sp.), and eelgrass (<i>Zostera marina</i>) were observed along the ocean floor. One Atlantic Rock Crab (<i>Cancer irroratus</i>) and numerous Periwinkle (<i>Littorina</i> sp.) observed.

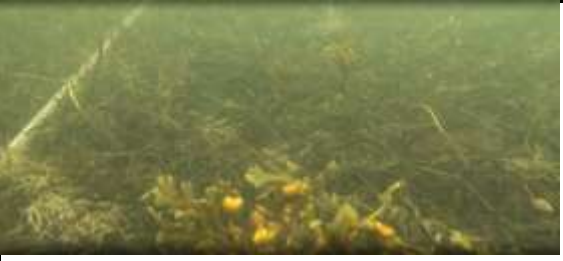
10-15	Sandy substrate with scattering of macroalgae debris.	Intermittent patches of anchored bladderwrack (<i>Fucus</i> sp.), and eelgrass (<i>Zostera marina</i>) were observed along the ocean floor.

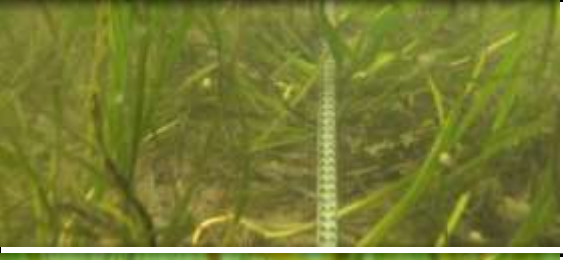
15-20	Sandy substrate.	Dense, healthy live eelgrass bed (<i>Zostera marina</i>). One Atlantic Rock Crab (<i>Cancer irroratus</i>) and numerous Periwinkle (<i>Littorina</i> sp.) observed.

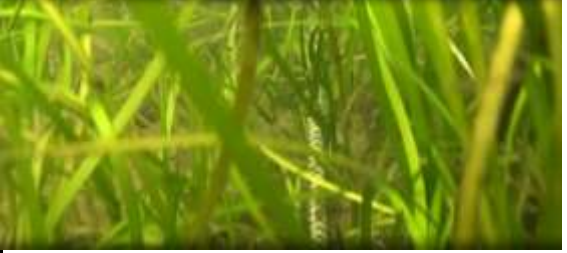
Transect 4			
Area Distance (m)	Substrate Observation	Macroflora/fauna Observations	Representative bottom camera images captured from the diver video camera
20-25	Sandy substrate.	Dense, healthy live eelgrass bed (<i>Zostera marina</i>). One Atlantic Rock Crab (<i>Cancer irroratus</i>) and numerous Periwinkle (<i>Littorina</i> sp.) observed.

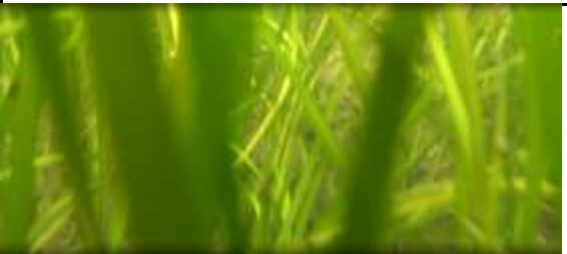
25-30	Sandy substrate.	Dense, healthy live eelgrass bed (<i>Zostera marina</i>). Numerous Periwinkle (<i>Littorina</i> sp.) observed.

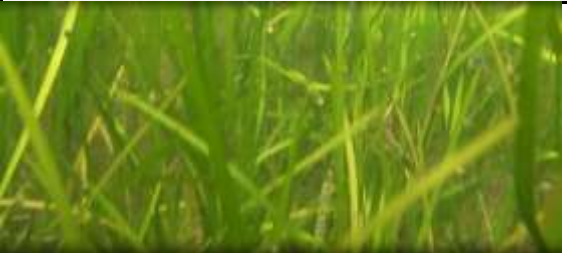
30-35	Sandy substrate.	Dense, healthy live eelgrass bed (<i>Zostera marina</i>). Numerous Periwinkle (<i>Littorina</i> sp.) observed.

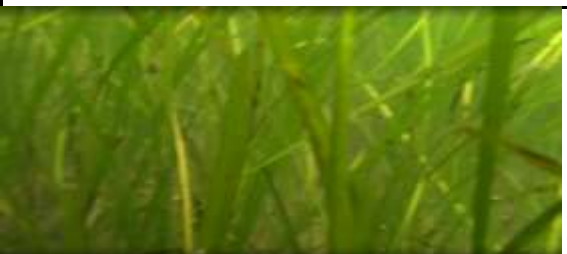
35-40	Sandy substrate.	Dense, healthy live eelgrass bed (<i>Zostera marina</i>). Numerous Periwinkle (<i>Littorina</i> sp.) observed.

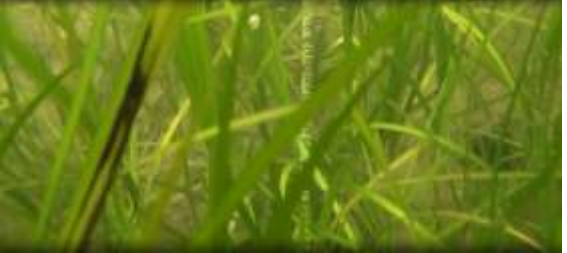
Transect 4			
Area Distance (m)	Substrate Observation	Macroflora/fauna Observations	Representative bottom camera images captured from the diver video camera
40-45	Sandy substrate.	Dense, healthy live eelgrass bed (<i>Zostera marina</i>). One Atlantic Rock Crab (<i>Cancer irroratus</i>) and numerous Periwinkle (<i>Littorina</i> sp.) observed.

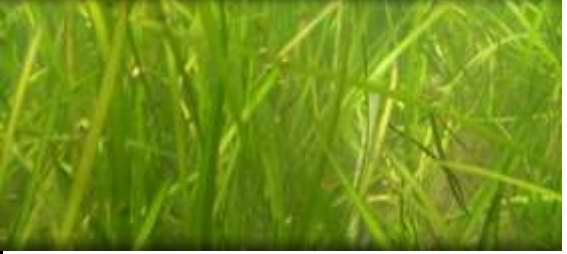
45-50	Sandy substrate.	Dense, healthy live eelgrass bed (<i>Zostera marina</i>) with Periwinkle (<i>Littorina</i> sp.) and Stickleback species (<i>Gasterosteus</i> sp.) living within the eelgrass bed.

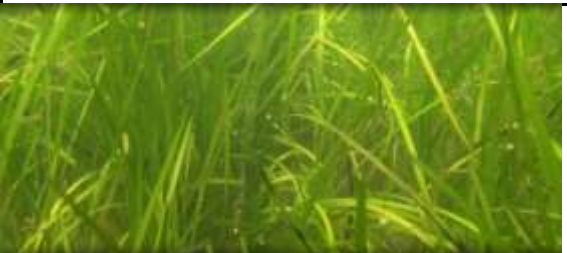
50-55	Sandy substrate.	Dense, healthy live eelgrass bed (<i>Zostera marina</i>) with Periwinkle (<i>Littorina</i> sp.) and Stickleback species (<i>Gasterosteus</i> sp.) living within the eelgrass bed.

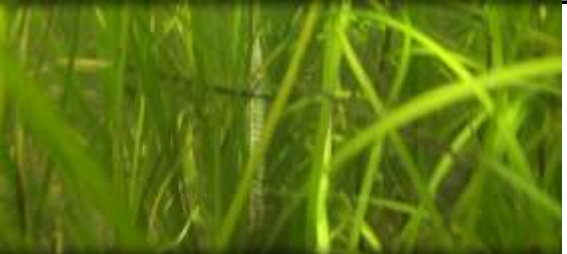
55-60	Sandy substrate.	Dense, healthy live eelgrass bed (<i>Zostera marina</i>) with Periwinkle (<i>Littorina</i> sp.) and Stickleback species (<i>Gasterosteus</i> sp.) living within the eelgrass bed.

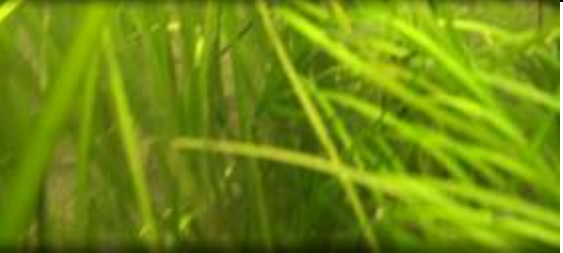
Transect 4			
Area Distance (m)	Substrate Observation	Macroflora/fauna Observations	Representative bottom camera images captured from the diver video camera
60-65	Sandy substrate.	Dense, healthy live eelgrass bed (<i>Zostera marina</i>) with Periwinkle (<i>Littorina</i> sp.) and Stickleback species (<i>Gasterosteus</i> sp.) living within the eelgrass bed.

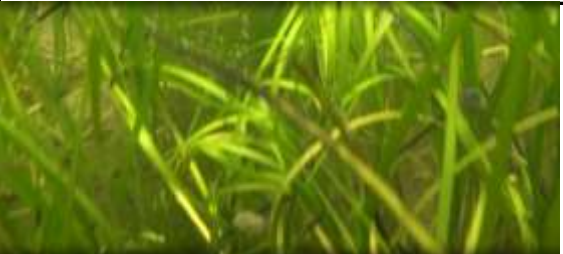
65-70	Sandy substrate.	Dense, healthy live eelgrass bed (<i>Zostera marina</i>) with Periwinkle (<i>Littorina</i> sp.) and Stickleback species (<i>Gasterosteus</i> sp.) living within the eelgrass bed.

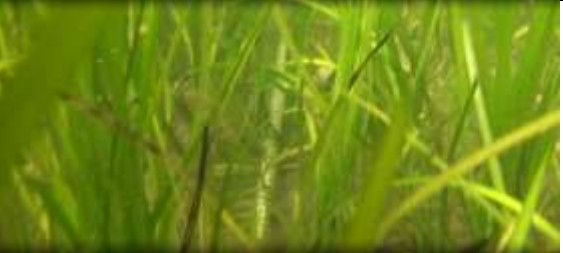
70-75	Sandy substrate.	Dense, healthy live eelgrass bed (<i>Zostera marina</i>) with Periwinkle (<i>Littorina</i> sp.) and Stickleback species (<i>Gasterosteus</i> sp.) living within the eelgrass bed.

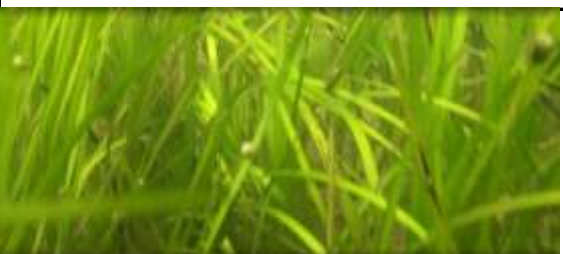
75-80	Sandy substrate.	Dense, healthy live eelgrass bed (<i>Zostera marina</i>) with Periwinkle (<i>Littorina</i> sp.) and Stickleback species (<i>Gasterosteus</i> sp.) living within the eelgrass bed.

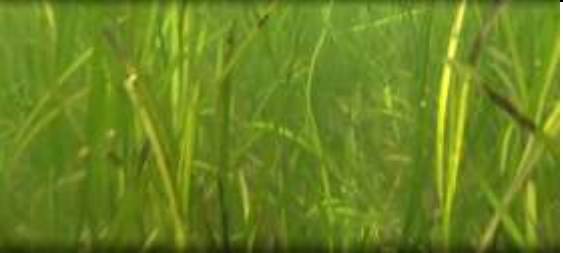
Transect 4			
Area Distance (m)	Substrate Observation	Macroflora/fauna Observations	Representative bottom camera images captured from the diver video camera
80-85	Sandy substrate.	Dense, healthy live eelgrass bed (<i>Zostera marina</i>) with Periwinkle (<i>Littorina</i> sp.) and Stickleback species (<i>Gasterosteus</i> sp.) living within the eelgrass bed.

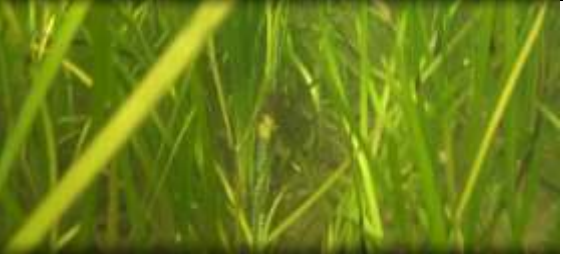
85-90	Sandy substrate.	Dense, healthy live eelgrass bed (<i>Zostera marina</i>) with Periwinkle (<i>Littorina</i> sp.) and Stickleback species (<i>Gasterosteus</i> sp.) living within the eelgrass bed.

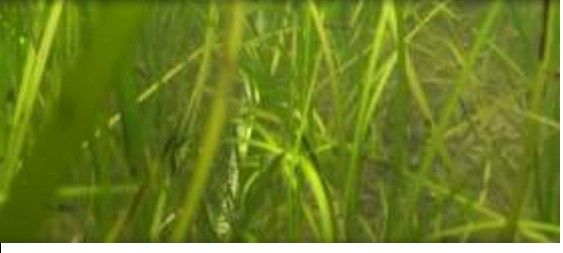
90-95	Sandy substrate.	Dense, healthy live eelgrass bed (<i>Zostera marina</i>) with Periwinkle (<i>Littorina</i> sp.) and Stickleback species (<i>Gasterosteus</i> sp.) living within the eelgrass bed.

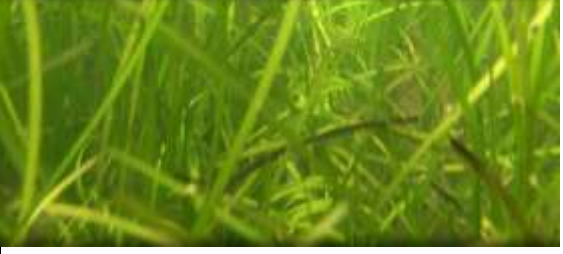
95-100	Sandy substrate.	Dense, healthy live eelgrass bed (<i>Zostera marina</i>) with Periwinkle (<i>Littorina</i> sp.) and Stickleback species (<i>Gasterosteus</i> sp.) living within the eelgrass bed.

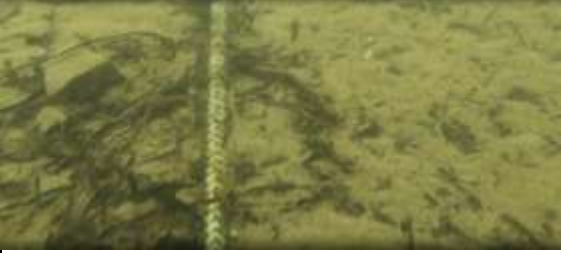
Transect 5			
Area Distance (m)	Substrate Observation	Macroflora/fauna Observations	Representative bottom camera images captured from the diver video camera
0-5	Sandy substrate with scattering of macroalgae debris.	Patches of anchored macroalgae dominated by soft sour weed (<i>Desmarestia viridis</i>) were observed along the ocean floor.

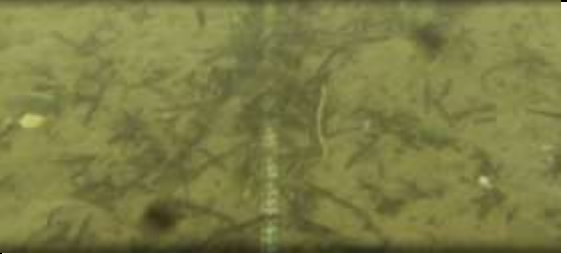
5-10	Sandy substrate with scattering of macroalgae debris.	Intermittent patches of anchored soft sour weed (<i>Desmarestia viridis</i>) and sea lettuce (<i>Ulva lactuca</i>) were observed along the ocean floor.

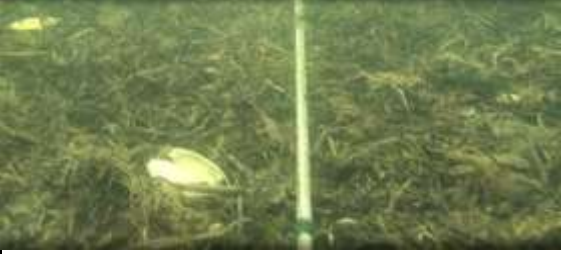
15-20	Sandy substrate with dense macroalgae debris.	Intermittent patches of anchored soft sour weed (<i>Desmarestia viridis</i>), sea lettuce (<i>Ulva lactuca</i>) and bladderwrack (<i>Fucus</i> sp.) were observed along the ocean floor. Empty bivalve shells were observed.

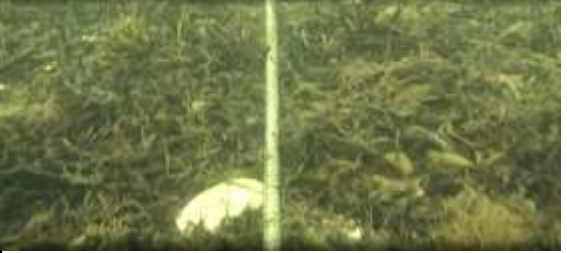
Transect 5			
Area Distance (m)	Substrate Observation	Macroflora/fauna Observations	Representative bottom camera images captured from the diver video camera
20-25	Sandy substrate with dense macroalgae debris.	Intermittent patches of anchored soft sour weed (<i>Desmarestia viridis</i>), sea lettuce (<i>Ulva lactuca</i>), bladderwrack (<i>Fucus</i> sp.) and eelgrass (<i>Zostera marina</i>) were observed along the ocean floor. Numerous periwinkle (<i>Littorina</i> sp.) were observed. Empty bivalve shells were observed.

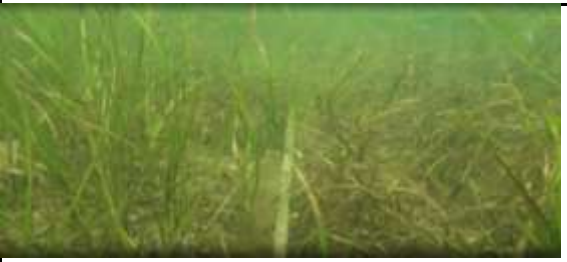
25-30	Sandy substrate with dense macroalgae debris.	Intermittent patches of anchored soft sour weed (<i>Desmarestia viridis</i>), sea lettuce (<i>Ulva lactuca</i>), bladderwrack (<i>Fucus</i> sp.) and eelgrass (<i>Zostera marina</i>) were observed along the ocean floor.

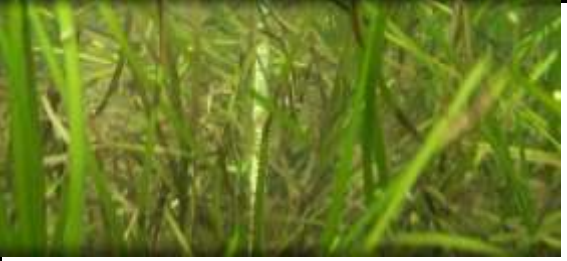
30-35	Sandy substrate.	Dense, healthy live eelgrass bed (<i>Zostera marina</i>) with Periwinkle (<i>Littorina</i> sp.) and Stickleback species (<i>Gasterosteus</i> sp.) living within the eelgrass bed.

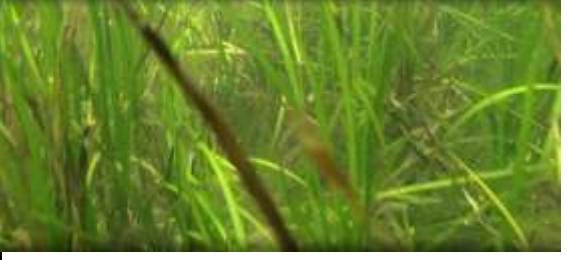
35-40	Sandy substrate.	Dense, healthy live eelgrass bed (<i>Zostera marina</i>) with Periwinkle (<i>Littorina</i> sp.) and Stickleback species (<i>Gasterosteus</i> sp.) living within the eelgrass bed.

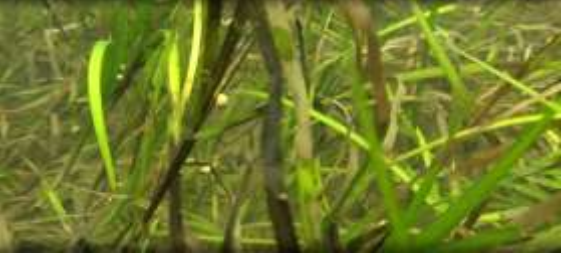
Transect 5			
Area Distance (m)	Substrate Observation	Macroflora/fauna Observations	Representative bottom camera images captured from the diver video camera
40-45	Sandy substrate.	Dense, healthy live eelgrass bed (<i>Zostera marina</i>) with Periwinkle (<i>Littorina</i> sp.) and Stickleback species (<i>Gasterosteus</i> sp.) living within the eelgrass bed.

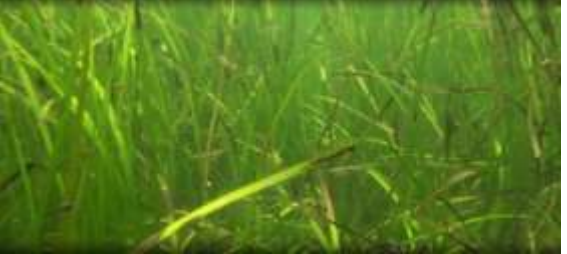
45-50	Sandy substrate.	Dense, healthy live eelgrass bed (<i>Zostera marina</i>) with Periwinkle (<i>Littorina</i> sp.) and Stickleback species (<i>Gasterosteus</i> sp.) living within the eelgrass bed.

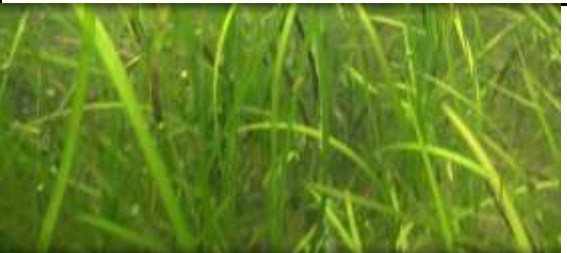
50-55	Sandy substrate.	Dense, healthy live eelgrass bed (<i>Zostera marina</i>) with Periwinkle (<i>Littorina</i> sp.) and Stickleback species (<i>Gasterosteus</i> sp.) living within the eelgrass bed.

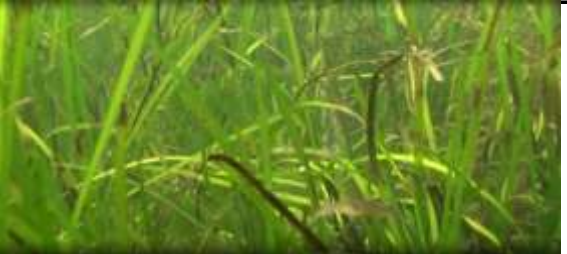
55-60	Sandy substrate.	Dense, healthy live eelgrass bed (<i>Zostera marina</i>) with Periwinkle (<i>Littorina</i> sp.) and Stickleback species (<i>Gasterosteus</i> sp.) living within the eelgrass bed.

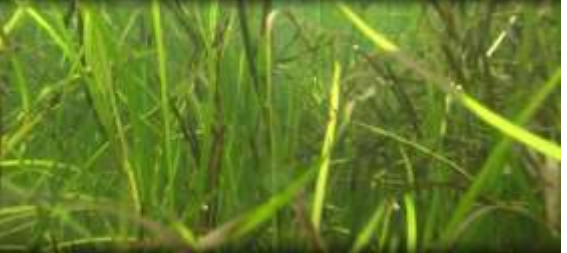
Transect 5			
Area Distance (m)	Substrate Observation	Macroflora/fauna Observations	Representative bottom camera images captured from the diver video camera
60-65	Sandy substrate.	Dense, healthy live eelgrass bed (<i>Zostera marina</i>) with Periwinkle (<i>Littorina</i> sp.) and Stickleback species (<i>Gasterosteus</i> sp.) living within the eelgrass bed.

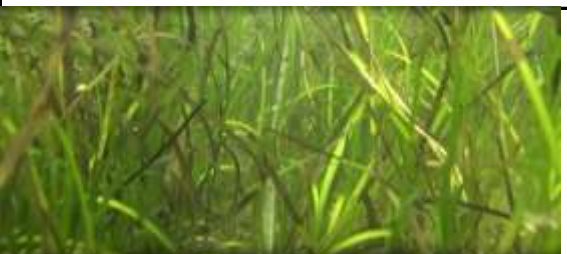
65-70	Sandy substrate.	Dense, healthy live eelgrass bed (<i>Zostera marina</i>) with Periwinkle (<i>Littorina</i> sp.) and Stickleback species (<i>Gasterosteus</i> sp.) living within the eelgrass bed.

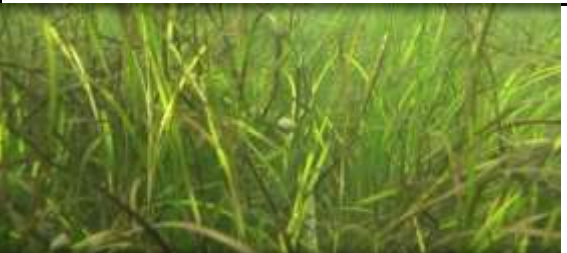
70-75	Sandy substrate.	Dense, healthy live eelgrass bed (<i>Zostera marina</i>) with Periwinkle (<i>Littorina</i> sp.) and Stickleback species (<i>Gasterosteus</i> sp.) living within the eelgrass bed.

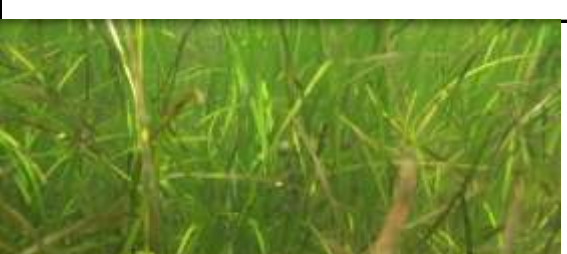
75-80	Sandy substrate.	Dense, healthy live eelgrass bed (<i>Zostera marina</i>) with Periwinkle (<i>Littorina</i> sp.) and Stickleback species (<i>Gasterosteus</i> sp.) living within the eelgrass bed.

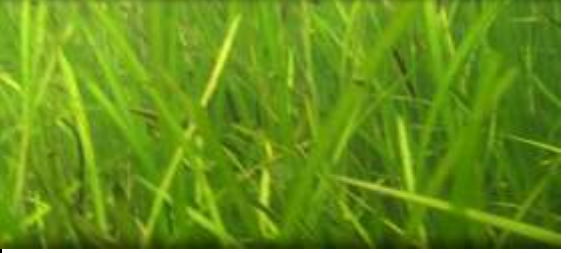
Transect 5			
Area Distance (m)	Substrate Observation	Macroflora/fauna Observations	Representative bottom camera images captured from the diver video camera
80-85	Sandy substrate.	Dense, healthy live eelgrass bed (<i>Zostera marina</i>) with Periwinkle (<i>Littorina</i> sp.) and Stickleback species (<i>Gasterosteus</i> sp.) living within the eelgrass bed.

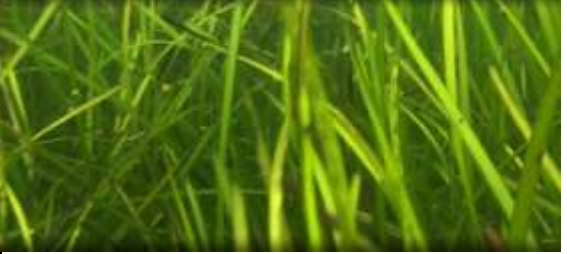
85-90	Sandy substrate.	Dense, healthy live eelgrass bed (<i>Zostera marina</i>) with Periwinkle (<i>Littorina</i> sp.) and Stickleback species (<i>Gasterosteus</i> sp.) living within the eelgrass bed.

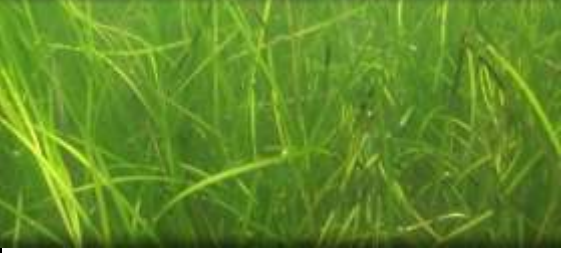
90-95	Sandy substrate.	Dense, healthy live eelgrass bed (<i>Zostera marina</i>) with Periwinkle (<i>Littorina</i> sp.) and Stickleback species (<i>Gasterosteus</i> sp.) living within the eelgrass bed.

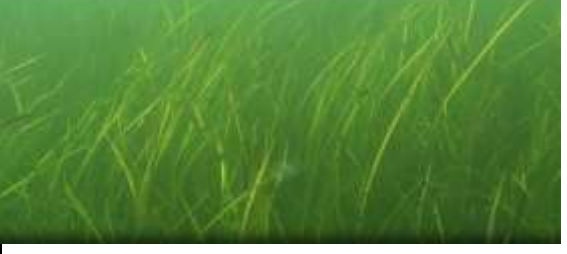
95-100	Sandy substrate.	Dense, healthy live eelgrass bed (<i>Zostera marina</i>) with Periwinkle (<i>Littorina</i> sp.) and Stickleback species (<i>Gasterosteus</i> sp.) living within the eelgrass bed.

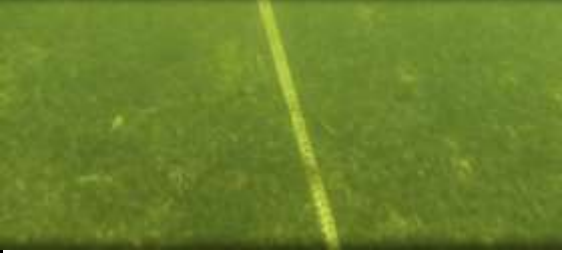
Transect 6			
Area Distance (m)	Substrate Observation	Macroflora/fauna Observations	Representative bottom camera images captured from the diver video camera
0-5	Sandy substrate with dense macroalgae debris.	No life observed

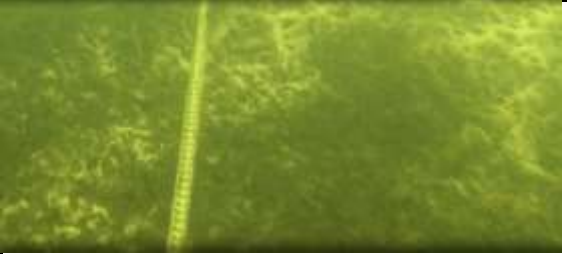
5-10	Sandy substrate with dense macroalgae debris.	No life observed

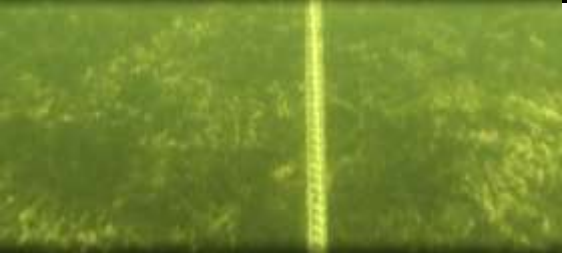
10-15	Sandy substrate with dense macroalgae debris.	No life observed

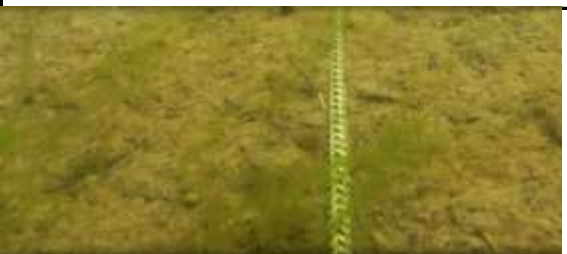
15-20	Sandy substrate with dense macroalgae debris.	Intermittent patches of anchored soft sour weed (<i>Desmarestia viridis</i>), sea lettuce (<i>Ulva compressa</i> and <i>Ulva lactuca</i>), and eelgrass (<i>Zostera marina</i>) were observed along the ocean floor. One Atlantic Rock Crab (<i>Cancer irroratus</i>) observed.

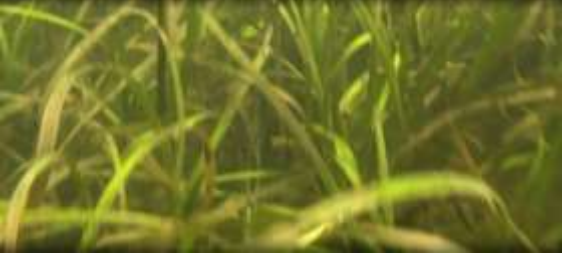
Transect 6			
Area Distance (m)	Substrate Observation	Macroflora/fauna Observations	Representative bottom camera images captured from the diver video camera
20-25	Sandy substrate.	Dense, healthy live eelgrass bed (<i>Zostera marina</i>) observed along the ocean floor.

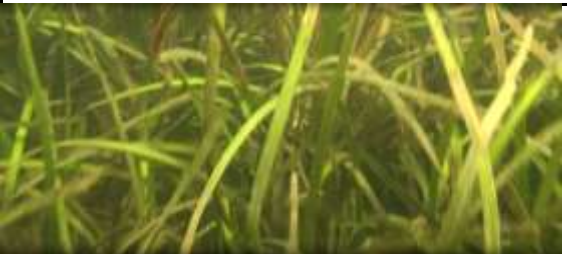
25-30	Sandy substrate.	Dense, healthy live eelgrass bed (<i>Zostera marina</i>) observed along the ocean floor.

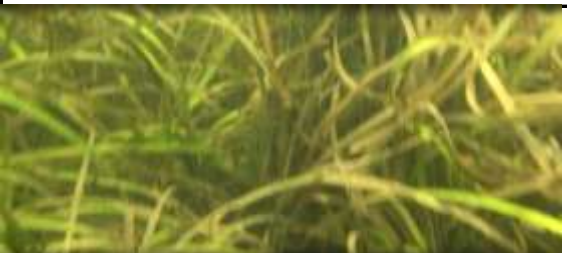
30-35	Sandy substrate.	Dense, healthy live eelgrass bed (<i>Zostera marina</i>) observed along the ocean floor.

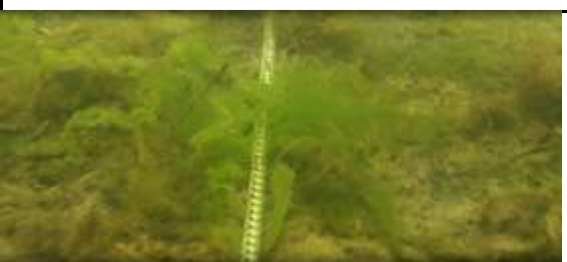
35-40	Sandy substrate with scattering macroalgae debris.	Intermittent patches of anchored soft sour weed (<i>Desmarestia viridis</i>), sea lettuce (<i>Ulva compressa</i> and <i>Ulva lactuca</i>), and eelgrass (<i>Zostera marina</i>) were observed along the ocean floor.

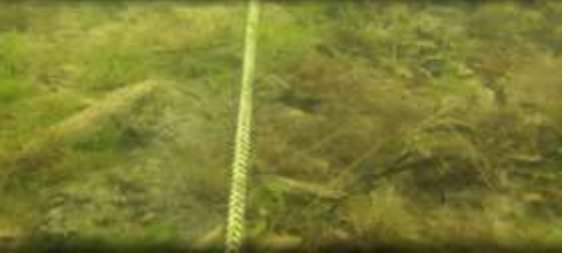
Transect 6			
Area Distance (m)	Substrate Observation	Macroflora/fauna Observations	Representative bottom camera images captured from the diver video camera
40-45	Sandy substrate with scattering macroalgae debris.	Intermittent patches of anchored soft sour weed (<i>Desmarestia viridis</i>), sea lettuce (<i>Ulva compressa</i> and <i>Ulva lactuca</i>), and eelgrass (<i>Zostera marina</i>) were observed along the ocean floor.

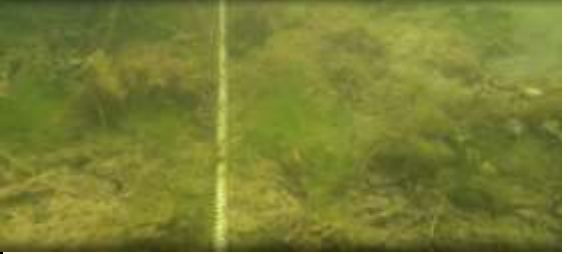
45-50	Sandy substrate with scattering macroalgae debris.	Intermittent patches of anchored soft sour weed (<i>Desmarestia viridis</i>), sea lettuce (<i>Ulva compressa</i> and <i>Ulva lactuca</i>), and eelgrass (<i>Zostera marina</i>) were observed along the ocean floor.

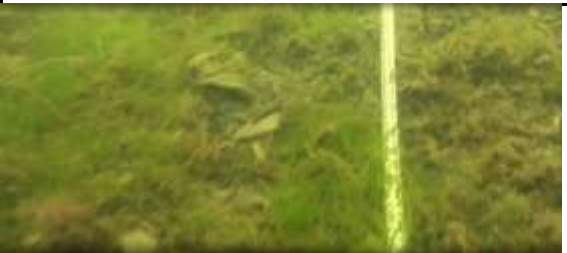
50-55	Sandy substrate with scattering macroalgae debris.	Intermittent patches of anchored soft sour weed (<i>Desmarestia viridis</i>), sea lettuce (<i>Ulva compressa</i> and <i>Ulva lactuca</i>), and eelgrass (<i>Zostera marina</i>) were observed along the ocean floor.

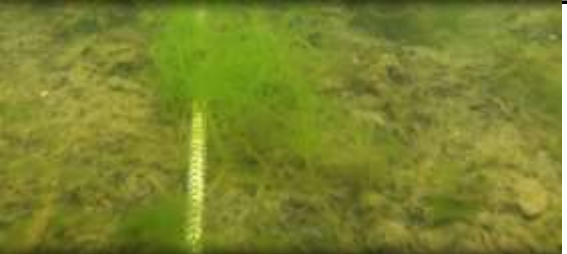
55-60	Sandy substrate with scattering macroalgae debris.	Intermittent patches of anchored soft sour weed (<i>Desmarestia viridis</i>), sea lettuce (<i>Ulva compressa</i> and <i>Ulva lactuca</i>), and eelgrass (<i>Zostera marina</i>) were observed along the ocean floor.

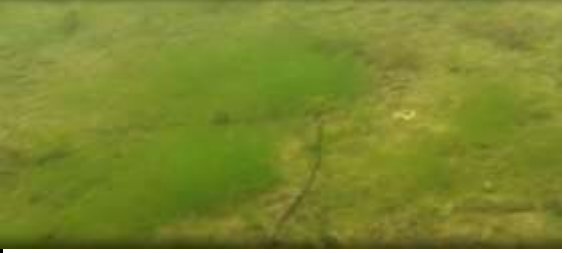
Transect 6			
Area Distance (m)	Substrate Observation	Macroflora/fauna Observations	Representative bottom camera images captured from the diver video camera
60-65	Sandy substrate with scattering macroalgae debris.	Intermittent patches of anchored soft sour weed (<i>Desmarestia viridis</i>), sea lettuce (<i>Ulva compressa</i> and <i>Ulva lactuca</i>), and eelgrass (<i>Zostera marina</i>) were observed along the ocean floor.

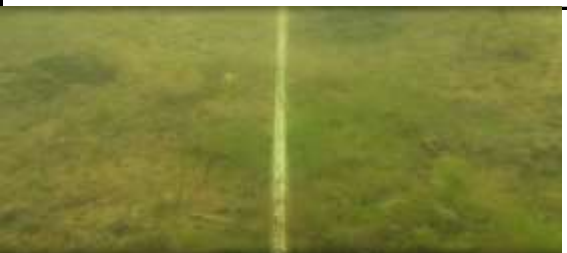
65-70	Sandy substrate with scattering macroalgae debris.	Intermittent patches of anchored soft sour weed (<i>Desmarestia viridis</i>), sea lettuce (<i>Ulva compressa</i> and <i>Ulva lactuca</i>), and eelgrass (<i>Zostera marina</i>) were observed along the ocean floor.

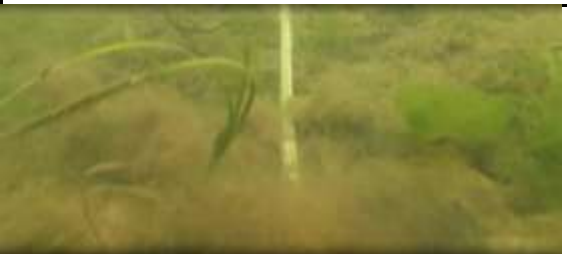
70-75	Sandy substrate with scattering macroalgae debris.	Intermittent patches of anchored soft sour weed (<i>Desmarestia viridis</i>), sea lettuce (<i>Ulva compressa</i> and <i>Ulva lactuca</i>), and eelgrass (<i>Zostera marina</i>) were observed along the ocean floor.

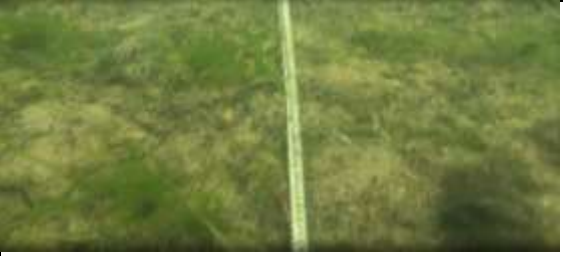
5-10	Sandy substrate with scattering macroalgae debris.	Intermittent patches of anchored soft sour weed (<i>Desmarestia viridis</i>) and sea lettuce (<i>Ulva compressa</i> and <i>Ulva lactuca</i>) were observed along the ocean floor. One Atlantic Rock Crab (<i>Cancer irroratus</i>) observed.

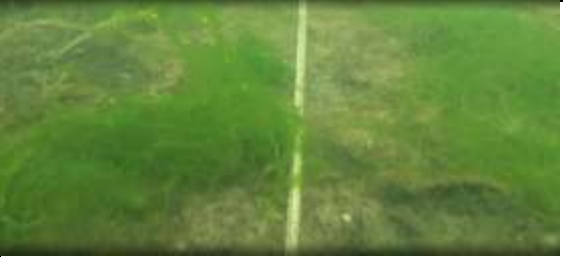
10-15	Sandy substrate with scattering macroalgae debris.	Intermittent patches of anchored soft sour weed (<i>Desmarestia viridis</i>) and sea lettuce (<i>Ulva compressa</i> and <i>Ulva lactuca</i>) were observed along the ocean floor.

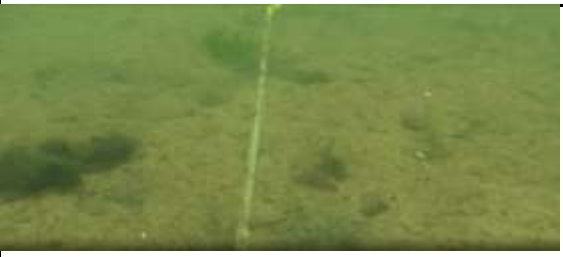
15-20	Sandy substrate with scattering macroalgae debris.	Intermittent patches of anchored soft sour weed (<i>Desmarestia viridis</i>) and sea lettuce (<i>Ulva lactuca</i>) were observed along the ocean floor. Two Atlantic Rock Crab (<i>Cancer irroratus</i>) observed.

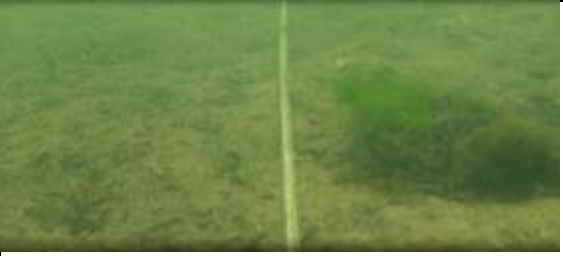
Transect 7			
Area Distance (m)	Substrate Observation	Macroflora/fauna Observations	Representative bottom camera images captured from the diver video camera
20-25	Sandy substrate with scattering macroalgae debris.	Intermittent patches of anchored soft sour weed (<i>Desmarestia viridis</i>) and sea lettuce (<i>Ulva lactuca</i>) were observed along the ocean floor. One Atlantic Rock Crab (<i>Cancer irroratus</i>) observed.

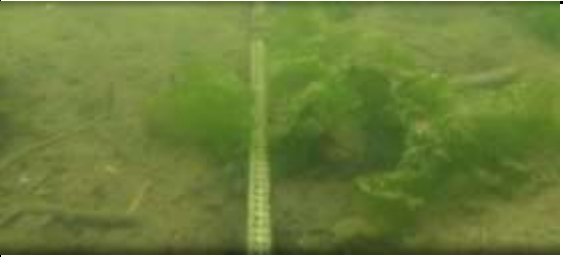
25-30	Sandy substrate with scattering macroalgae debris.	Intermittent patches of anchored soft sour weed (<i>Desmarestia viridis</i>) and sea lettuce (<i>Ulva lactuca</i>) were observed along the ocean floor. One Atlantic Rock Crab (<i>Cancer irroratus</i>) observed.

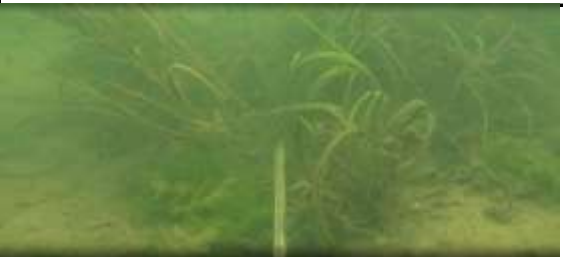
30-35	Sandy substrate with scattering macroalgae debris.	Intermittent patches of anchored soft sour weed (<i>Desmarestia viridis</i>) and sea lettuce (<i>Ulva lactuca</i>) were observed along the ocean floor. One Atlantic Rock Crab (<i>Cancer irroratus</i>) observed.

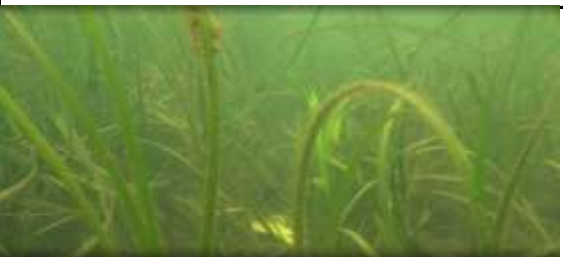
35-40	Sandy substrate.	Dense, healthy live eelgrass bed (<i>Zostera marina</i>) observed along the ocean floor.

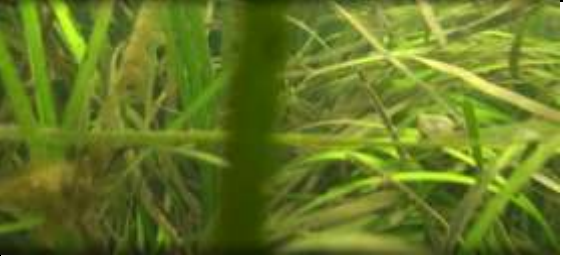
Transect 7			
Area Distance (m)	Substrate Observation	Macroflora/fauna Observations	Representative bottom camera images captured from the diver video camera
40-45	Sandy substrate.	Dense, healthy live eelgrass bed (<i>Zostera marina</i>) with Periwinkle (<i>Littorina</i> sp.) and Stickleback species (<i>Gasterosteus</i> sp.) living within the eelgrass bed. One Atlantic Rock Crab (<i>Cancer irroratus</i>) observed.

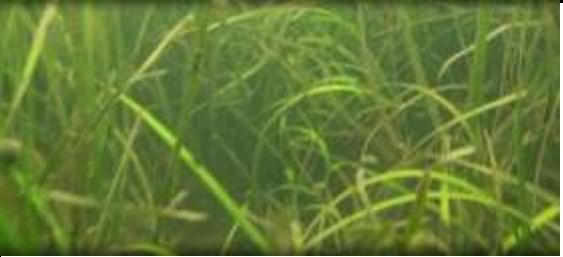
45-50	Sandy substrate.	Dense, healthy live eelgrass bed (<i>Zostera marina</i>) with Periwinkle (<i>Littorina</i> sp.) and Stickleback species (<i>Gasterosteus</i> sp.) living within the eelgrass bed.

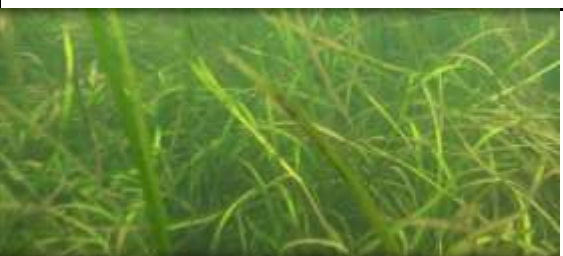
50-55	Sandy substrate.	Dense, healthy live eelgrass bed (<i>Zostera marina</i>) with Periwinkle (<i>Littorina</i> sp.) and Stickleback species (<i>Gasterosteus</i> sp.) living within the eelgrass bed.

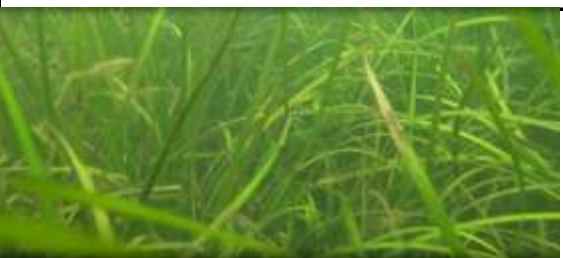
55-60	Sandy substrate.	Dense, healthy live eelgrass bed (<i>Zostera marina</i>) with Periwinkle (<i>Littorina</i> sp.) and Stickleback species (<i>Gasterosteus</i> sp.) living within the eelgrass bed.

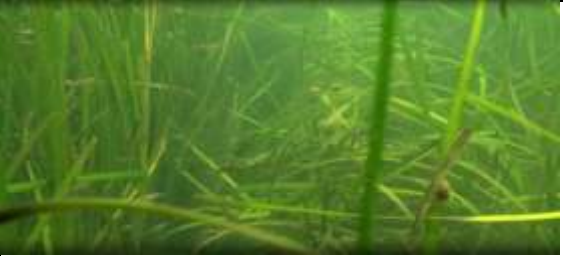
Transect 7			
Area Distance (m)	Substrate Observation	Macroflora/fauna Observations	Representative bottom camera images captured from the diver video camera
60-65	Sandy substrate.	Dense, healthy live eelgrass bed (<i>Zostera marina</i>) with Periwinkle (<i>Littorina</i> sp.) and Stickleback species (<i>Gasterosteus</i> sp.) living within the eelgrass bed.

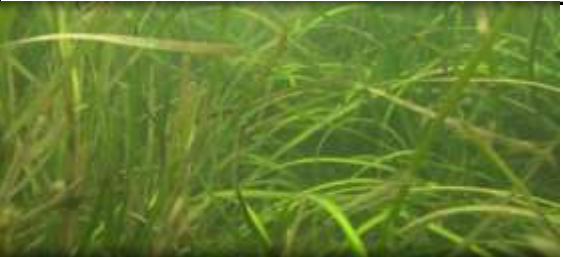
65-70	Sandy substrate.	Dense, healthy live eelgrass bed (<i>Zostera marina</i>) with Periwinkle (<i>Littorina</i> sp.) and Stickleback species (<i>Gasterosteus</i> sp.) living within the eelgrass bed.

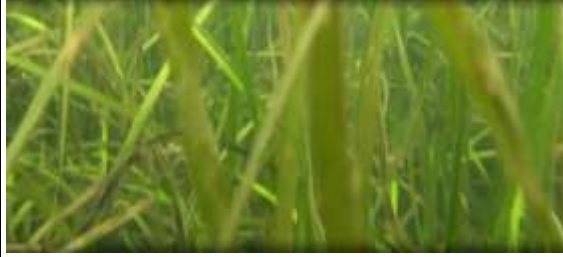
70-75	Sandy substrate.	Dense, healthy live eelgrass bed (<i>Zostera marina</i>) with Periwinkle (<i>Littorina</i> sp.) and Stickleback species (<i>Gasterosteus</i> sp.) living within the eelgrass bed. One Hermit crab (<i>Pagurus</i> sp.) observed.

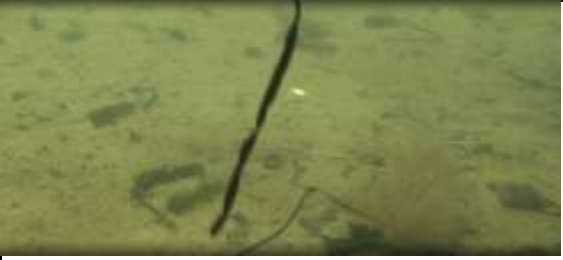
5-10	Sandy substrate with scattering macroalgae debris.	Intermittent patches of anchored soft sour weed (<i>Desmarestia viridis</i>) and sea lettuce (<i>Ulva compressa</i>) were observed along the ocean floor.

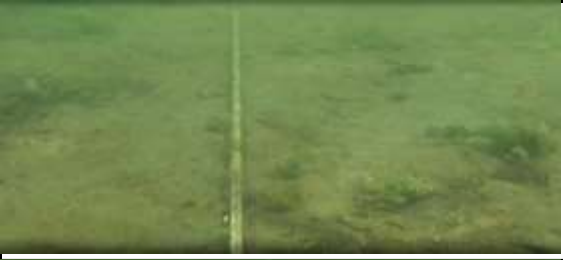
10-15	Sandy substrate with scattering macroalgae debris.	Intermittent patches of anchored soft sour weed (<i>Desmarestia viridis</i>), and sea lettuce (<i>Ulva compressa</i> and <i>Ulva lactuca</i>) were observed along the ocean floor. One Atlantic Rock Crab (<i>Cancer irroratus</i>) observed.

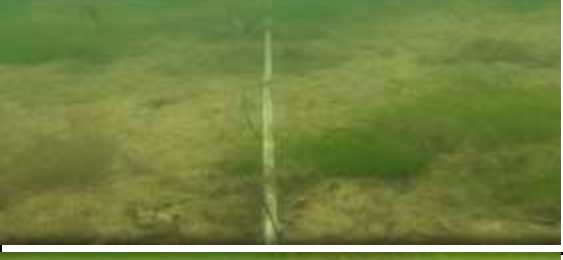
15-20	Sandy substrate with scattering macroalgae debris.	Intermittent patches of anchored soft sour weed (<i>Desmarestia viridis</i>), and sea lettuce (<i>Ulva compressa</i> and <i>Ulva lactuca</i>) were observed along the ocean floor.

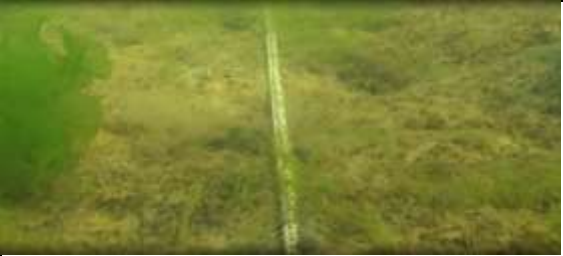
Transect 8			
Area Distance (m)	Substrate Observation	Macroflora/fauna Observations	Representative bottom camera images captured from the diver video camera
20-25	Sandy substrate with scattering macroalgae debris.	Intermittent patches of anchored soft sour weed (<i>Desmarestia viridis</i>), and sea lettuce (<i>Ulva compressa</i> and <i>Ulva lactuca</i>) were observed along the ocean floor.

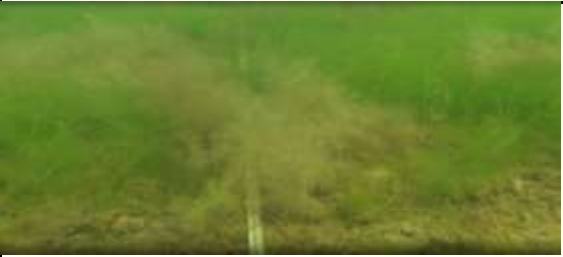
25-30	Sandy substrate with scattering macroalgae debris.	Intermittent patches of anchored soft sour weed (<i>Desmarestia viridis</i>), and sea lettuce (<i>Ulva compressa</i> and <i>Ulva lactuca</i>) were observed along the ocean floor.

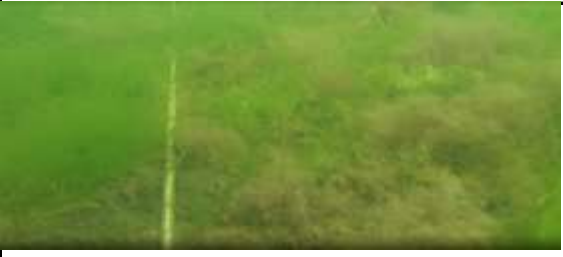
30-35	Sandy substrate with scattering macroalgae debris.	Intermittent patches of anchored soft sour weed (<i>Desmarestia viridis</i>), and sea lettuce (<i>Ulva compressa</i> and <i>Ulva lactuca</i>) were observed along the ocean floor.

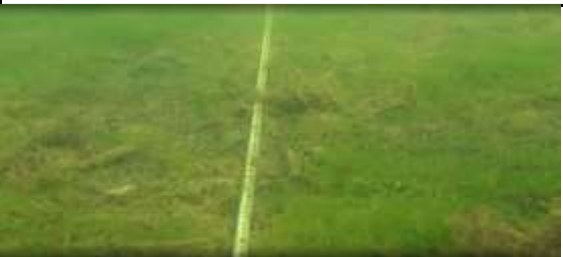
35-40	Sandy substrate with scattering macroalgae debris.	Intermittent patches of anchored soft sour weed (<i>Desmarestia viridis</i>), and sea lettuce (<i>Ulva compressa</i> and <i>Ulva lactuca</i>) were observed along the ocean floor.

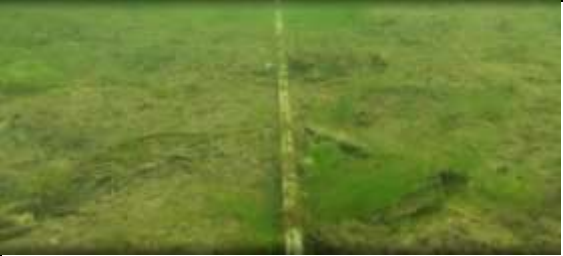
Transect 8			
Area Distance (m)	Substrate Observation	Macroflora/fauna Observations	Representative bottom camera images captured from the diver video camera
40-45	Sandy substrate with scattering macroalgae debris.	Intermittent patches of anchored soft sour weed (<i>Desmarestia viridis</i>), and sea lettuce (<i>Ulva compressa</i> and <i>Ulva lactuca</i>) were observed along the ocean floor. One Atlantic Rock Crab (<i>Cancer irroratus</i>) observed.

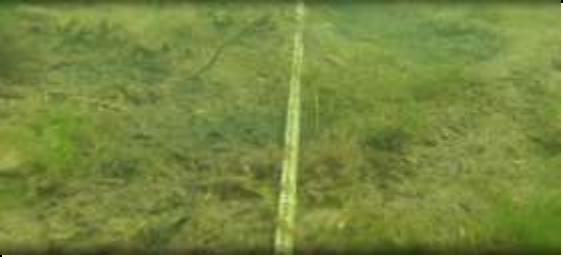
45-50	Sandy substrate with scattering macroalgae debris.	Intermittent patches of anchored soft sour weed (<i>Desmarestia viridis</i>), and sea lettuce (<i>Ulva compressa</i> and <i>Ulva lactuca</i>) were observed along the ocean floor. Two Atlantic Rock Crab (<i>Cancer irroratus</i>) observed.

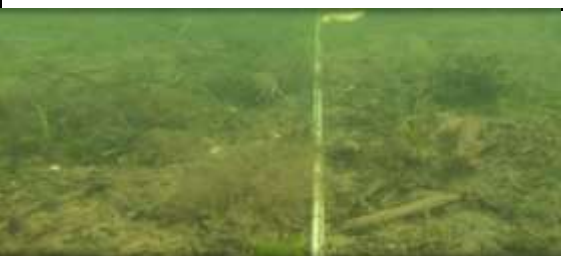
50-55	Sandy substrate with scattering macroalgae debris.	Intermittent patches of anchored soft sour weed (<i>Desmarestia viridis</i>), and sea lettuce (<i>Ulva compressa</i> and <i>Ulva lactuca</i>) were observed along the ocean floor. One Atlantic Rock Crab (<i>Cancer irroratus</i>) observed.

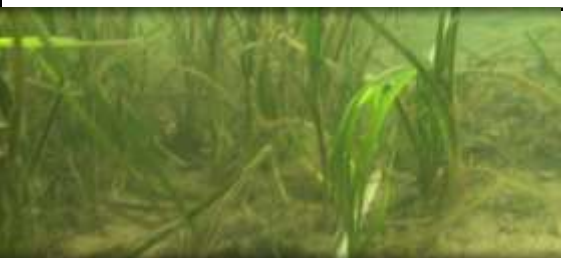
55-60	Sandy substrate with scattering macroalgae debris.	Intermittent patches of anchored soft sour weed (<i>Desmarestia viridis</i>), and sea lettuce (<i>Ulva compressa</i> and <i>Ulva lactuca</i>) were observed along the ocean floor. Numerous stickleback species (<i>Gasterosteus</i> sp.) were observed.

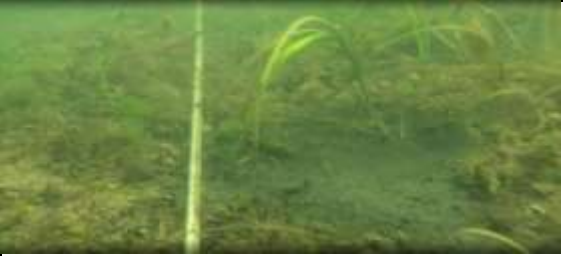
Transect 8			
Area Distance (m)	Substrate Observation	Macroflora/fauna Observations	Representative bottom camera images captured from the diver video camera
60-65	Sandy substrate with scattering macroalgae debris.	Intermittent patches of anchored soft sour weed (<i>Desmarestia viridis</i>), and sea lettuce (<i>Ulva compressa</i> and <i>Ulva lactuca</i>) were observed along the ocean floor.

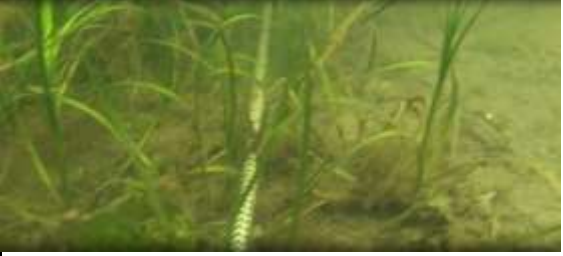
65-70	Sandy substrate with scattering macroalgae debris.	Intermittent patches of anchored soft sour weed (<i>Desmarestia viridis</i>), and sea lettuce (<i>Ulva compressa</i> and <i>Ulva lactuca</i>) were observed along the ocean floor. One Atlantic Rock Crab (<i>Cancer irroratus</i>) and numerous stickleback species (<i>Gasterosteus</i> sp.) were observed.

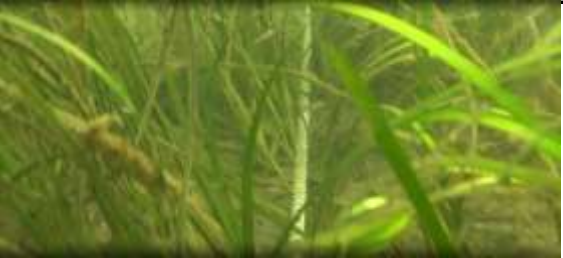
70-75	Sandy substrate with scattering macroalgae debris.	Dense live eelgrass (<i>Zostera marina</i>) was observed along the ocean floor. Numerous stickleback species (<i>Gasterosteus</i> sp.) were observed.
