APPENDIX

C-1 *HYDROGEOLOGICAL ASSESSMENTS*

Re: Groundwater Supply – Drilling and Test Pumping of Well TW-02, New Maryland

VILLAGE OF NEW MARYLAND

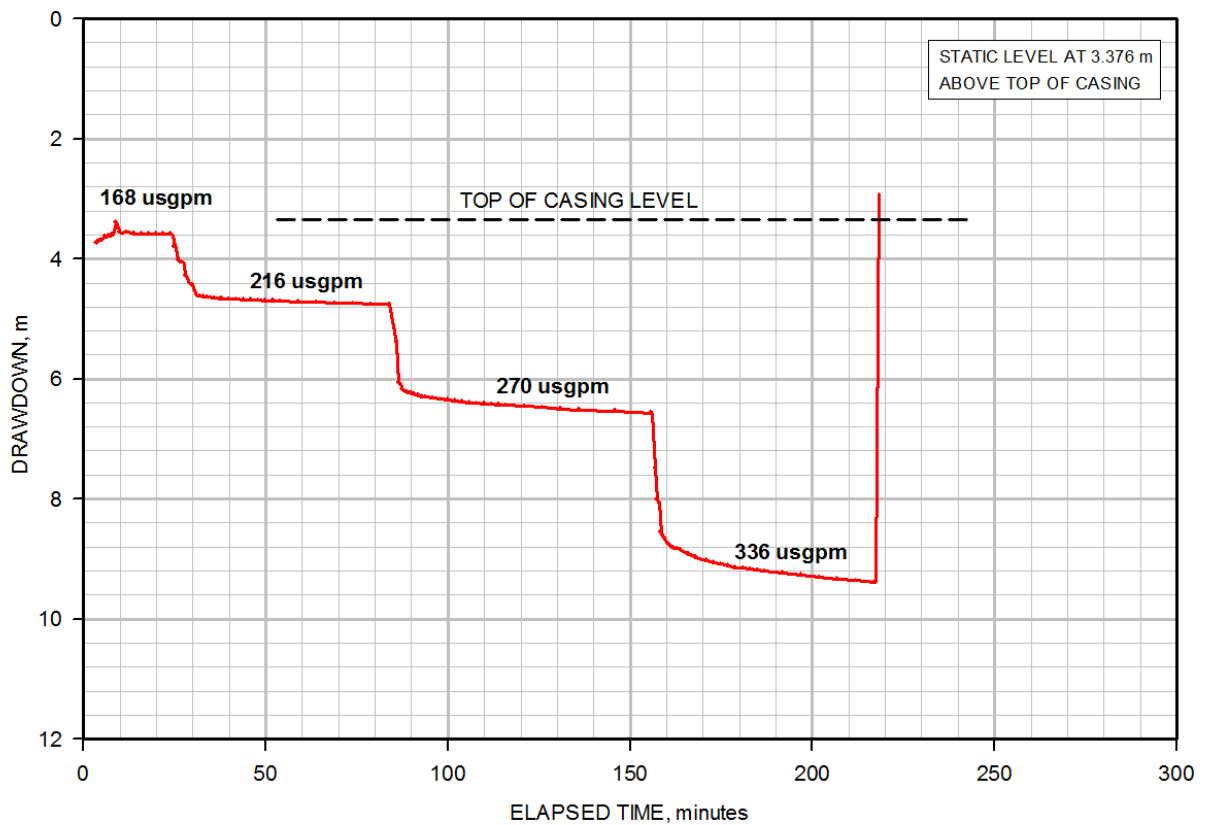
On February 27, 2017 a step-drawdown pumping test was carried out on Well TW 05-02. The well was tested at four incremental steps, these pumping rates being as shown in Table 1. Each rate was maintained for approximately 60 minutes before proceeding to the next step. Water levels were recorded both manually and with automatic dataloggers, by measuring the depth to groundwater below the top of casing (BTOC) in the available wells, then converting to drawdowns. The results are summarized in Table 1 and plotted in Figure 2. From the step test it was concluded that the constant rate pumping test should be carried out at 1,832 m³/d (336 usgpm).

Figure 2. Step Test of Well TW 05-02 – Drawdown vs. Time

Aquifer Loss Coefficient, B = 0.002 days/m² or 0.035 feet/usgpm

Well Loss Coefficient, C = 1.64 x 10⁻⁶ days/m⁵ or 1.64 x 10⁻⁴ feet/usgpm²

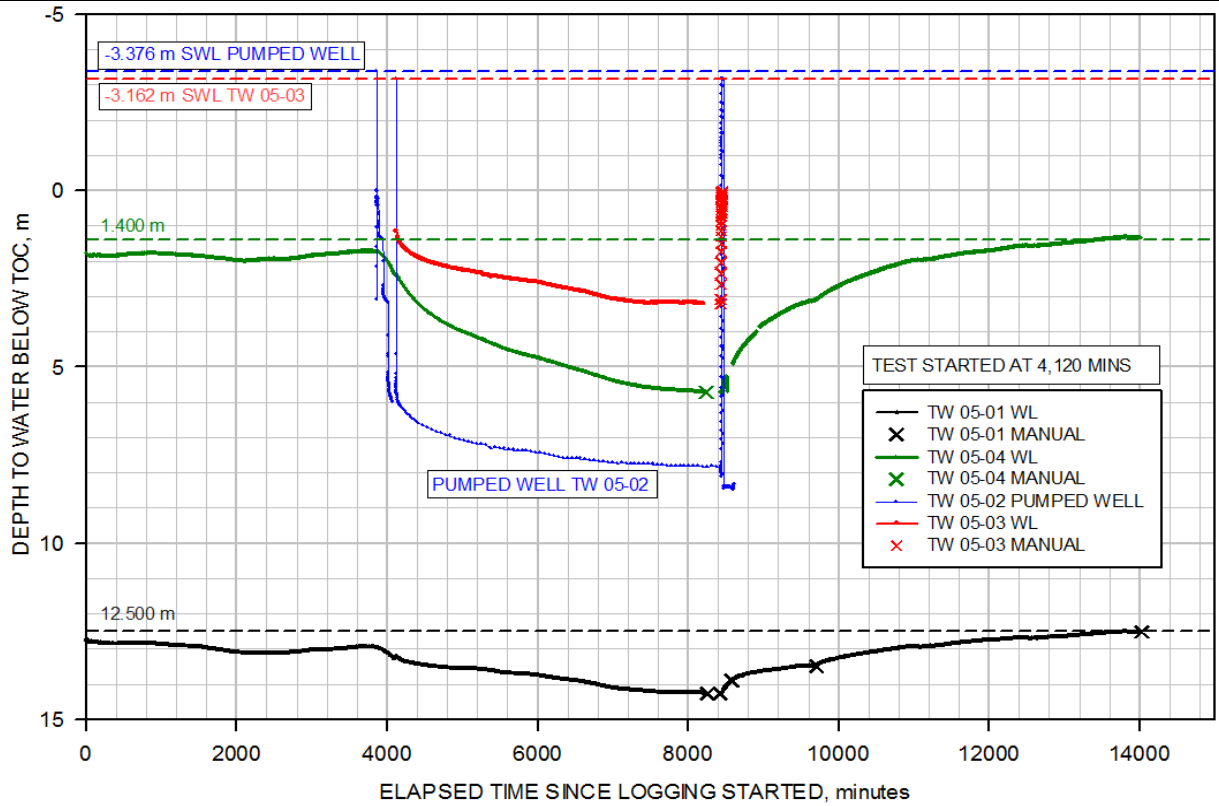
The constant rate test began at 1:40 pm on February 27, 2017, following the (almost) immediate recovery of the pumped well from the step testing. Water levels in the pumped well and in three observation wells (TW 05-01, 03 and 04 in Figure 1) were observed. The initial static water level in the pumped well (TW 05-02) was not measured, but was later assumed to be 3.376 m above the top of the casing, as measured after the test. The pumping phase of the test continued for 72 hours and both the drawdown and (post-pumping) recovery stages were measured manually and

Figure 3. Step Test and Constant Rate Pumping Test of Well TW 05-02 – Water Levels vs. Time

The hydraulic responses of the two other observation wells (TW 05-01 and 04) during the pumping test are also presented in Figures 3 and 4. The drawdown in Well TW 05-04 (64 m from the pumped well) was 4.32 m at the end of the pumping period while the drawdown in Well TW 05-01 (145 m from the pumped well) was 1.77 m at the end of the test. Distance drawdown data are plotted in Figure 5, from which an aquifer transmissivity of 225 m²/d (~18,200 usgpd/ft) is inferred.

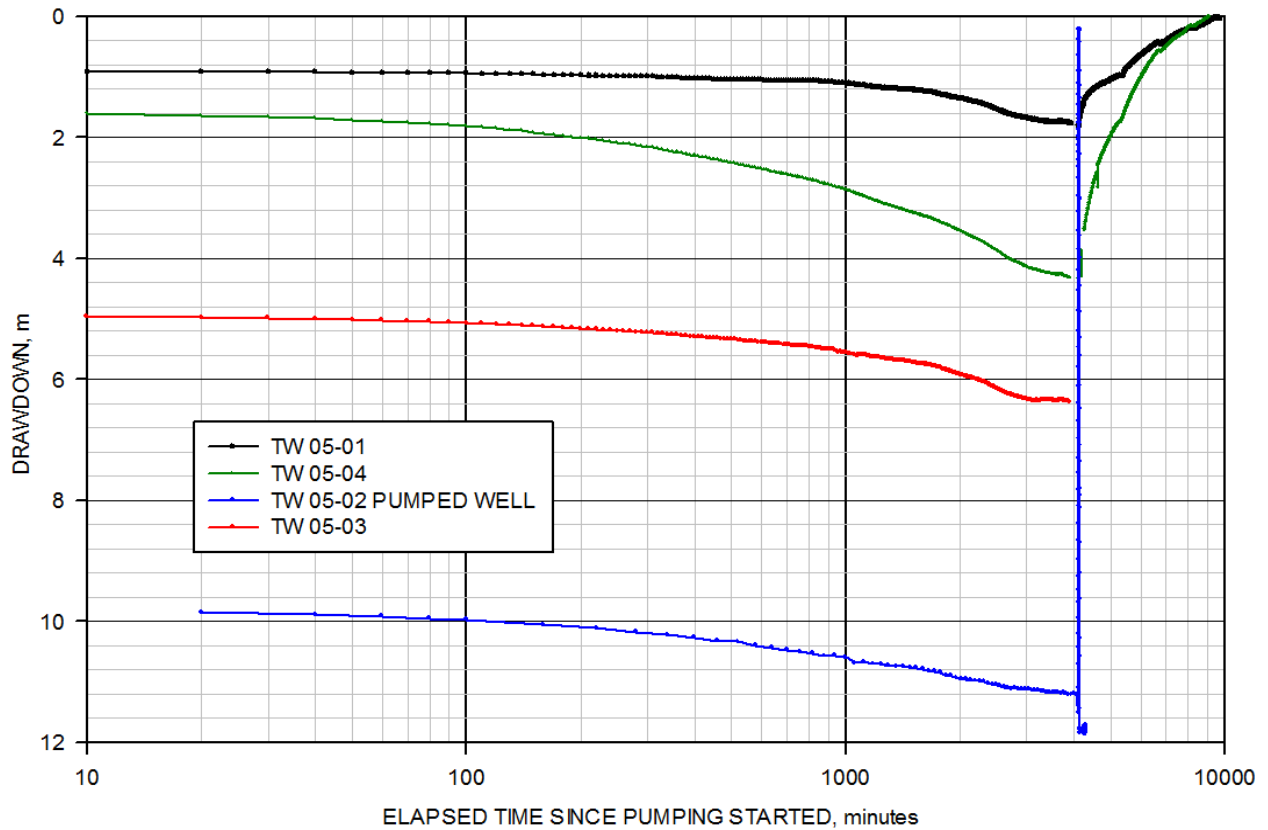
Figure 4. Constant Rate Pumping Test of Well TW 05-02 – Drawdown vs. Log Time

After 72 hours (4,320 minutes) of continuous pumping, the drawdown in the pumped well was 11.22 m. From the slope of the drawdown versus log time plot (Figure 4), it was inferred that some recharge was intercepted two days into the test (~2,880 minutes) when the cone of depression had expanded some 600 m from the pumped well (inferred later from Figure 5). The data suggest an aquifer transmissivity of approximately 250 m²/d (20,000 usgpd/ft) and a storativity of 3x10⁻³ or lower, the latter indicating confined aquifer conditions supported by the presence of artesian flow.

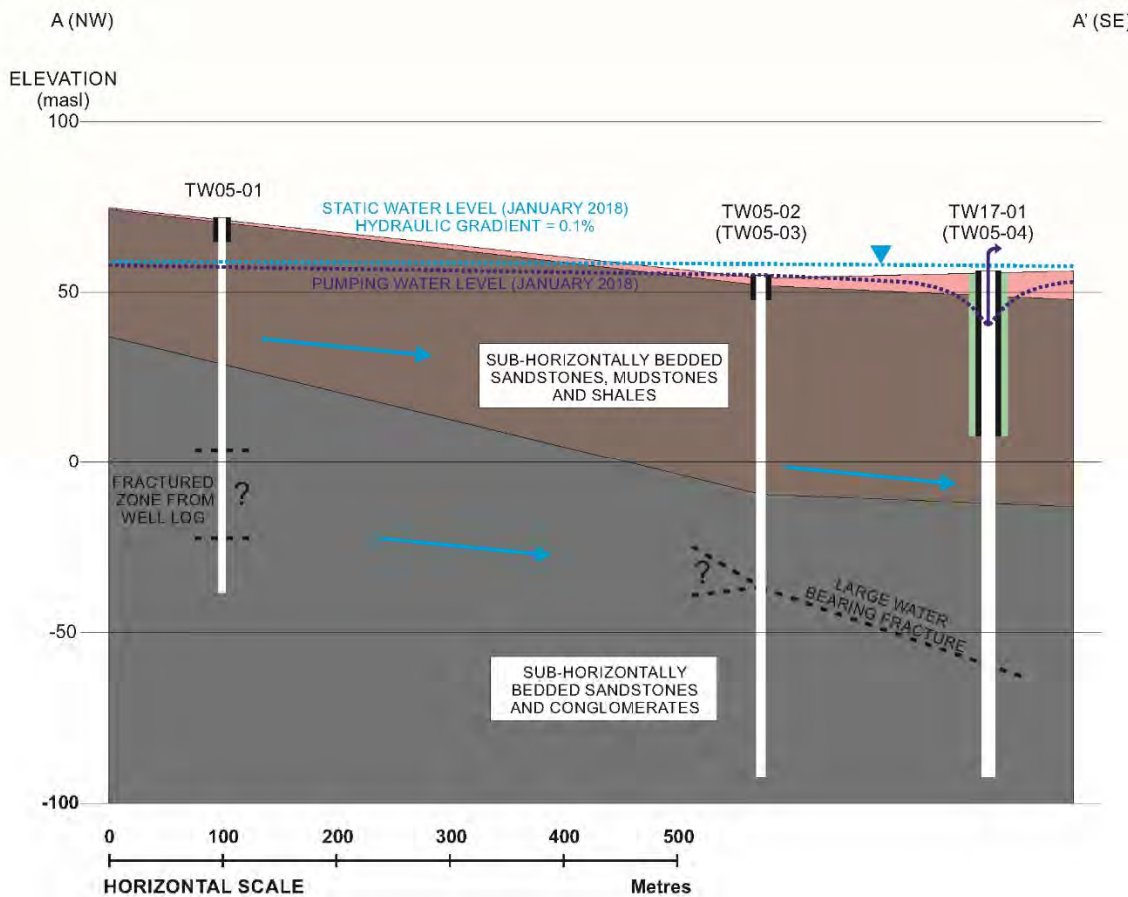
An interpreted sub-surface cross section of the Property from northwest to southeast (section A-A' as shown in Figure 2-1) is depicted in Figure 2-3. The general topography, bedding, and groundwater table slope from northwest to southeast. A large water bearing fracture was encountered at depth while deepening test wells TW05-02 and TW05-04, and during drilling of TW17-01. Test well TW05-01 may also intersect this fracture, within a likely zone between 65 and 95 m (213 and 312 feet) asl (refer to Appendix A for the well driller's log, and the identified zone on Figure 2-3) but this is not confirmed since this well was drilled by others. Due to an approximate 20 m difference in elevation between test well TW05-01 and the other wells on the Property, and the artesian pressures in the intercepted aquifer at depth, overflow conditions are only observed at the wells at lower elevation (TW05-02, TW05-03, TW05-04 and TW17-01) during the bulk of the year. Based on this information, it is suspected that overflow conditions are absent at TW05-01 due to its much higher elevation, as the conceptual model in Figure 2-3 depicts.

Figure 2-3. Conceptual cross-section along the test wells on the subject Property.

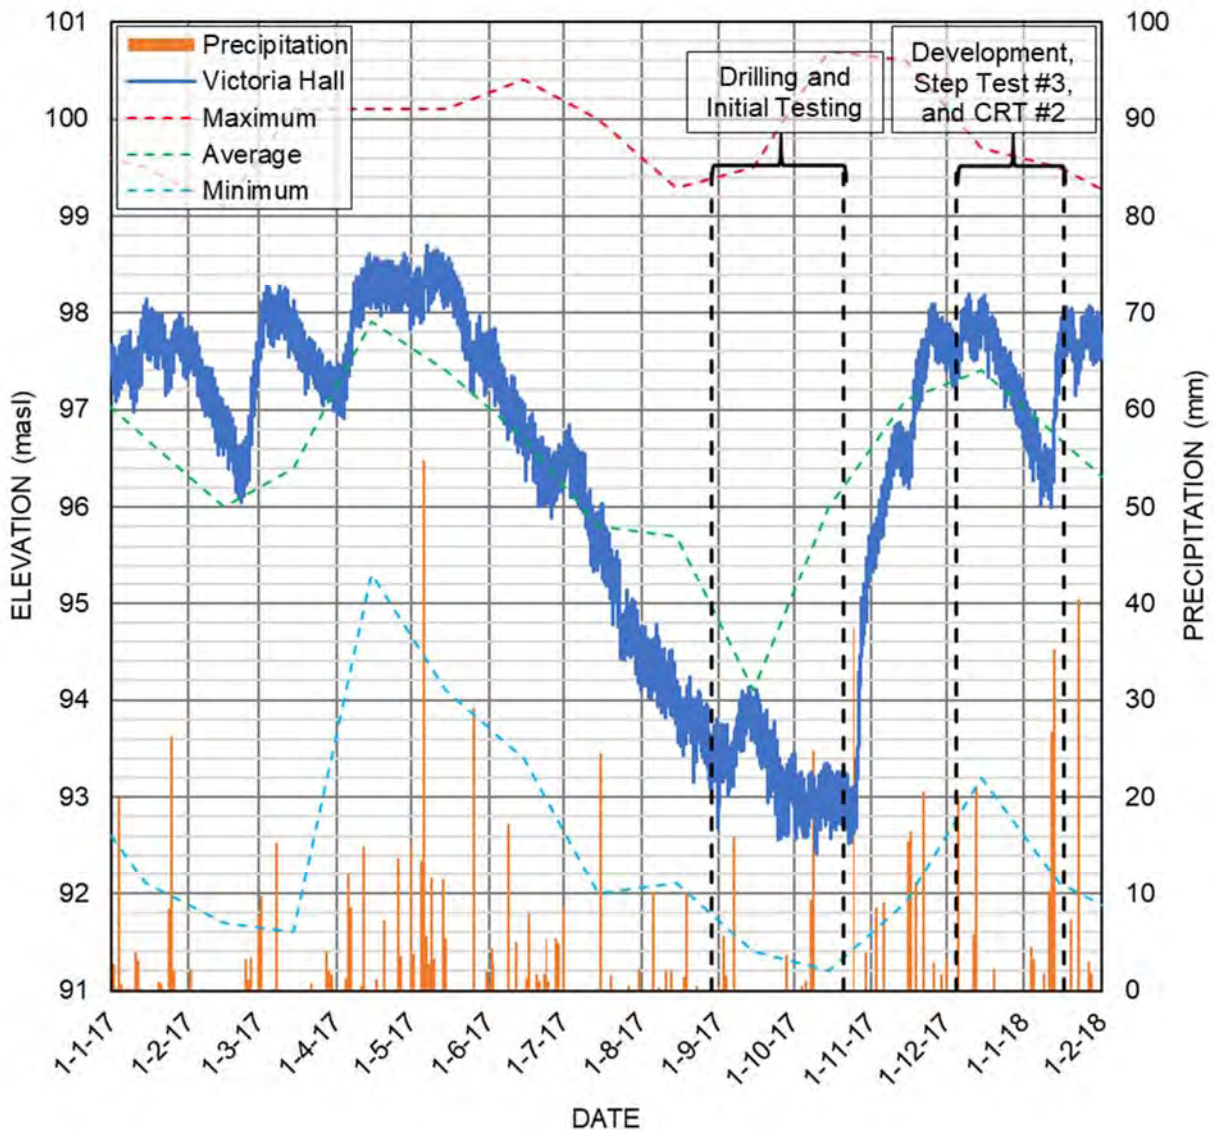
Groundwater levels at an observation well belonging to the Provincial monitoring network, located near Victoria Hall on PID 75064253 in New Maryland, have been monitored by the Government of New Brunswick since 1979 (NBDELG 2018). The Victoria Hall well (location identified on Figure 1-1) is located approximately 2 km from the subject Property (and approximately due north from the test wells), and on ground that is approximately 40 m higher in elevation. The historical data provide some indication of general water table trends in this aquifer. From January 2017 to January 2018, groundwater levels regularly fluctuated by 1 to 2 m, with a maximum fluctuation over that period of 6 m from May to October 2017, as shown in Figure 2-4. This prolonged decline in the groundwater level confirms the extremely dry conditions under which the drilling and initial testing were completed (refer to Figure 2-4).

Figure 2-4. Groundwater elevations in the Victoria Hall well with precipitation.

The extended 6-month decline in groundwater levels had resulted in levels descending below the historical (39-year) average between July and November 2017 (green dashed line in Figure 2-4). This decline is attributed to limited precipitation being received in the area over this period, (254 mm at the Fredericton International Airport monitoring station, ECCC 2018) which produced extremely dry (drought-like) conditions over these months (the precipitation is also shown in Figure 2-4 over that time period). The high variability in groundwater elevations measured at the Victoria Hall well, up to 10 m between the historical maximum and minimum water levels over the period of record (red and blue dashed lines, respectively), suggests that this aquifer is highly influenced by precipitation and snowmelt (with a time lag² of 5 days for its effects to reach the aquifer), and the antecedent moisture condition.

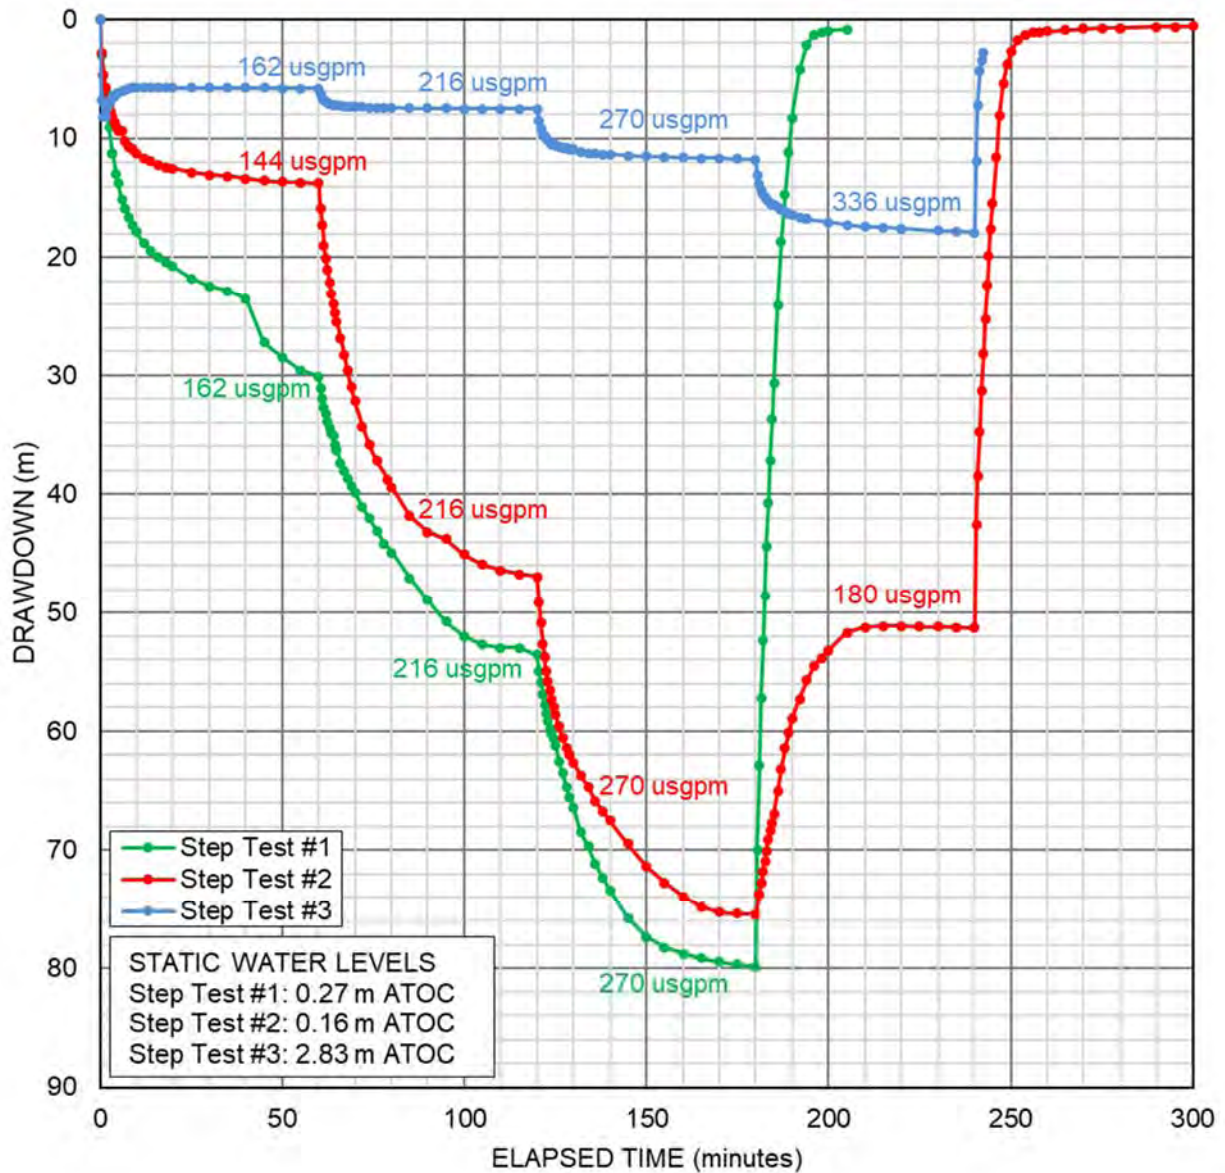
Figure 4-1. TW17-01 step-drawdown tests – Drawdown vs. Time.

1. Aquifer Loss Coefficient, B = 2.88×10^{-3} days/m² (5.15×10^{-2} feet/usgpm).
2. Well Loss Coefficient, C = 3.59×10^{-6} day/m⁵ (3.50×10^{-4} feet/usgpm²).

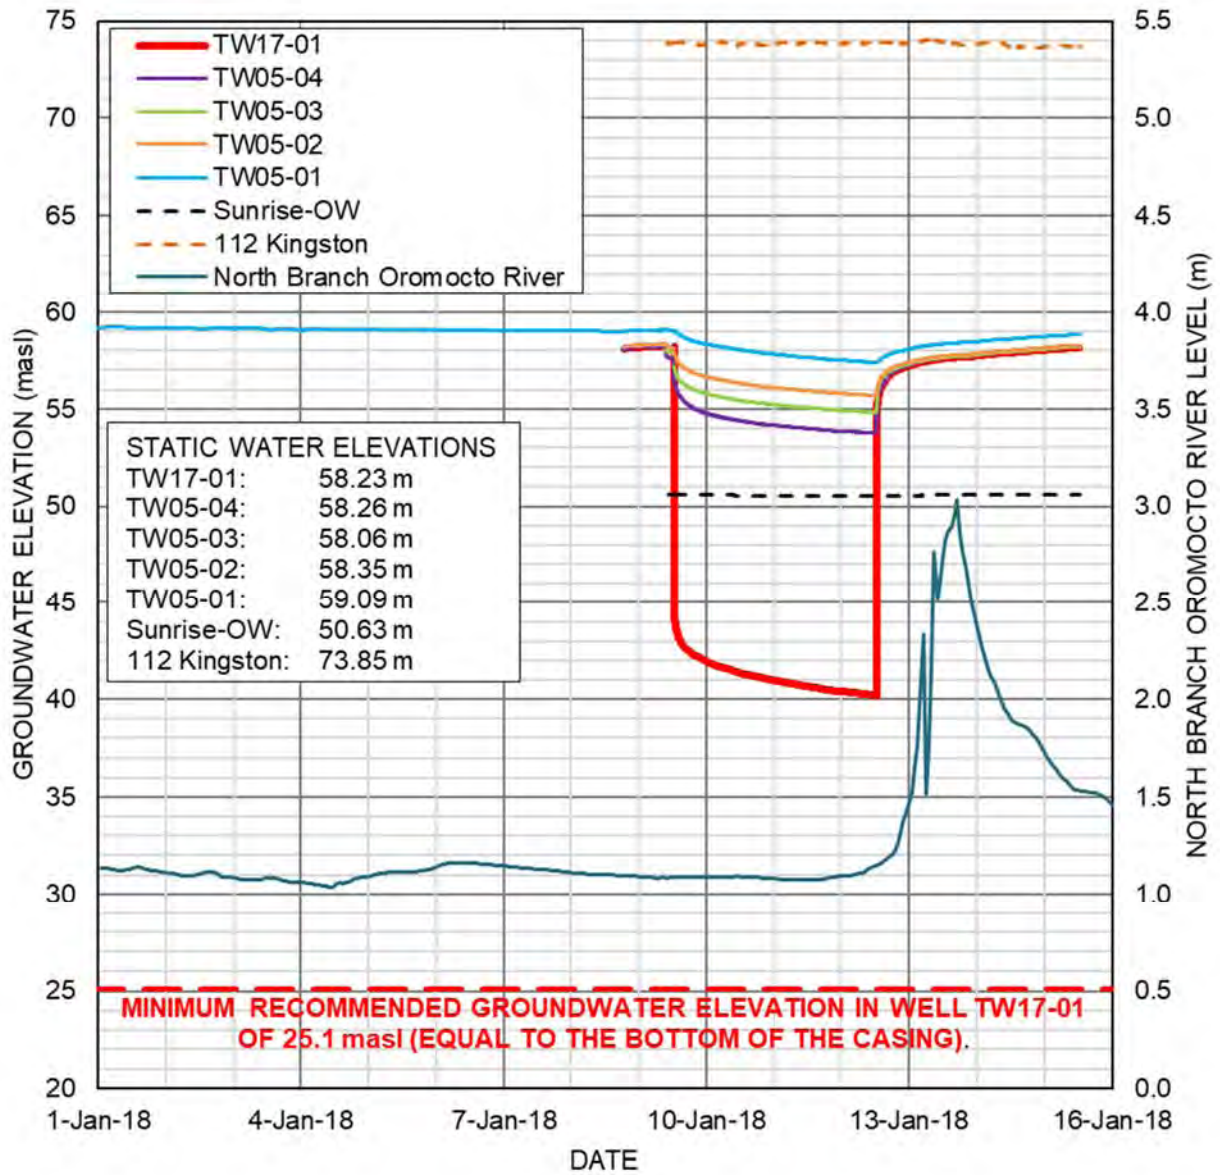
Figure 4-4. TW17-01 constant-rate pumping test – Elevation vs. Time.

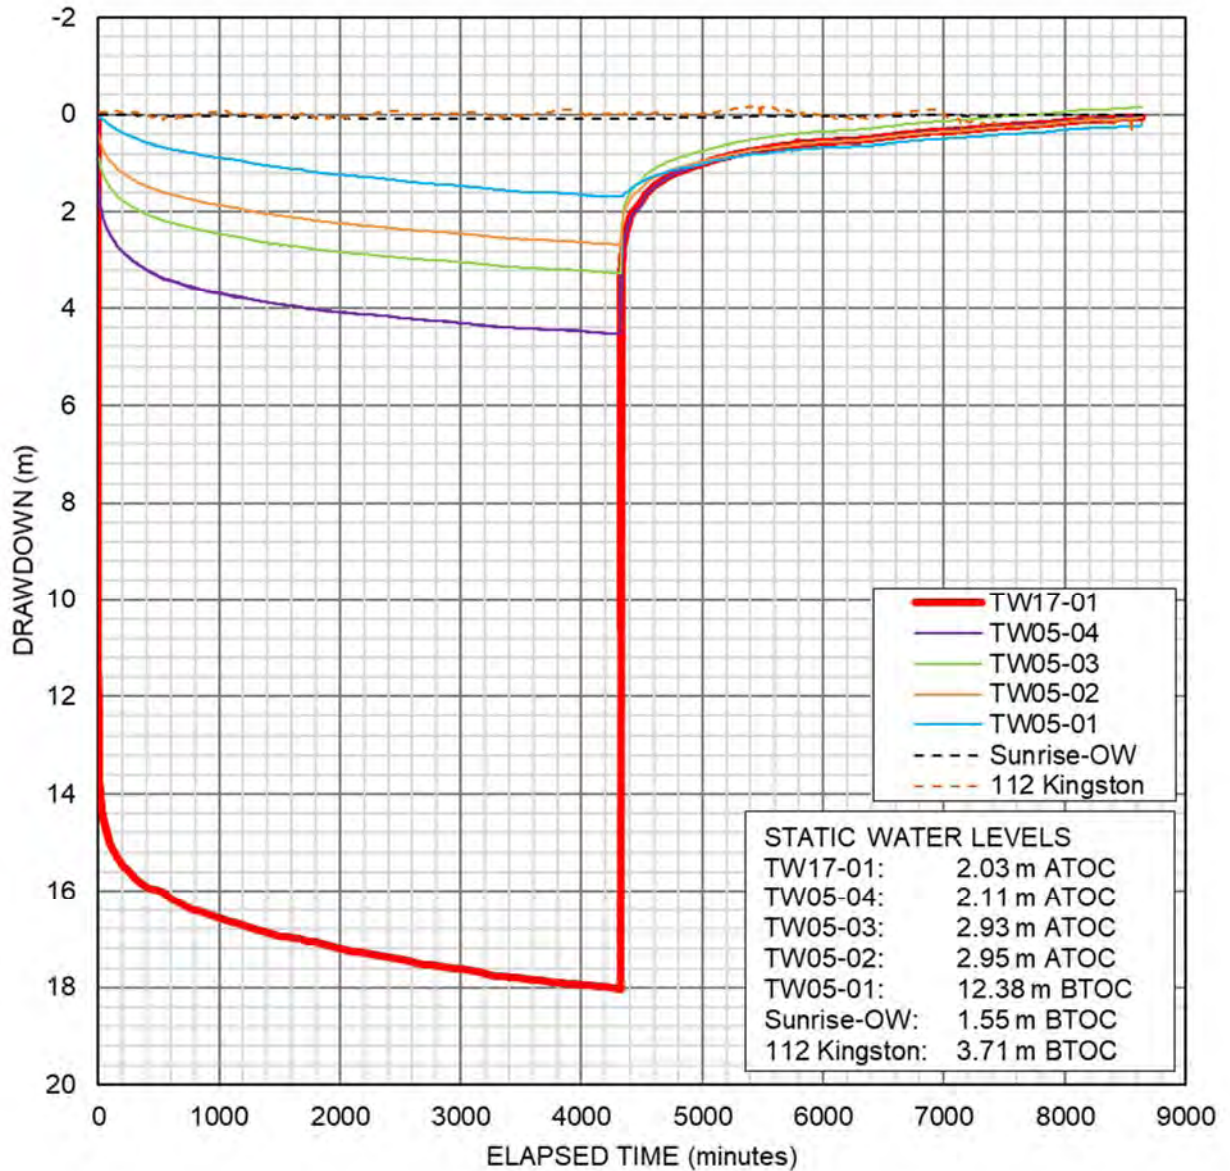
Figure 4-5. TW17-01 constant-rate pumping test – Drawdown vs. Linear Time.

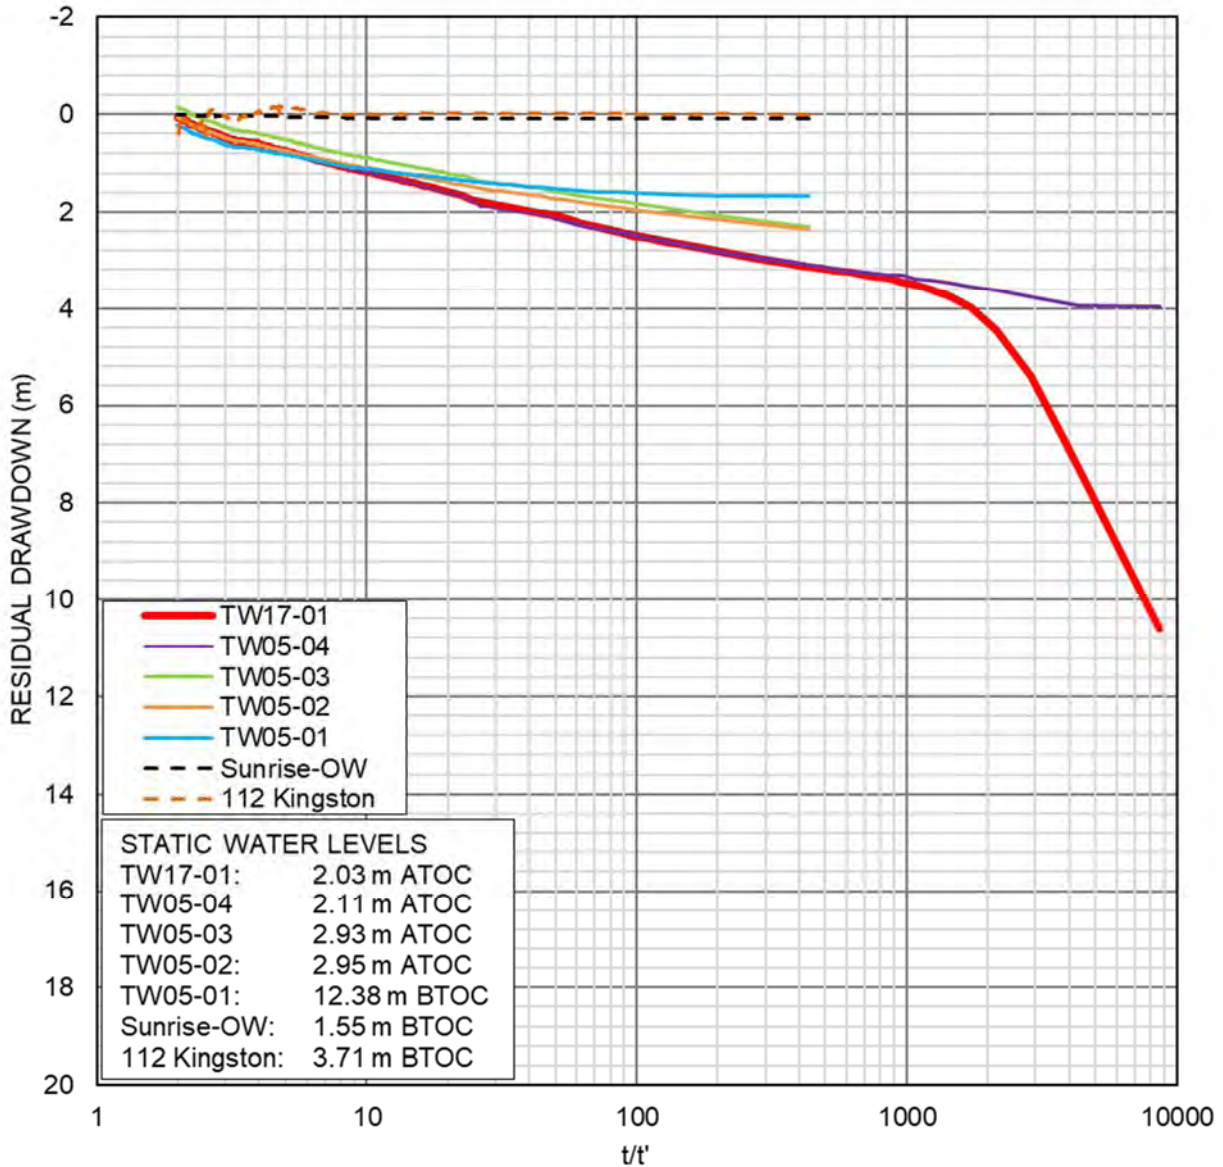
Figure 4-8. TW17-01 constant-rate pumping test – Recovery.

Note: 1. The recovery results are not shown, as they are not representative of the response to the constant-rate pumping test.

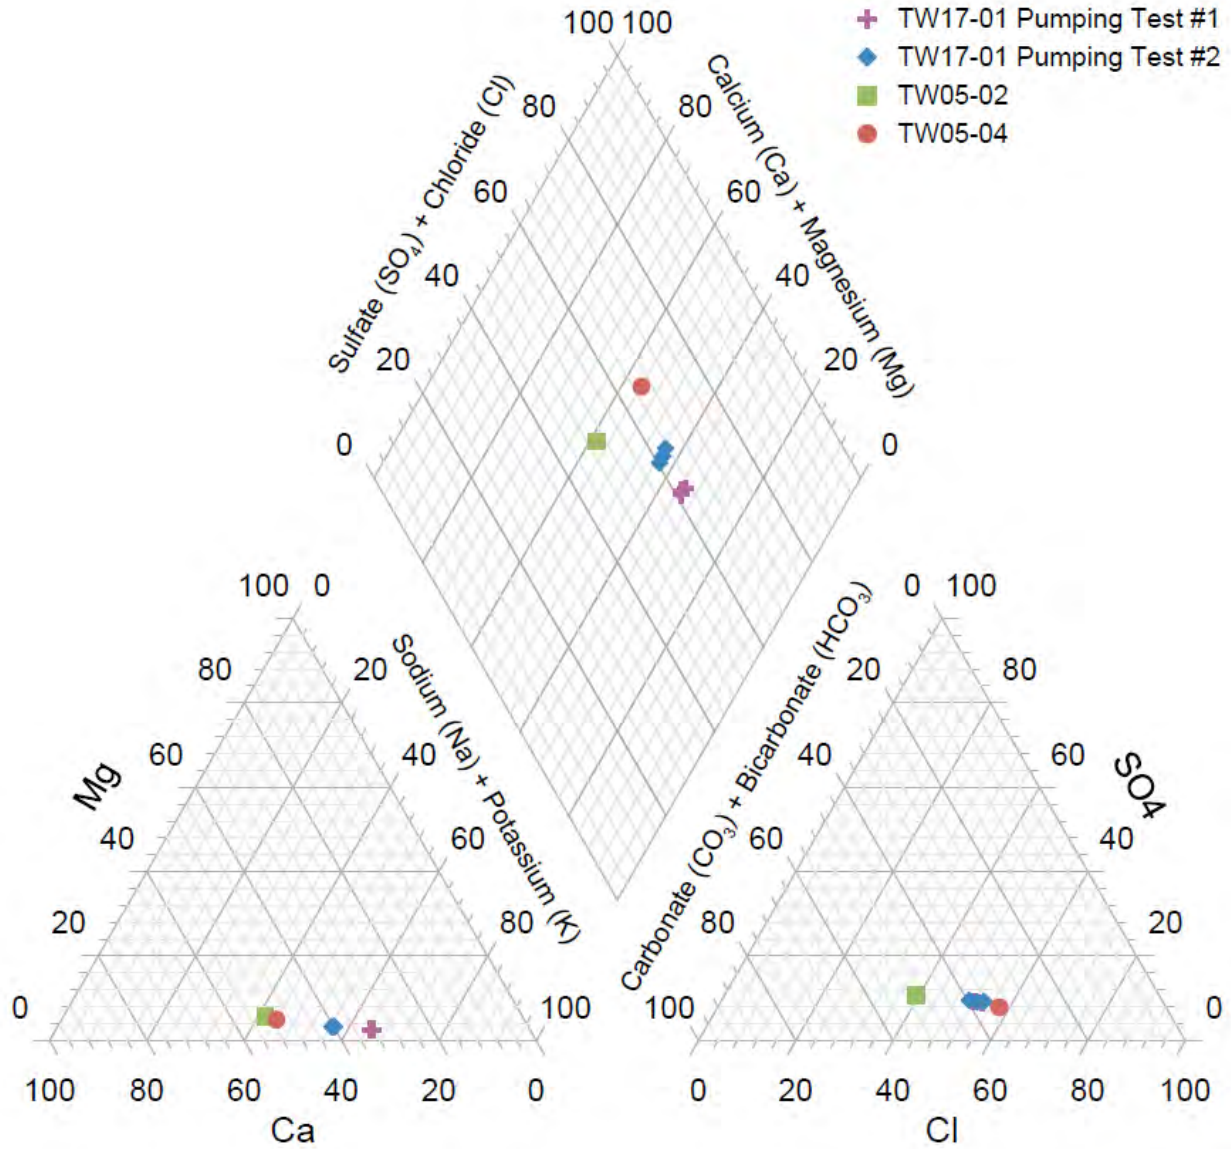
Figure 4-9. Piper plot of major ions of the groundwater samples.

None of the 37 separate VOCs in the analysis suite were detected in the eight samples collected. Table 4-10 shows a summary of the exceedances observed in groundwater samples collected from well TW17-01. Refer also to Appendix C for complete tables of groundwater quality results: Table C-1 (general chemistry), Table C-2 (dissolved metals) and Table C-3 (microbiology and VOCs). Exceedances of the GCDWQ are flagged in the tables. Appendix D contains the signed laboratory certificates from the RPC analytical laboratory.

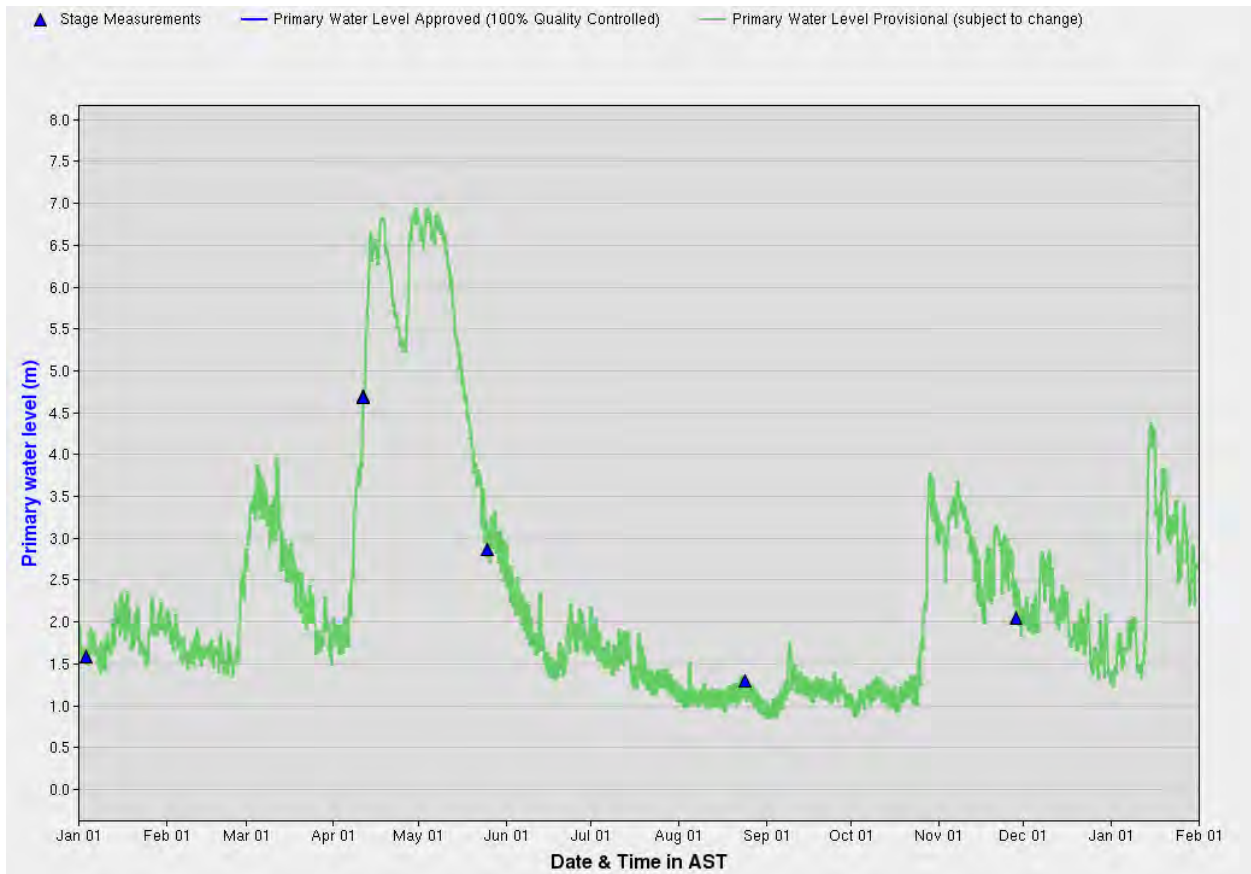
Figure B-1. St. John River level for January 2017 to January 2018 at the Fredericton monitoring station (WSC 2018).

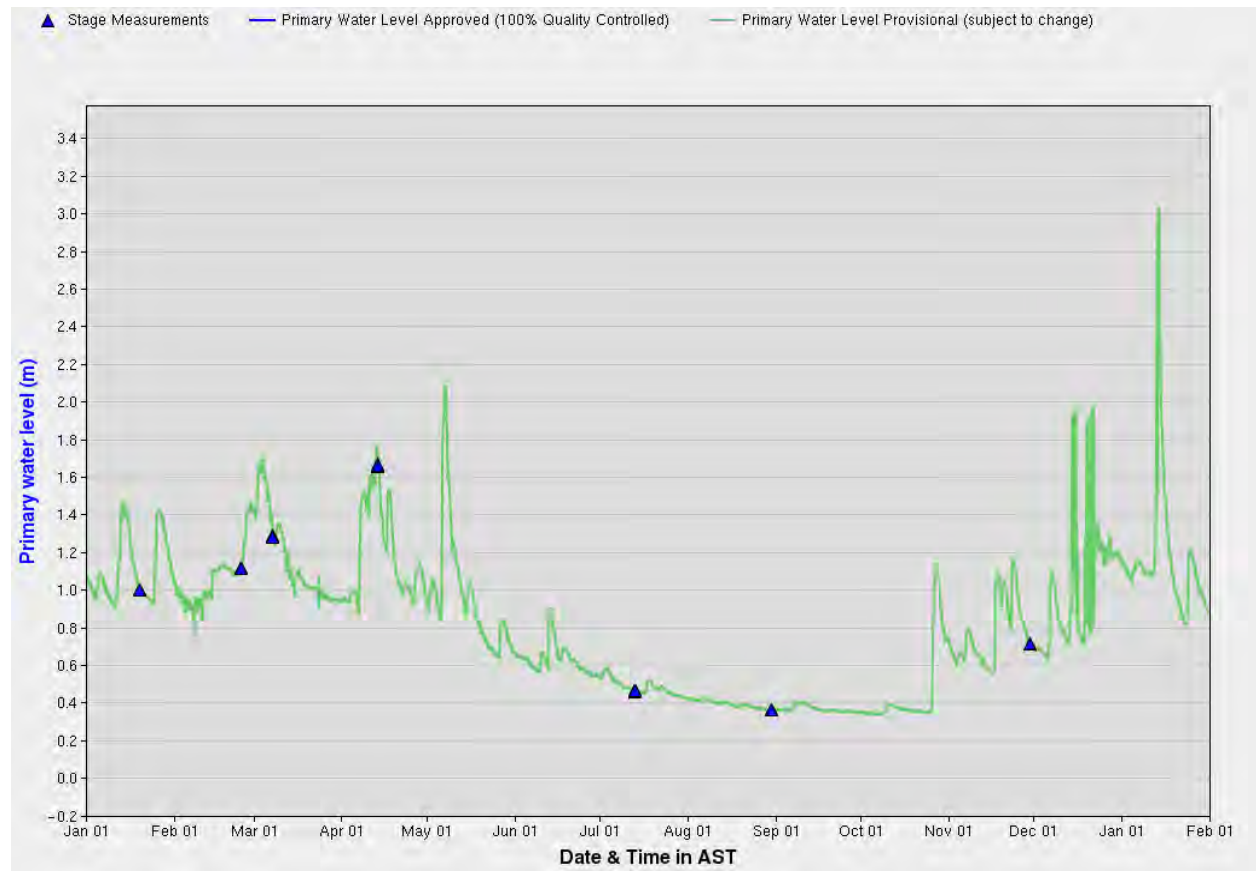
Figure B-2. North Branch Oromocto River level for January 2017 to January 2018 at the Tracy monitoring station (WSC 2018).
