Environmental Impact Assessment St. George Groundwater Supply Exploration

Municipality of Eastern Charlotte
Registration Document

212918.00 • February 2024

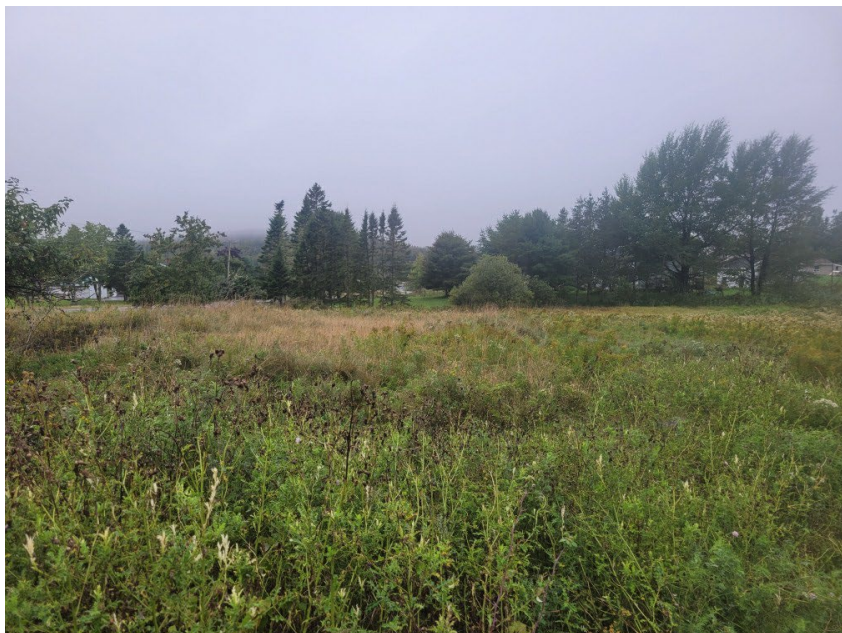
Photo 1: Project Site

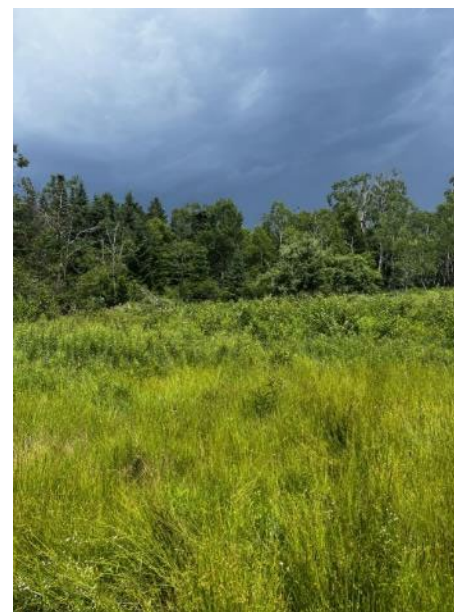
Photo 2: WL 4 vegetation viewed north east from within wetland.

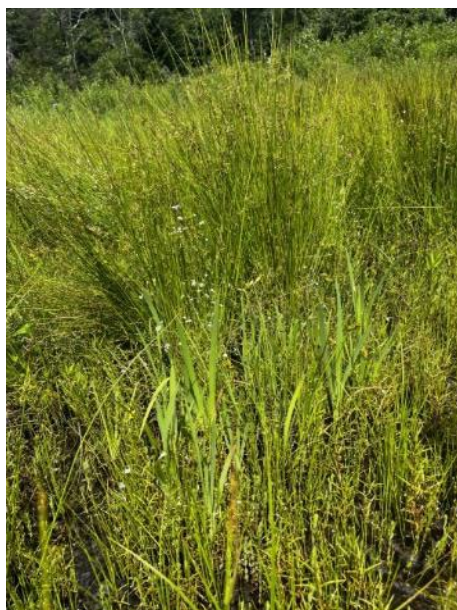
Photo 3: Representative herbaceous vegetation within WL 4 wetland data point.

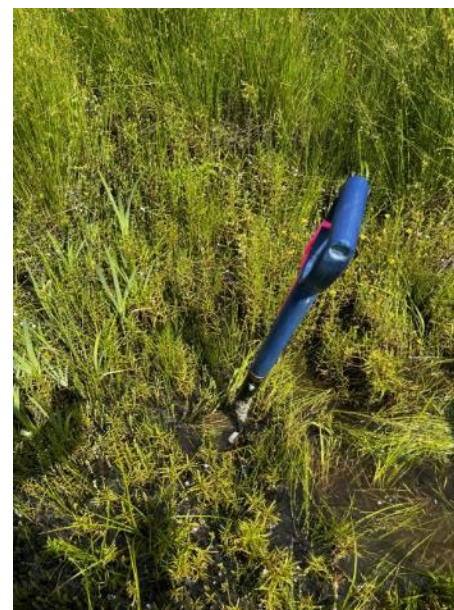
Photo 4: Standing water at the WL 4 data point.

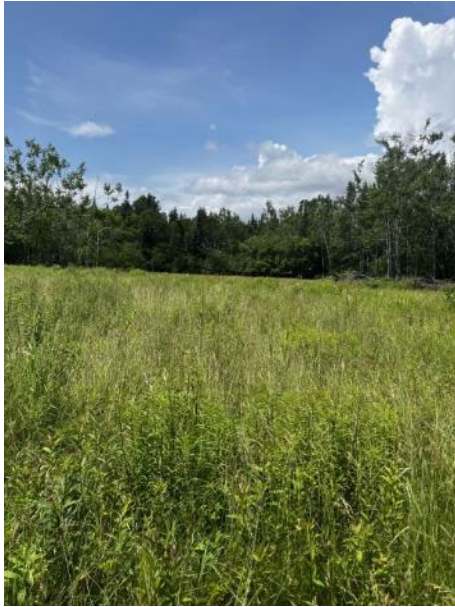
Photo 5: Upland shrub and herbaceous stratum at WL 4 upland data point.

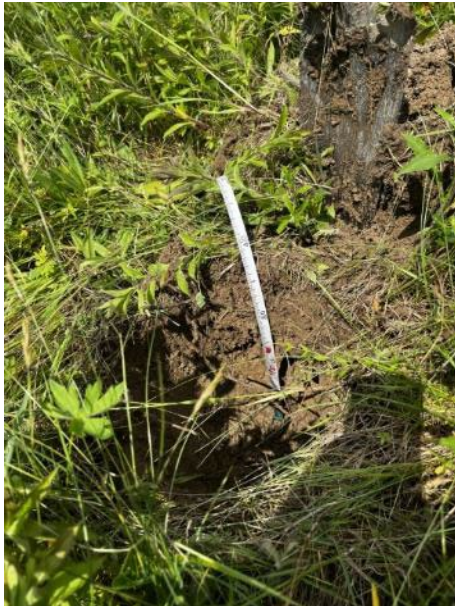
Photo 7: Upland soil profile for WL 4 upland data point.
