# **SAGEWILL LIMESTONE QUARRY EIA – Addendum: New Access Road**

French Village, New Brunswick  
TE181001

**Sagewill Enterprises Ltd.**

Wood Environment & Infrastructure Solutions,  
a Division of Wood Canada Limited  
495 Prospect Street, Suite 1  
Fredericton, New Brunswick E3B 9M4  
T: 506-458-1000

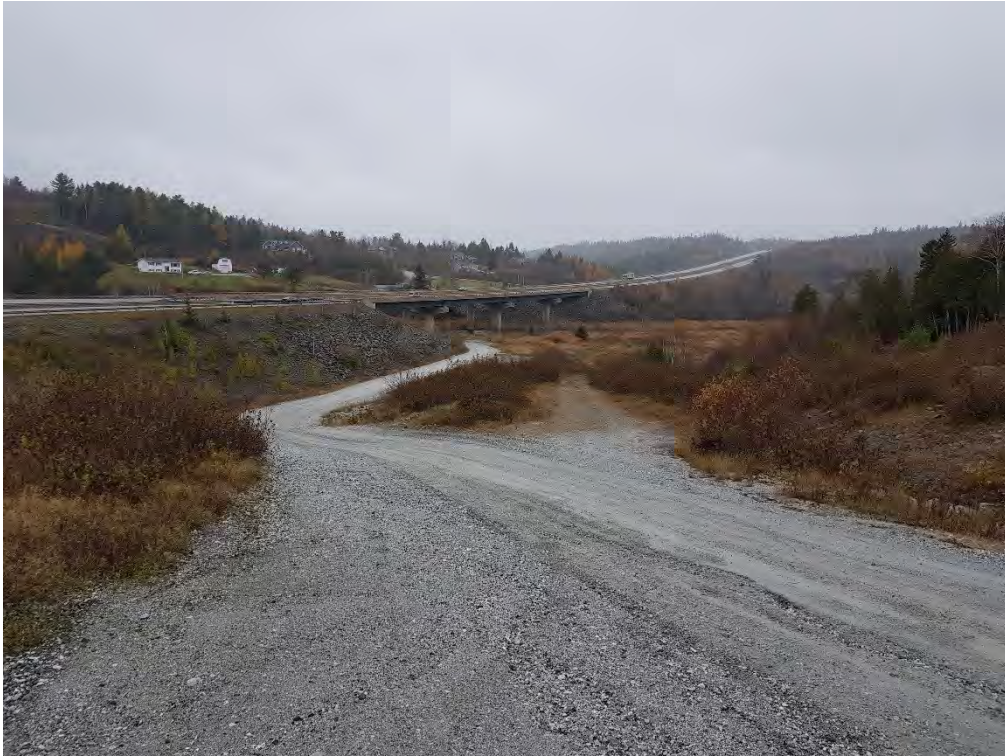
Photo 1. Looking south along the existing access road from the approximate take-off point for the new access road.

The supplementary biophysical field survey was conducted on October 30, 2019. The new access road footprint will be approximately 2.5 hectares (ha) in total area. Of this, 40% has been previously disturbed by past earthworks and quarrying (Attachment A, Photos 1 to 8). There are a few small patches of remnant forest within this disturbed landscape consisting of mixed hardwood and softwood of varying ages from young to mature. The rest of the access road area, east of the disturbed landscape, is mature mixed (conifer dominant) forest (Attachment A, Photos 9 to 14). All forest areas showed signs of past timber harvesting, including old stumps and overgrown roads, and there is an actively used ATV trail along the property boundary (Figure 3). There were some older trees on steeper parts of the hill, but no concentrations of over-mature forest were observed.

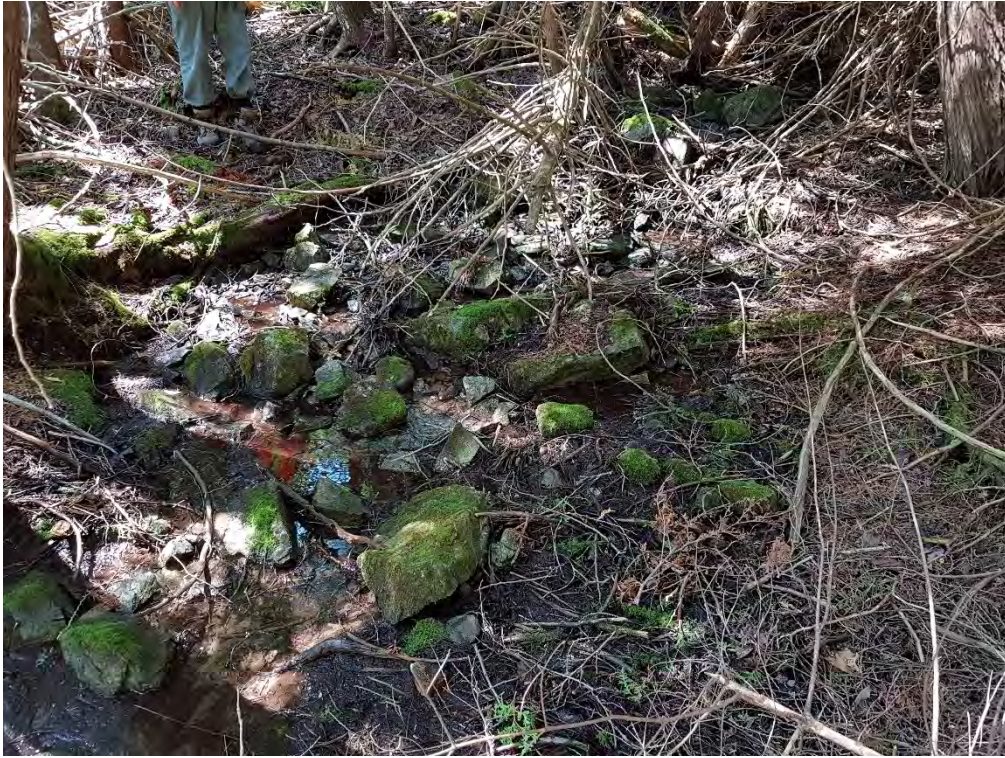
Photo 17. Watercourse 1 (WC1) has maximum bank width of about 2 m and height of 0.2 m. The water flow was almost dry in October.

**WC1** drains from the steep hillside east of the existing quarry and flows eastward, downhill, across the path of the proposed access road. WC1 has a highly variable channel but averages 0.5 m wet-width and a bank width of about 2 m; the bank height about 0.2 m. The water depth was about 5 cm in July and was almost dry in October. The stream bed is composed of very coarse cobbles with medium sand and gravel, showing signs of short term high seasonal flow (Photos 17 and 18). WC1 separates into multiple channels as it comes to the base of the slope and is intercepted by the existing ATV trail (Photos 19 and 20) and then dissipates into the forest floor within a few metres beyond the ATV trail (Photo 21). WC1 completely disappears before it reaches WC4, and it is not considered to provide fish passage.

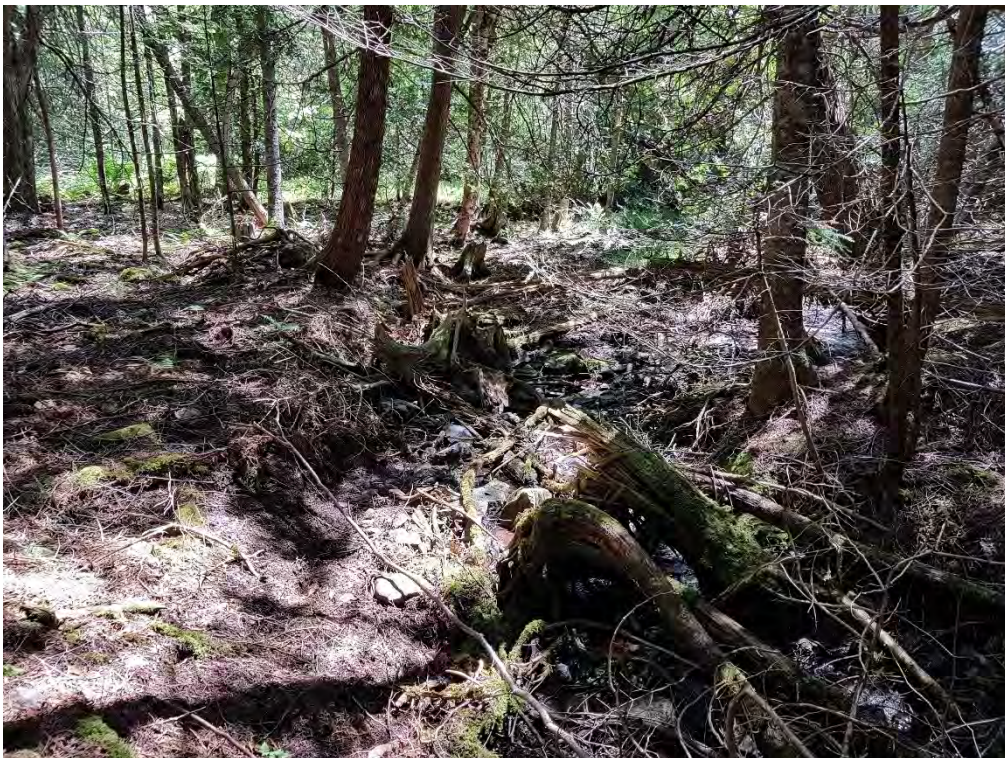
Photo 18. Looking downstream along WC1, there are signs of high seasonal flow causing severe erosion.

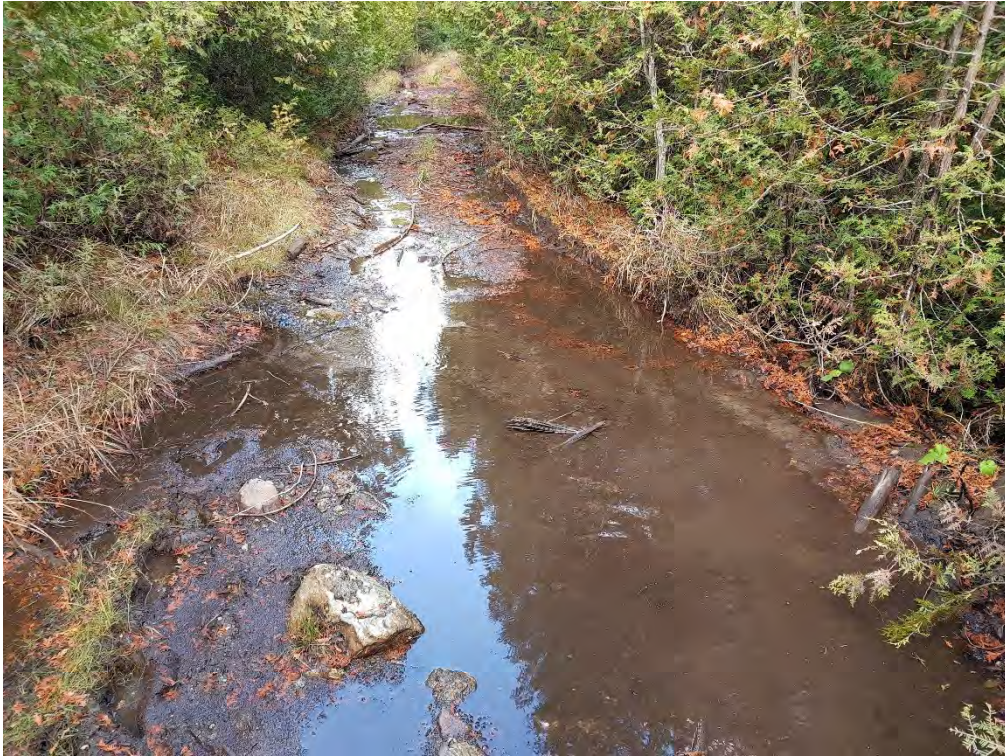
Photo 19. WC1 is intercepted by the ATV trail near the bottom of the slope where it also spreads out into several smaller channels.

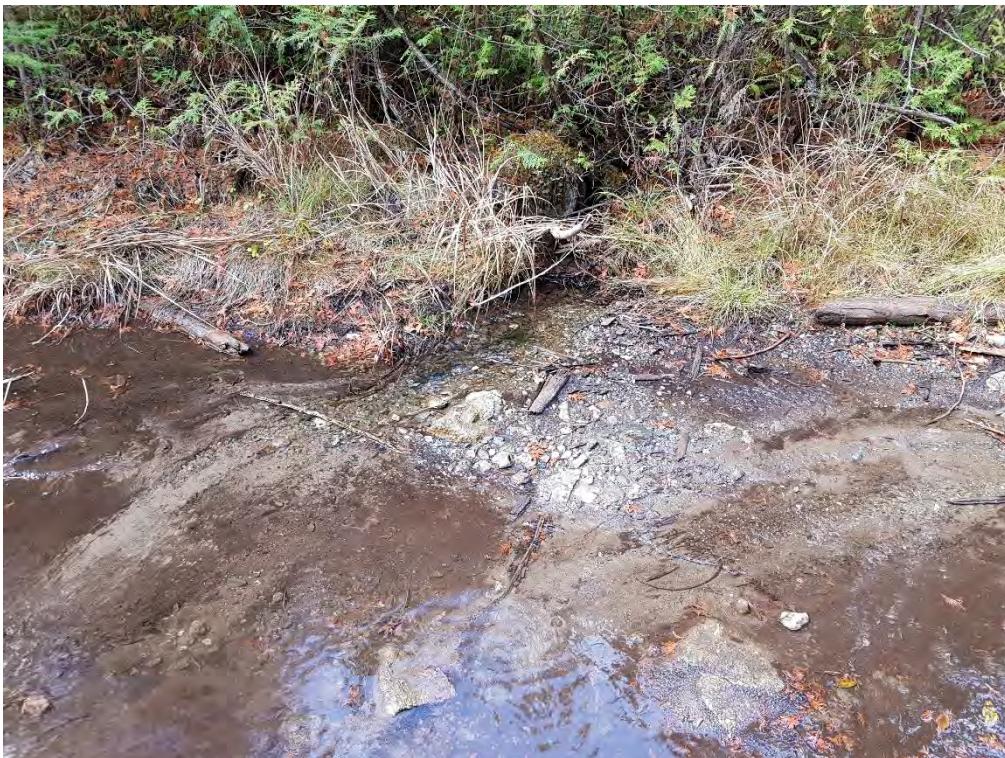
Photo 20. WC1 has deposited coarse material into the ATV trail, during high volume run-off events. Photo facing upslope, where the sub-channel enters the trail.

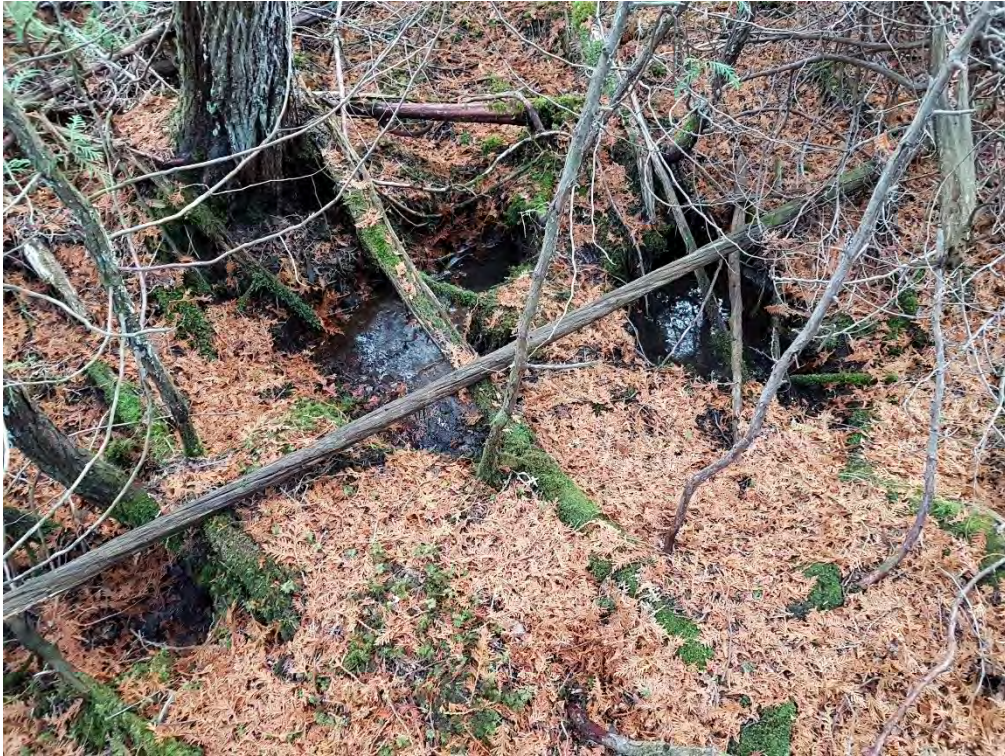
Photo 21. Within a few metres downgradient from the ATV trail, all parts of WC1 dwindle into separate pools and infiltrate into the ground.

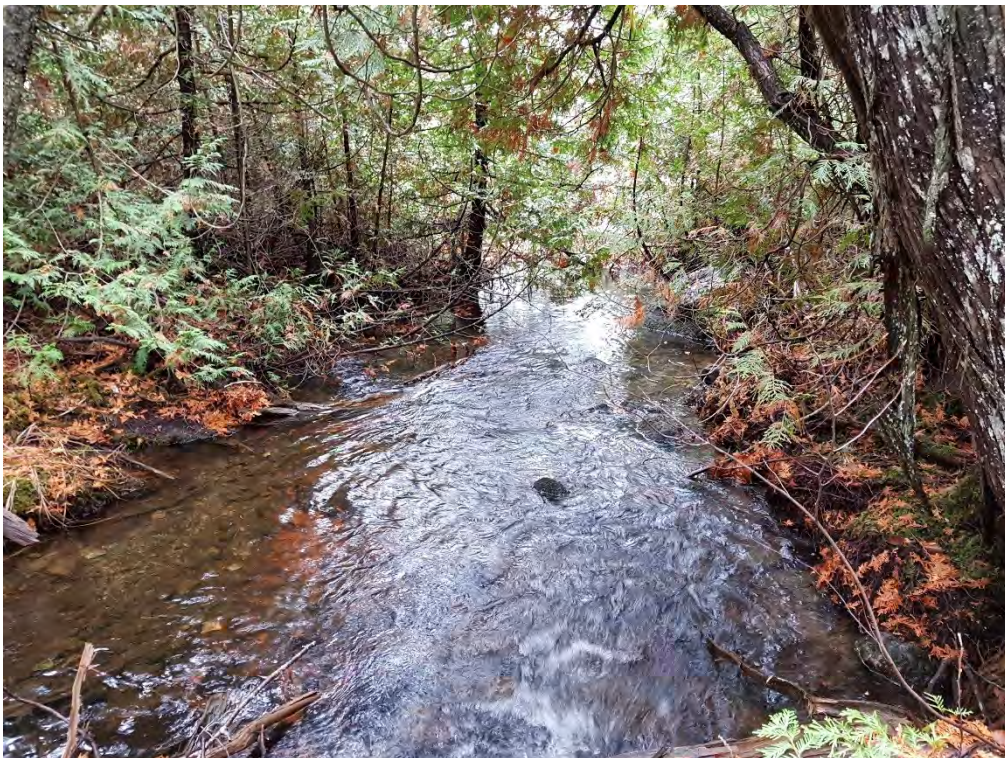
Photo 22. Watercourse 4 (WC4) was almost bank full, following intense rain the previous day. WC4 has a maximum bank width of 4 - 5 m and bank height of 0.5 m.

**WC4** flows southward, roughly parallel to the Route 1 highway. It flows along the west side of the highway adjacent to the proposed new access road for 300 m before crossing the highway through a large culvert. WC4 appears to be a permanent fast flowing stream, with a wet width of 1.5 - 2.0 m and a depth of 30 - 40 cm. The channel is well defined within the mature forest habitat (Photos 22 and 23). The substrate is a relatively coarse mixture of gravel, cobble, and boulders. Some sand is deposited in bends, but embeddedness is generally low. There is good structure, with high woody debris content. The bank width is variable from 2 - 5 m. Some of the channel has been reconstructed during highway construction (Photos 24 and 25). There are signs of seasonal high flows such as sediment drifts above the regular banks and hanging floated debris. No fish were observed, but it is assumed that there is connectivity to the Hammond River and that any associated aquatic species may be present. WC4 is crossed by the existing ATV trail at an unconfined fording location, where the channel has spread out across an 8 m wide bedrock riffle.

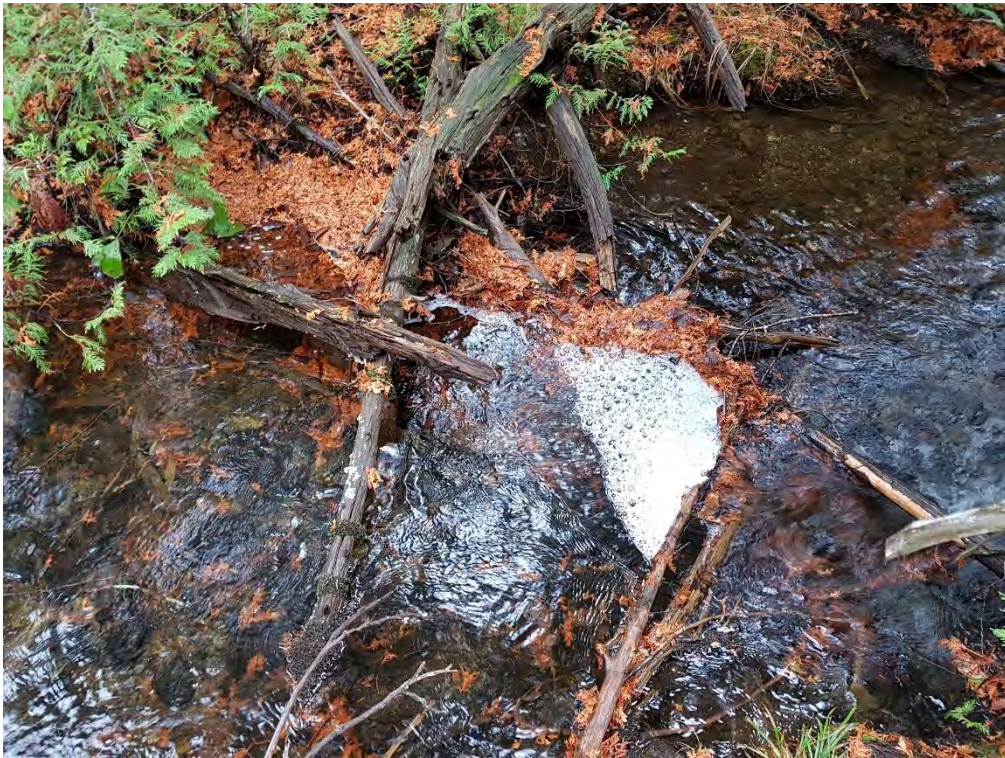
Photo 23. WC4 has good shade and structure for fish habitat with much woody material in the channel.

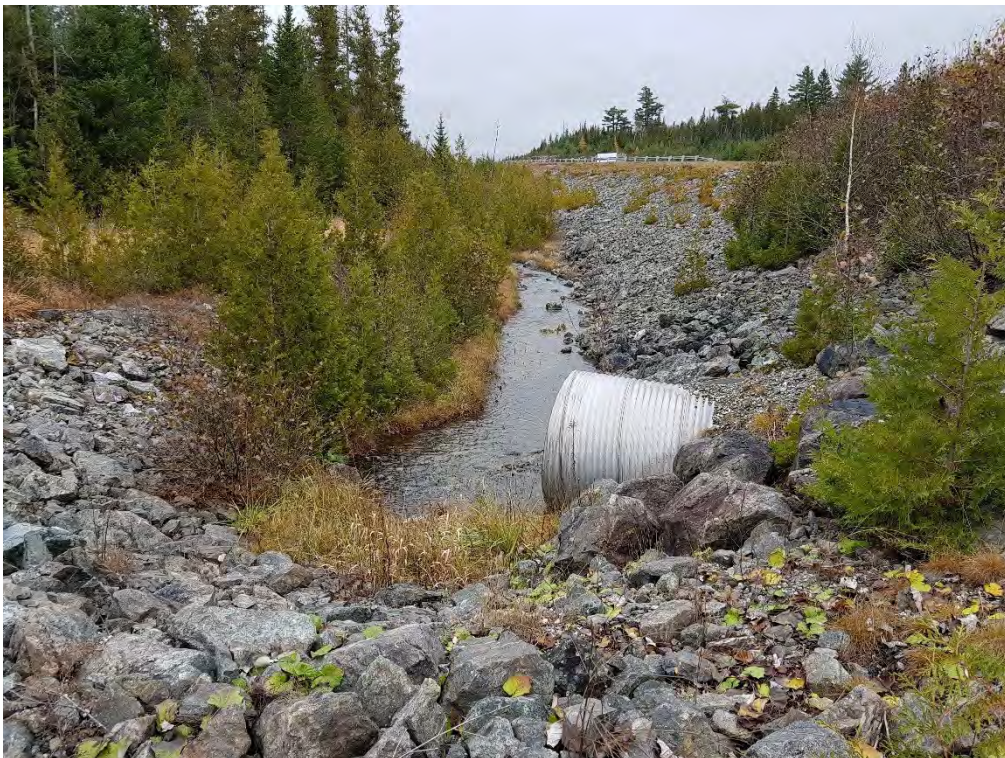
Photo 24. Parts of WC4 near the highway have been reconstructed.

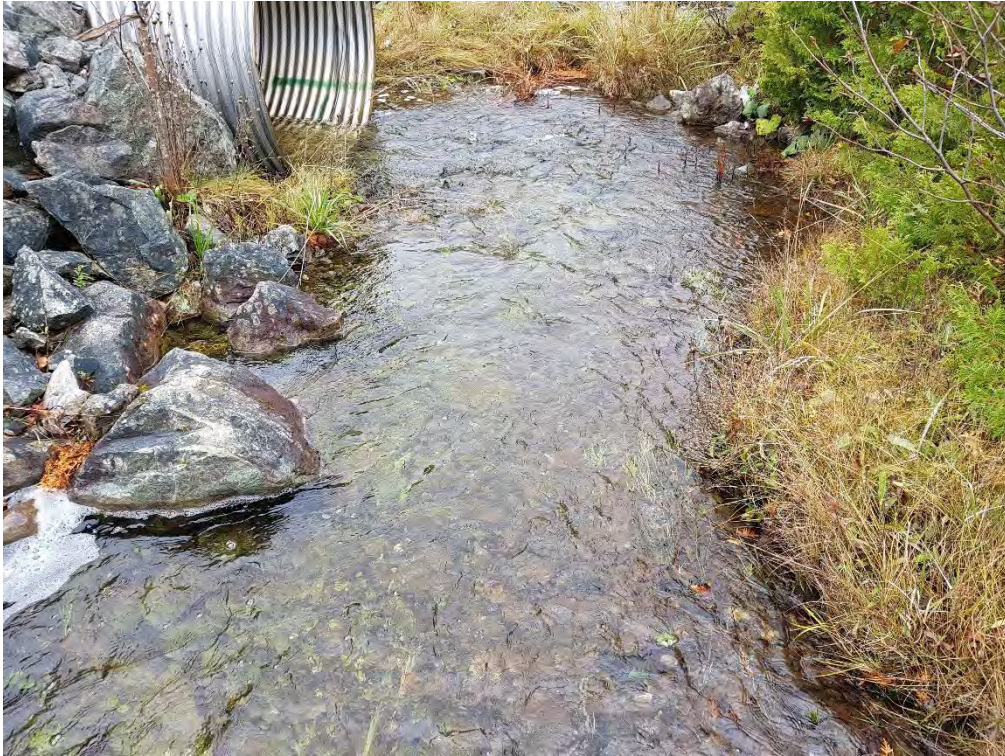
Photo 25. The substrate in WC4 is coarse with sparse aquatic vegetation.

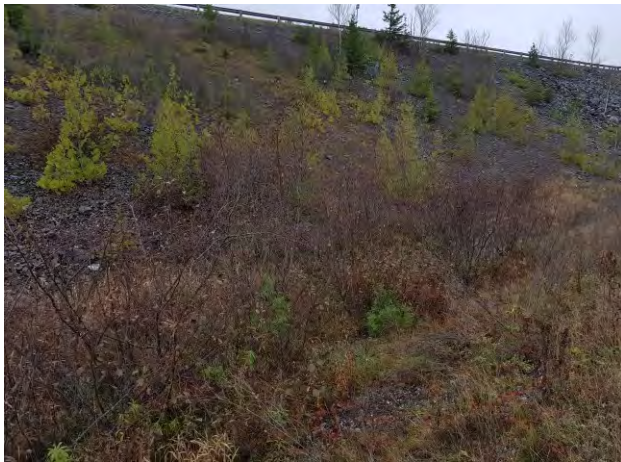
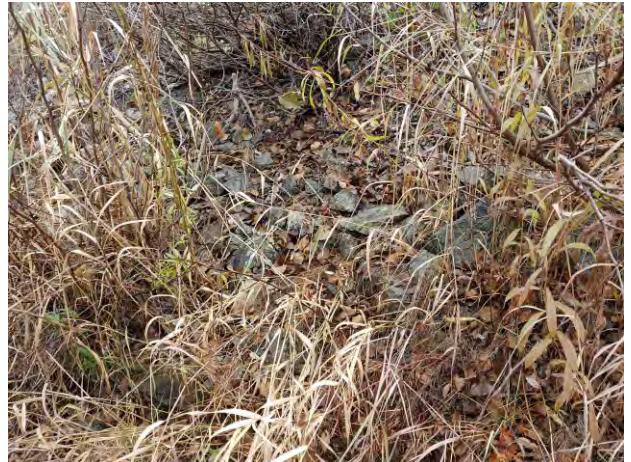
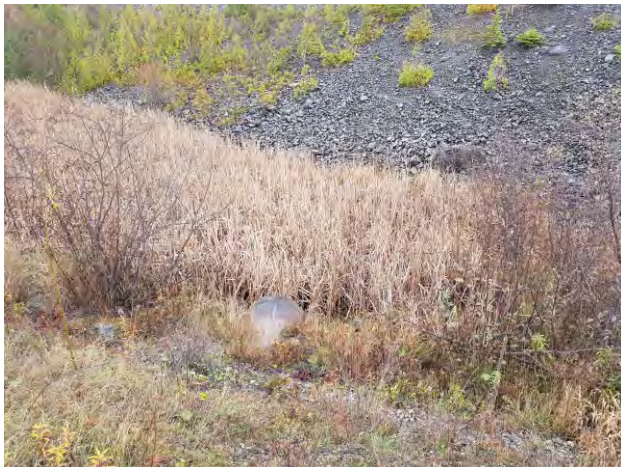
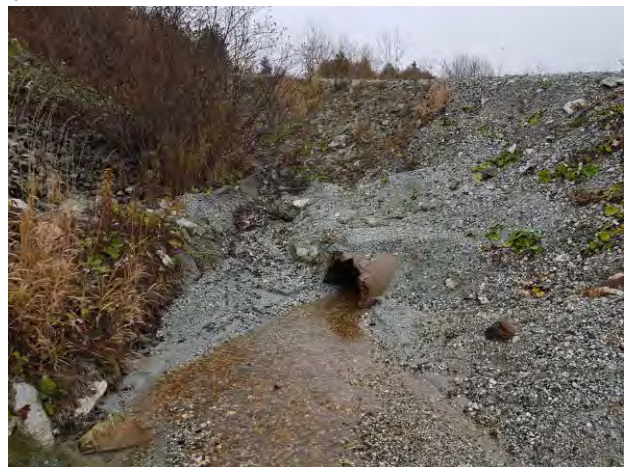
Photos 1,2 - Looking north in Cattail Marsh (Route 1 beyond. Photo 3 - Scrub-covered road banks are steep with loose rock. Photo 4 - Rock lined ditch at inlet with no flow. Photo 5 - Outlet at culvert in quarry road. Photo 6 - Discharge from culvert has stained the gravel in the ditch.
