**Archaeological Testing at a Proposed Wind Farm Transmission Line near  
Sussex, NB**

Permit #: 2018 NB 29

**Natural Forces**

**Archaeological Prospectors**

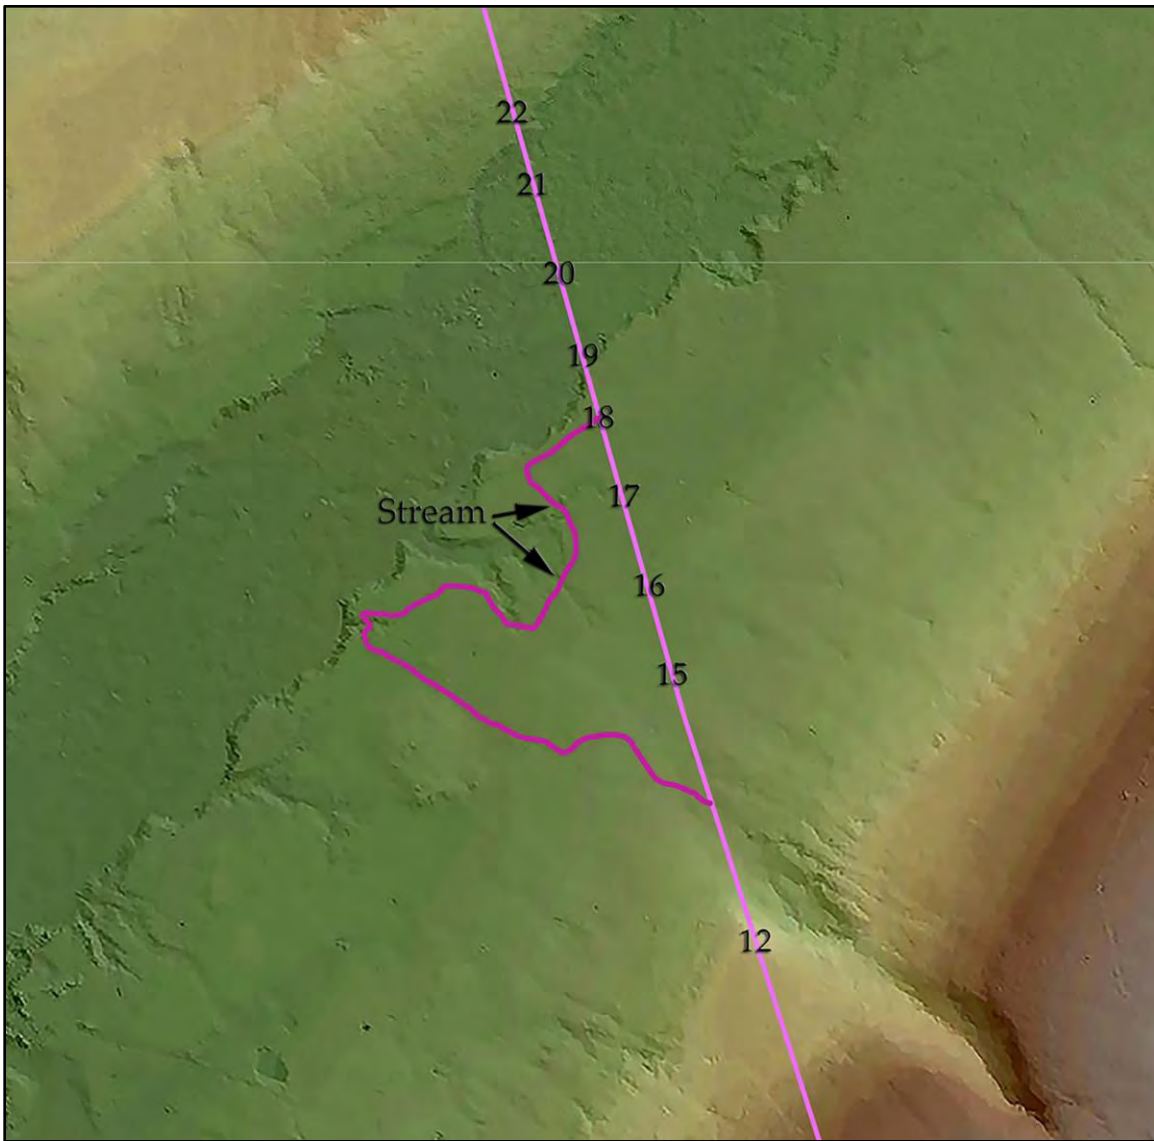
**Figure 4:** Approximate locations of transmission line structures and access road on LiDAR image.

As the elevation decreases along the transmission line, a series of terraces were noted in the initial pedestrian survey. The uppermost terrace, at ~140 m asl (see Figures 3-5) is quite level and suitable for habitation, overlooking the wide valley, particularly during the early post-glacial period, and is the proposed location for Structure 12. Due to its suitability for habitation that certainly could have attracted the ancestors of today's Wolastoqiyik, it was recommended for test excavation ahead of any construction activities. Based on the proposed plan for the erection of Structure 12, the excavation of seven standardised test pits (STPs) were scheduled at this location. The specific locations of each structure were laid out in advance (by a surveyor, using wooden stakes). The proximity of this structure was near the edge of a steep decline that ruled out the excavation of three of the STP's. However, four STPs were excavated on the more level areas which resulted in the recovery of a single stone flake, the by-product of making stone tools (see Figures 7 & 8).

The more recent Kennebecasis River valley is over 400 m wide (along the transmission line route) and is clearly visible in the LiDAR data and surficial geology map (see Figures 4 & 5). In the early historic aerial photos, satellite imagery and the LiDAR data, the abandoned channels of the former location of the Kennebecasis River are visible. Portions of this modern valley are described as ancient alluvium (sand and gravel, some silt)(Seaman, A., 1986). Within this northern end, Structures 19-22 are proposed.

During this field visit, an access road of approximately 1.7 km distance was assessed (see Figures 29 & 30). This proposed access road travels predominately over glaciofluvial outwash (see Figure 5) and along the upper tread of a river terrace of the former location of the Kennebecasis River (see Figure 4). At least two streams cross the proposed access road, and are within wider valleys. These valleys may have been formed near the end of the last glaciation but the modern channels appear to run regularly and are certainly suitable to support habitation nearby.

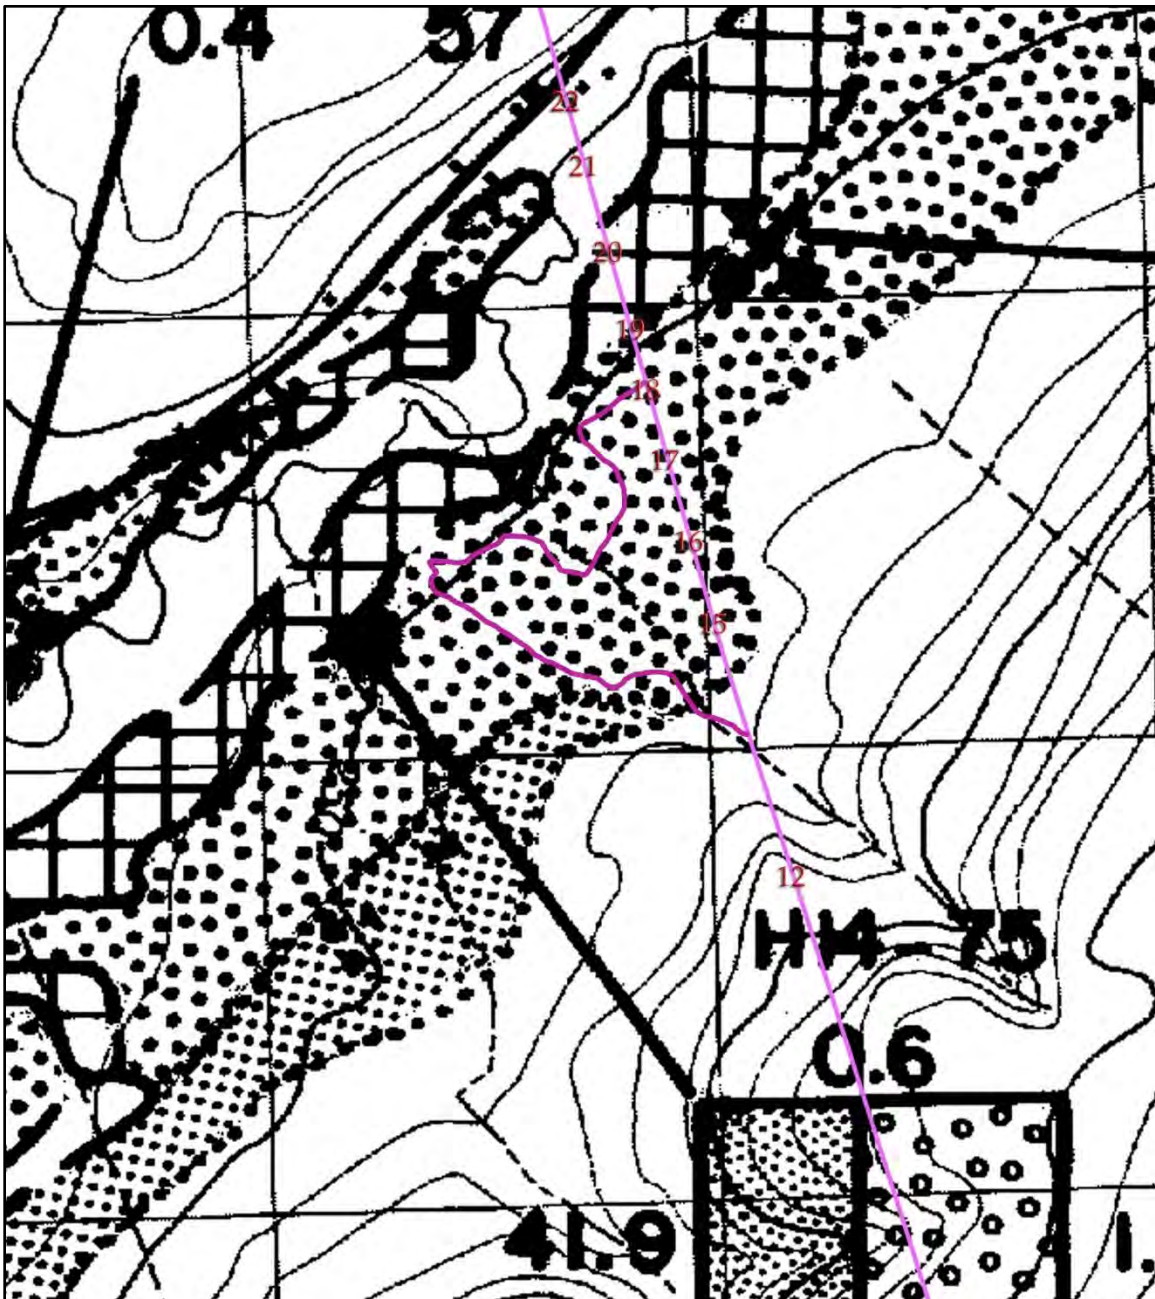
Figure 5: Transmission line with approx. structure locations on the surficial geology map (Seaman 1986).

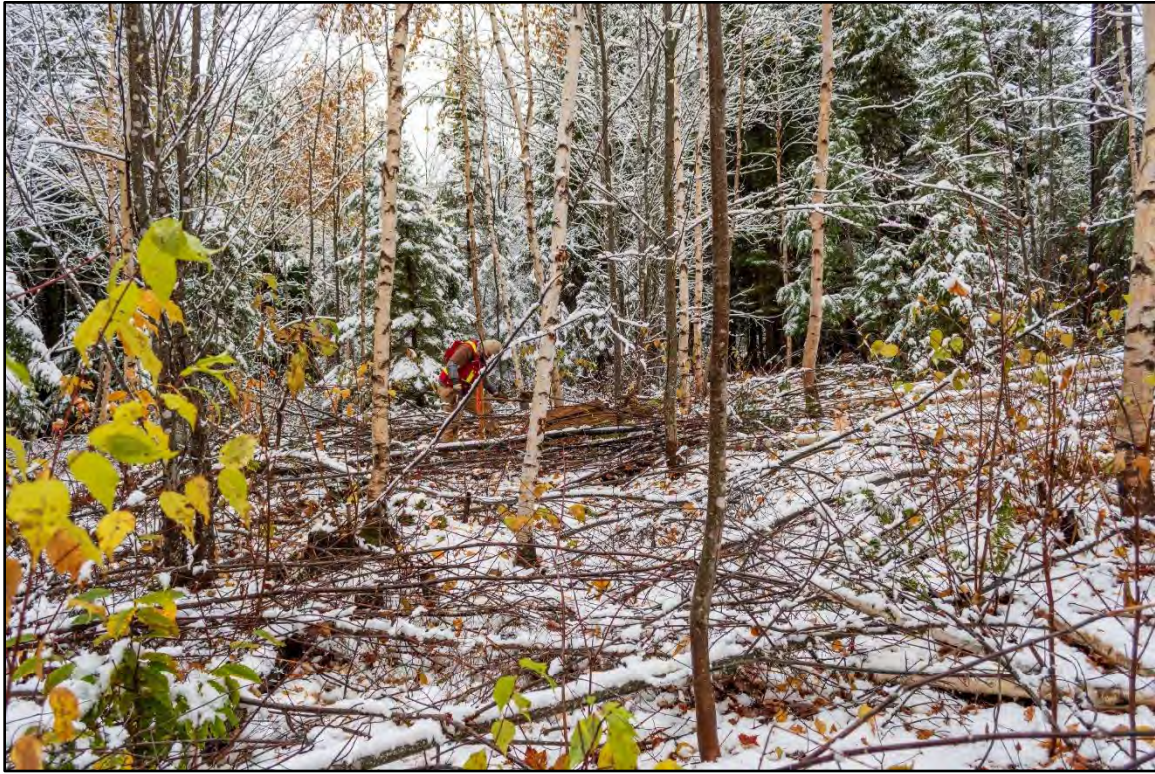
**Figure 6:** Excavating a test pit at the first loc. of Structure 12 – facing south-west.

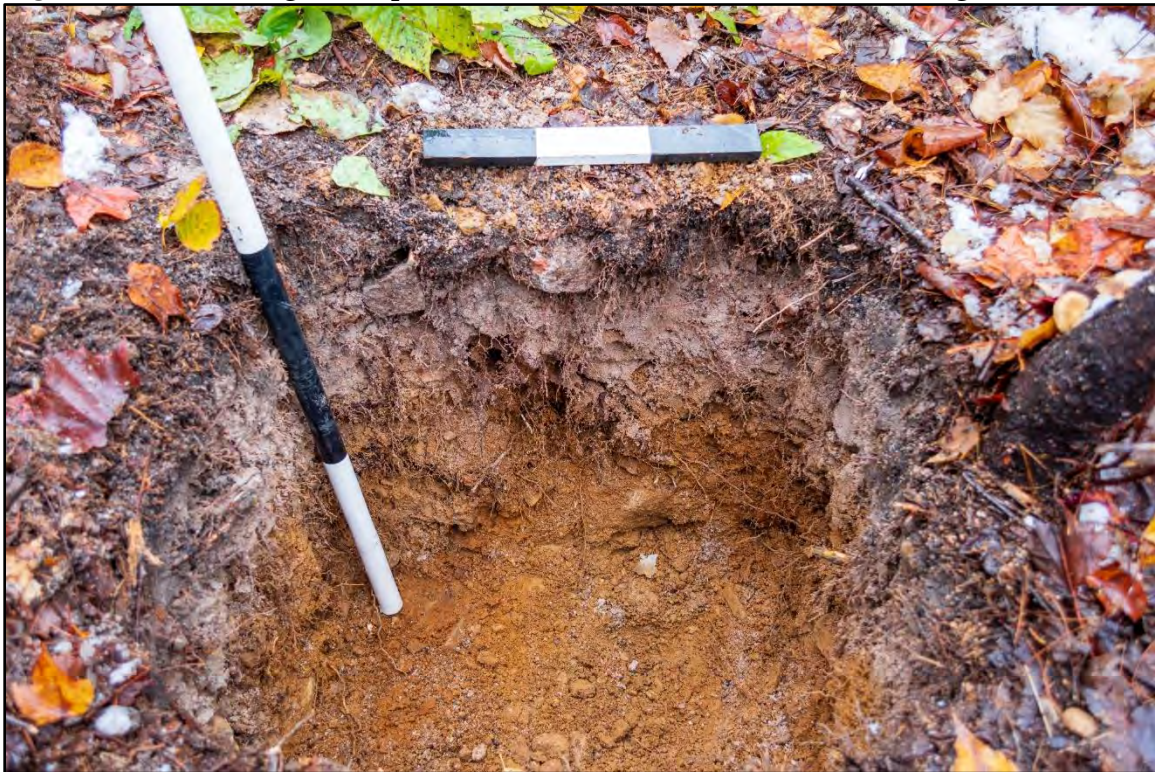
**Figure 7:** Test pit on east side of south guy trench. Positive for a stone flake.

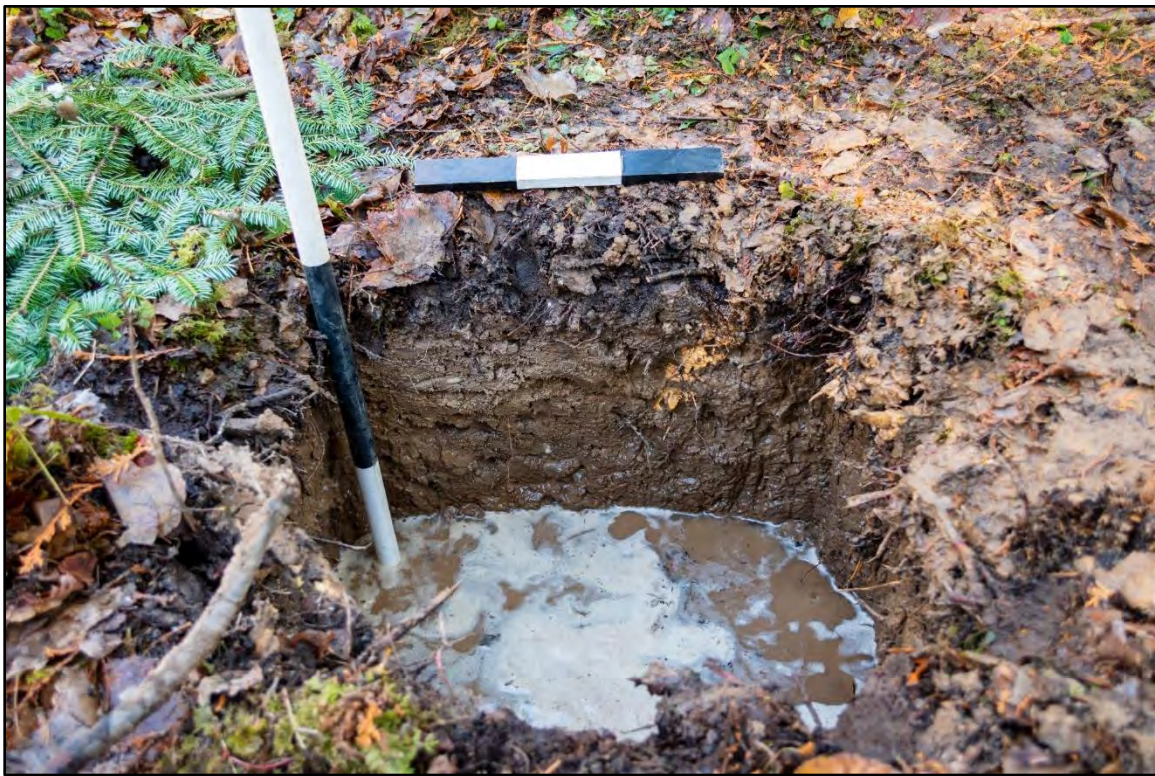
**Figure 10:** Test pit on east side of poles trench at Structure 15.

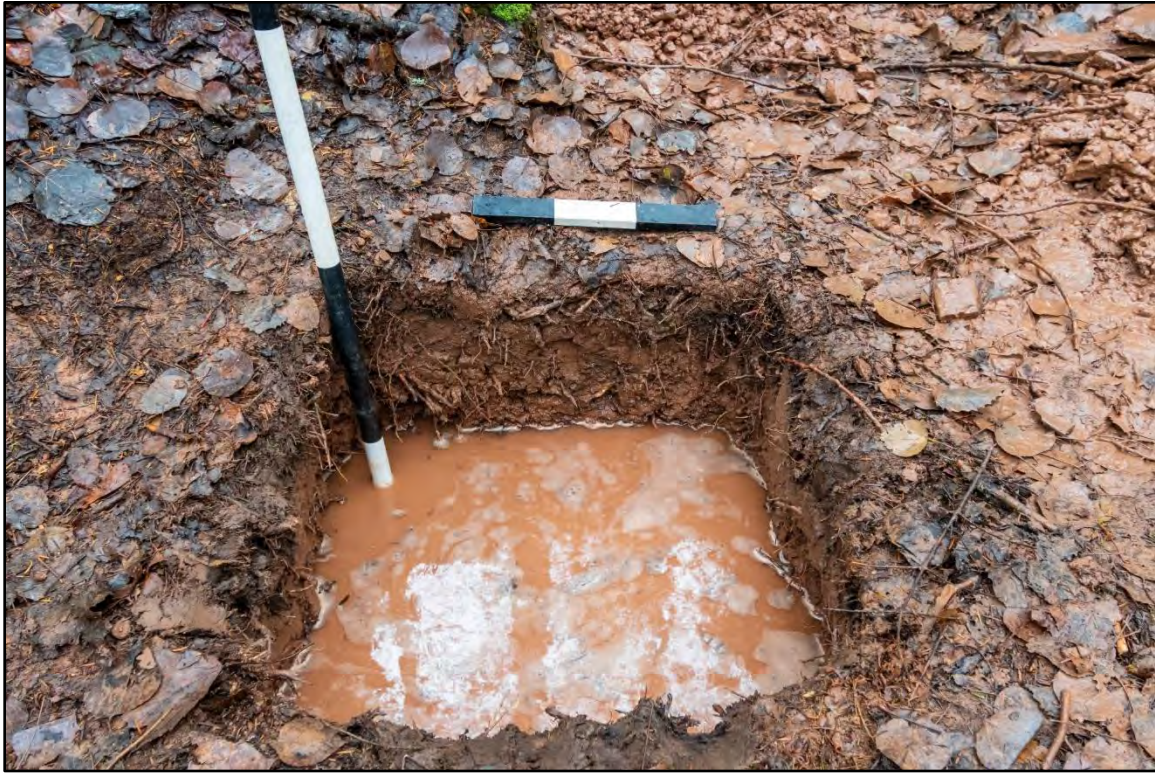
**Figure 12:** Test pit on east side of poles trench at Structure 16.

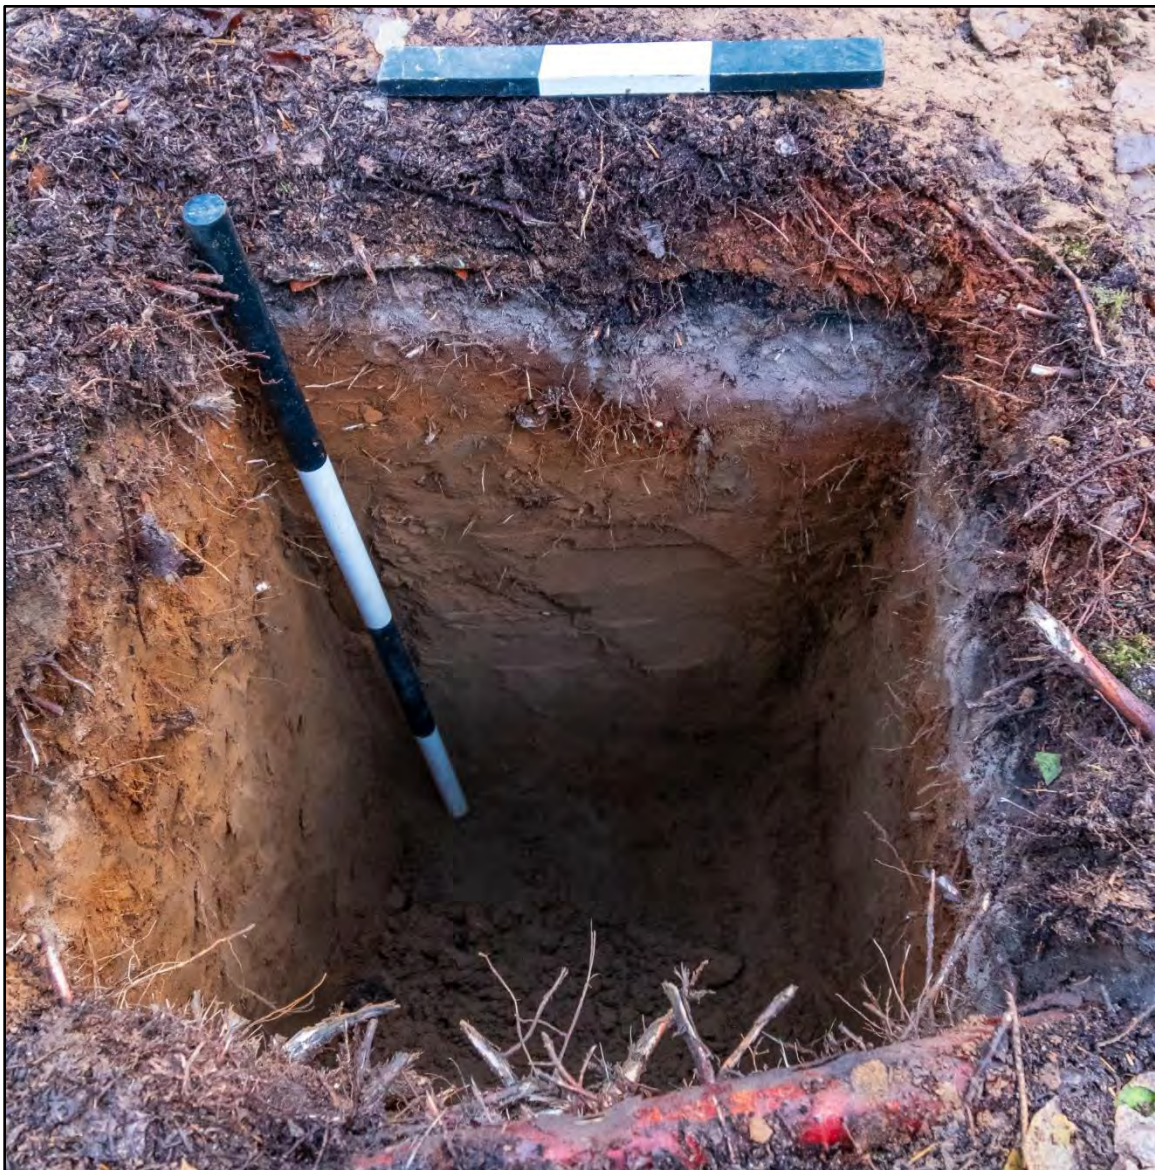
**Figure 14:** Test pit on west side of poles trench at Structure 17.

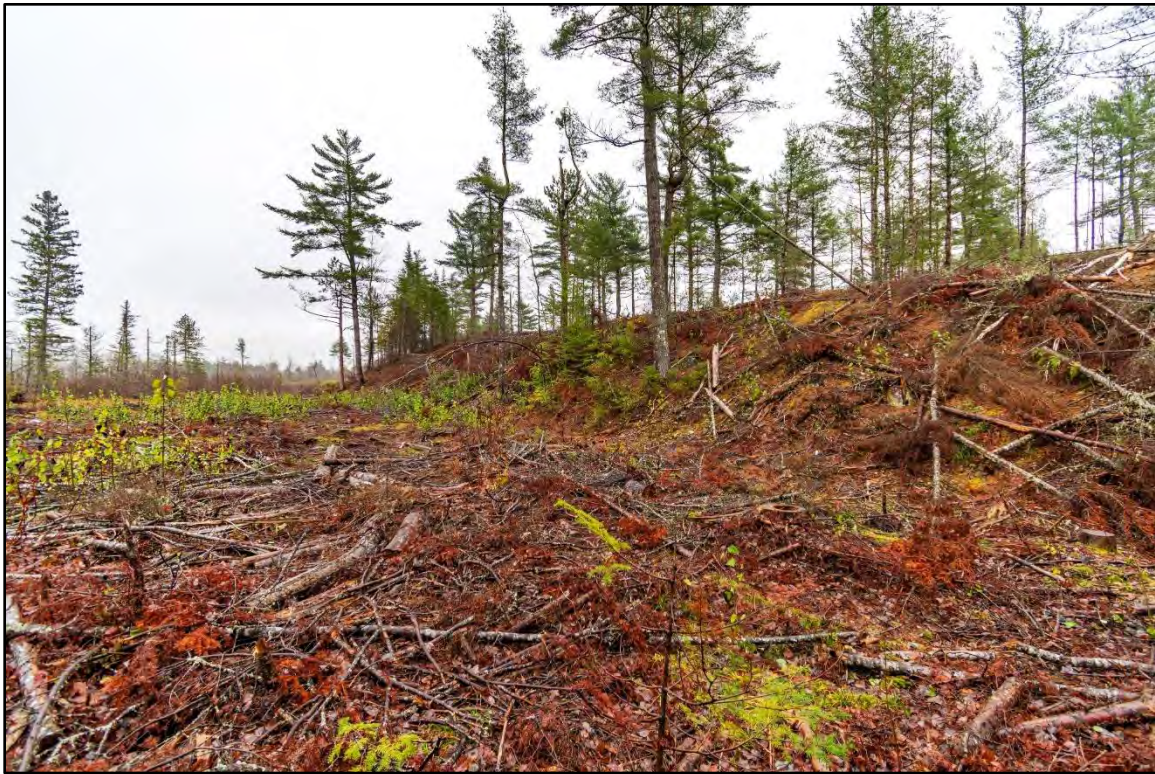
**Figure 15:** Former river terrace, south of Structure 18, exposed in nearby clear cut.

From structure locations 15-18, this approximately 550 m long section of the transmission line (from the edge of the modern floodplain to near the sharp rise in elevation to the south) is described as glaciofluvial outwash (deltaic, mainly sand and gravel)(Seaman, A., 1986). A pair of test pits were excavated at each of these four locations, to cover off the single 7 x 1 m trench to be excavated for each structure. The STPs at Structure 15 were excavated to 48 cm and 60 cm deep with a high water table. A compact, rocky bottom ended excavation without any artifacts recovered (see Figures 9 & 10). Structure 16's test pits ended just before 50 cm dbs with a primary matrix of silty-sand and ~30% gravel and pebbles. A high water table was also encountered here and the test pits were ended at a presumed till of compact base with a sharp increase in rock content (see Figures 11 & 12). At Structure 17, a nearby stream channel had a reasonable amount of running water in it (but may be seasonal drainage, now) and was less than 10 m away from the test pits. These STPs were excavated to ~1 m deep and failed to reach archaeological bottom. The entire column was comprised of sand (fluvially derived) with almost no rock content (see Figures 13 & 14). While the nearby stream channel is of a reasonable size, it seems unlikely to have produced this much alluvium; it's possible that this is an ancestral beach. At Structure 18, till was encountered below ~40 cm dbs (see Figures 16 & 17). One very notable and obvious feature near Structure 18 is the ancient river terrace pictured in Figure 15.

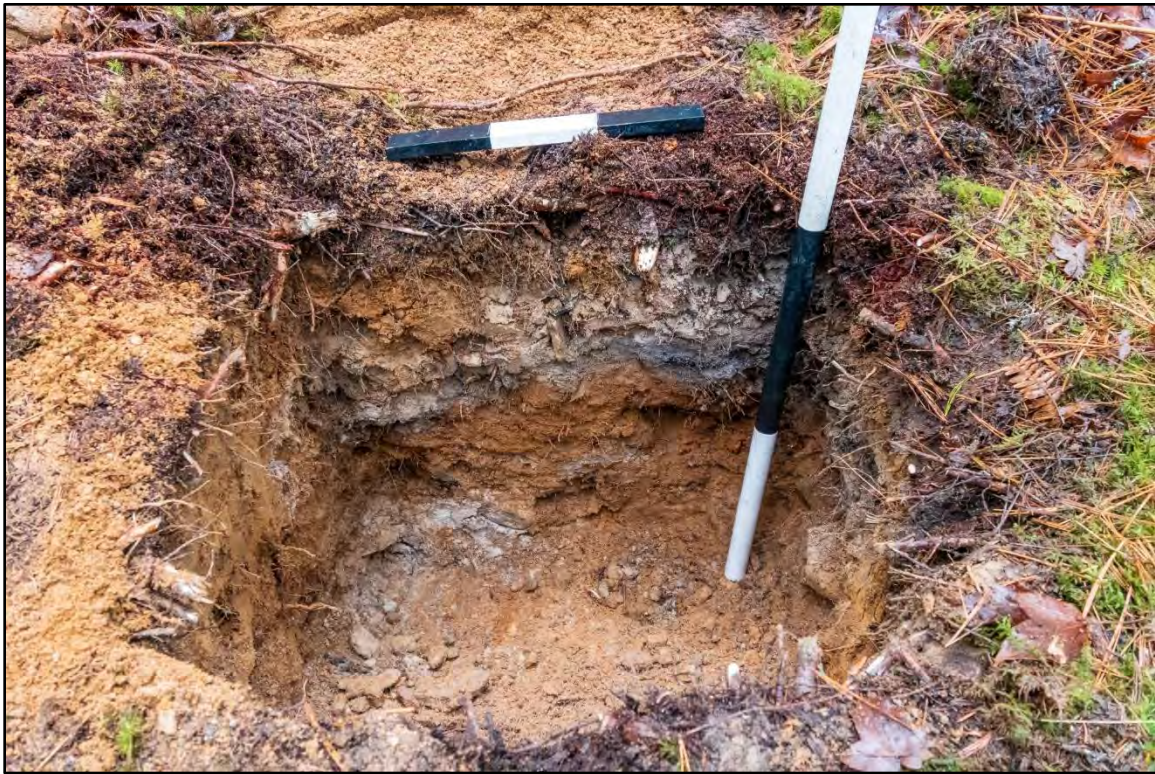
**Figure 17:** Test pit on west side of poles trench at Structure 18.

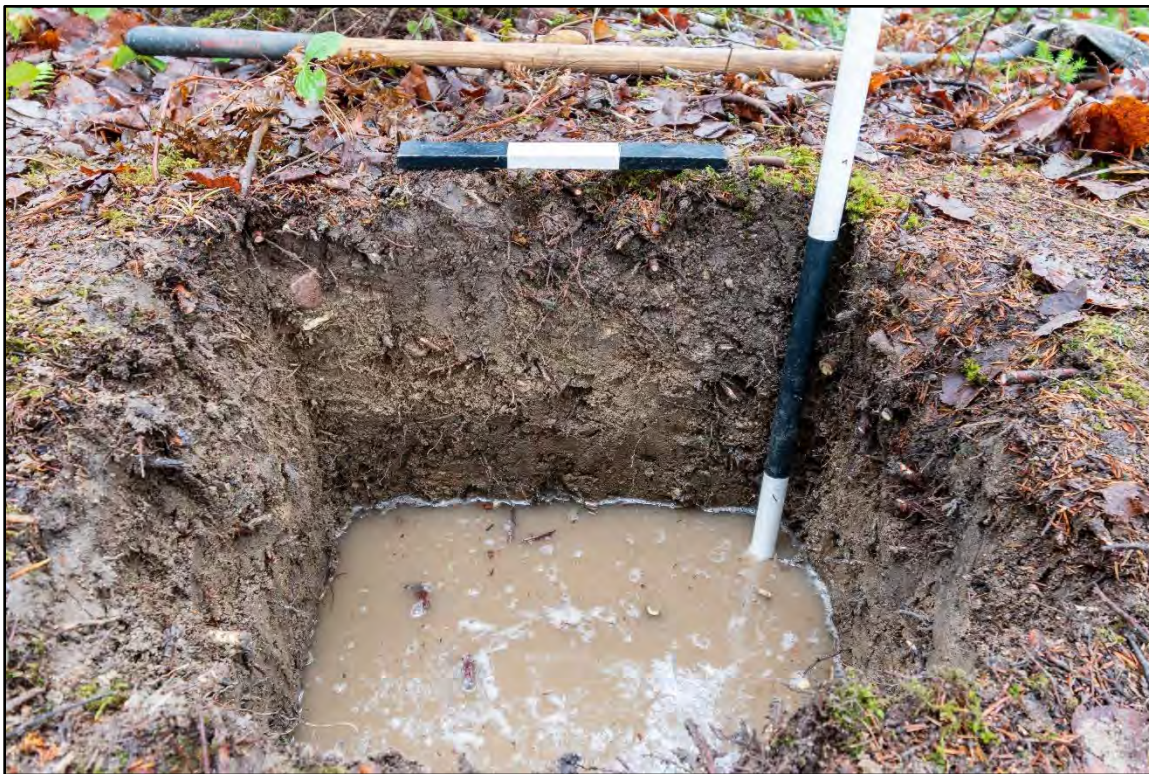
**Figure 19:** Test pit on east side of poles trench at Structure 19.

The stakes for Structure 19 were placed in a shallow, water-filled linear depression. While one test pit was offset ~3 m from one of the stakes, the nearest suitable place to excavate a test pit for the second location was over 5 m away and thus abandoned. The sole test pit here revealed a high content of gravel through most of the column (~50%) and ended at 50 cm in till or stream bottom (see Figures 18 & 19). Structure 20 is placed approximately 5 m south of another stream. The test pits at Structure 20 ended at ~50 cm db, at a very rocky bottom. The upper layers consisted of sandy-silt and sand with less than 5% gravel and pebbles (see Figures 20 & 21). At Structure 21, approximately 15 m south of the Kennebecasis River, two STP's were excavated in a former farmer's field (see Figures 21 & 22). Below what may be a plough zone, gravel content increased to ~60%. Till or stream bottom was reached between 53 and 63 cm db.

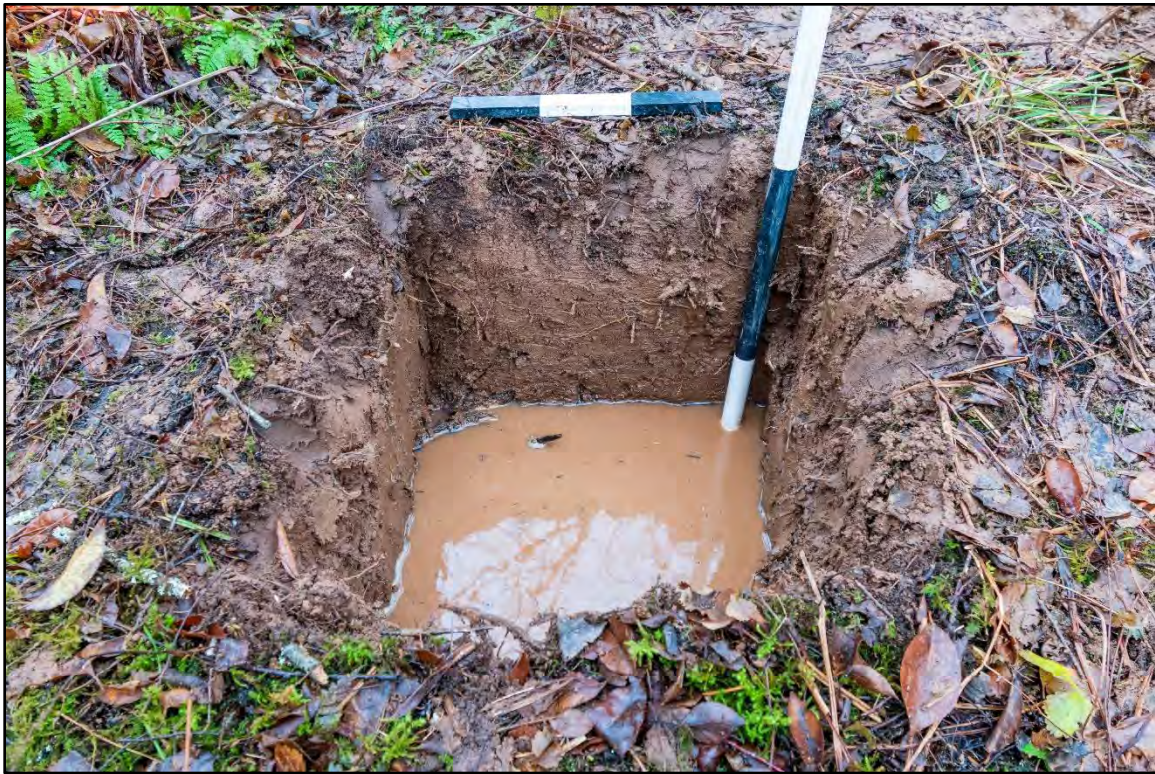
**Figure 21:** Test pit on east side of poles trench at Structure 20.

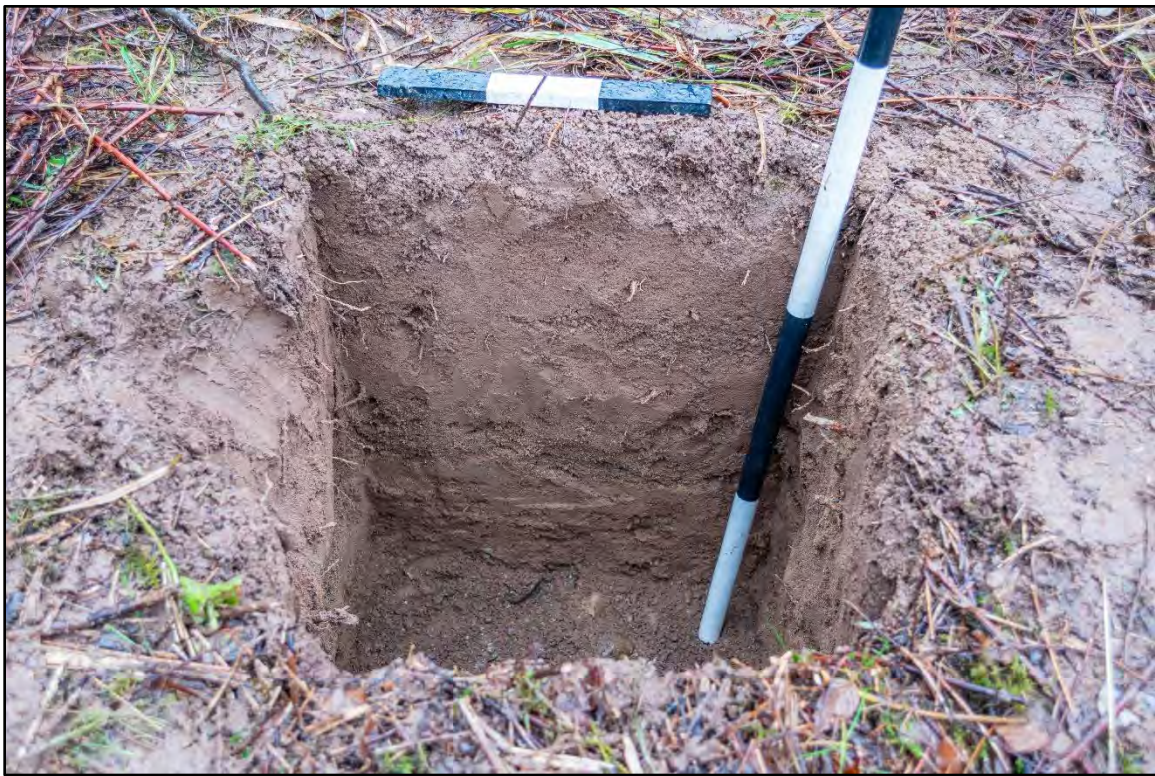
**Figure 23:** Test pit on east side of poles trench at Structure 21.

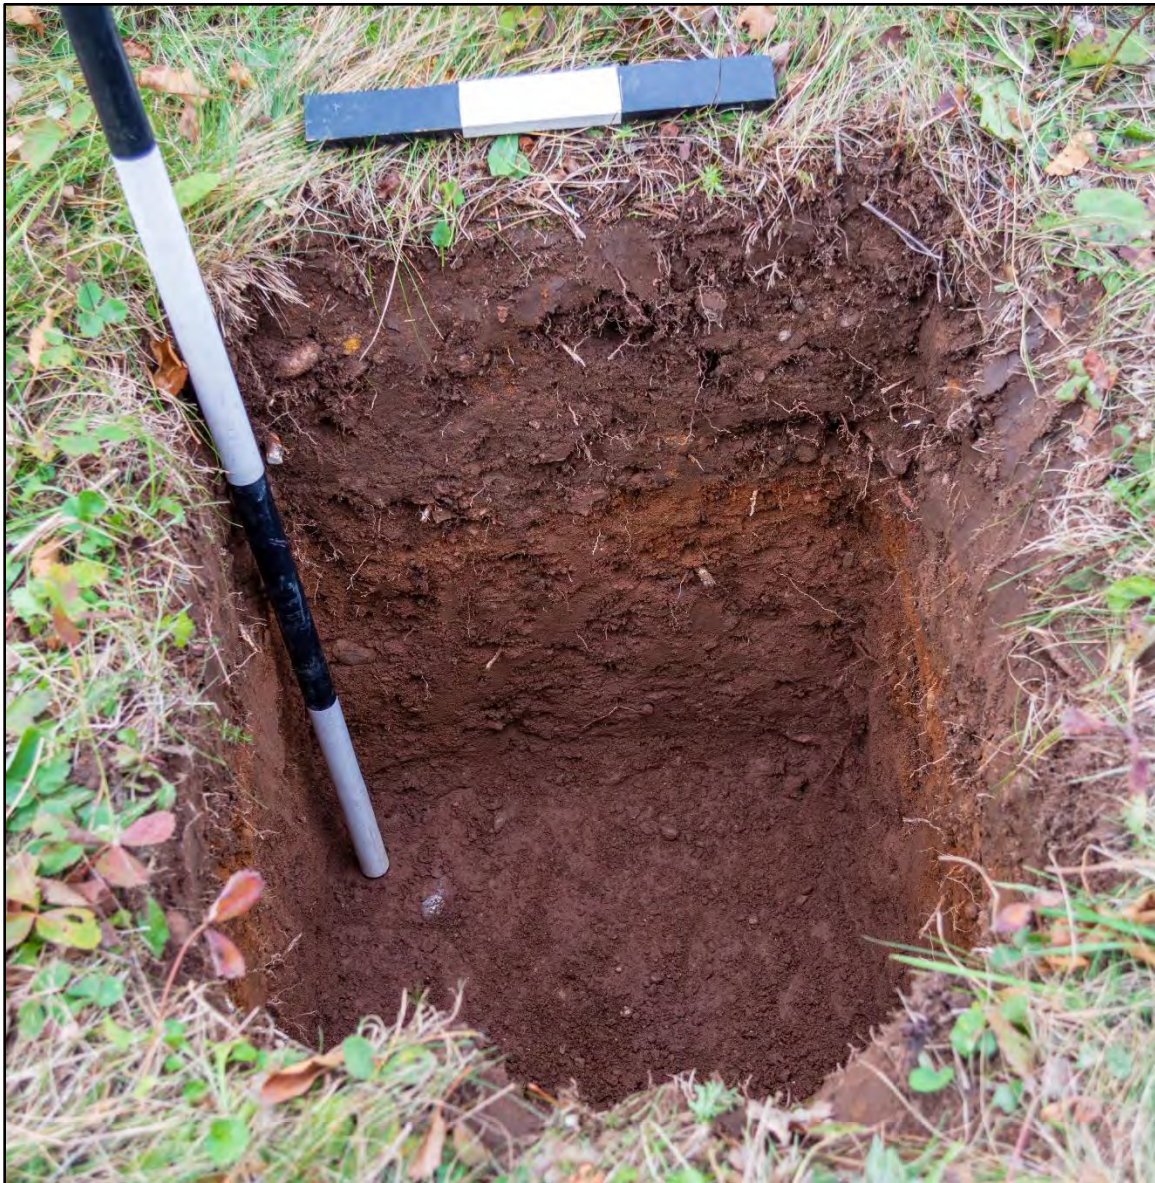
**Figure 25:** Test pit on east side of poles trench at Structure 22.

Immediately south of the Portage Vale Road (north of the Kennebecasis River), Structure 22 is laid out in a farmer's field. This section between the road and the nearby river is also suitable for Indigenous and early European occupation. This larger structure requires the mechanical excavation of 3 trenches (for poles and guy wires) and a total of 6 STPs (see Figures 24 & 25). These test pits ranged in depth from 51-67 cm db and included a discernible plough zone. A noticeable increase in the volume of rock ended the test pits. Aside from the single artifact recovered from Structure 12, no other significant artifacts or features were noted.

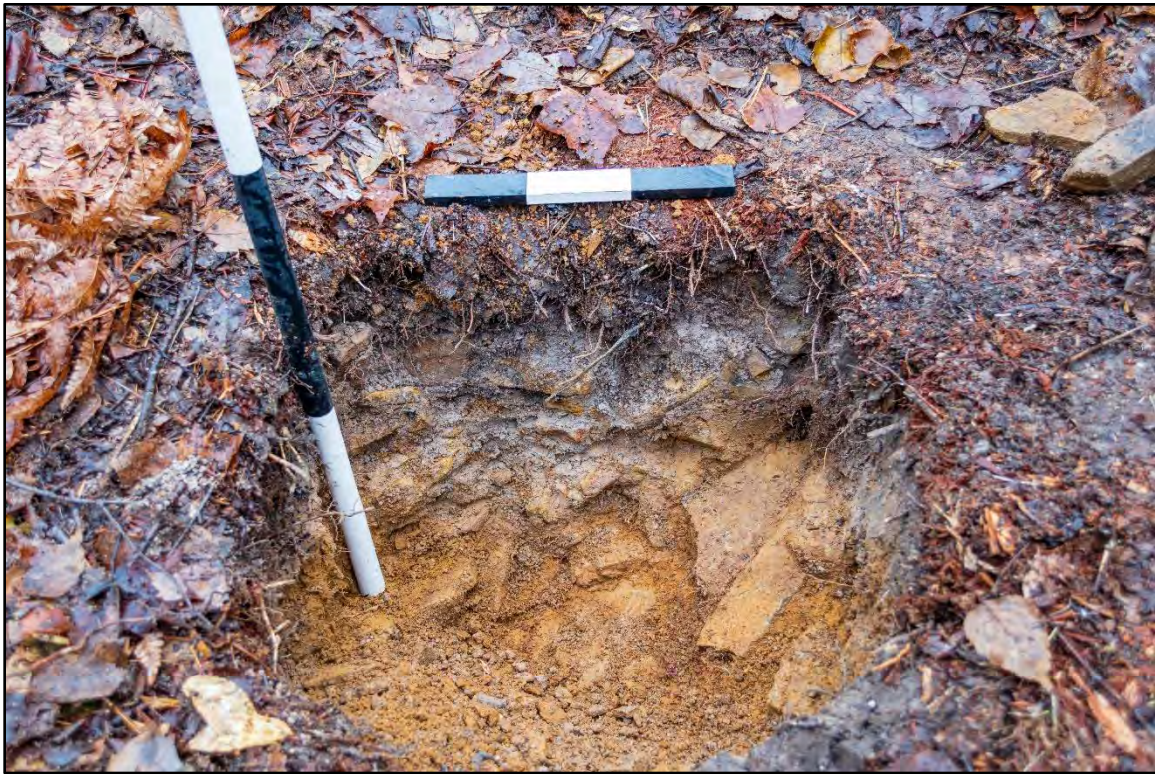
**Figure 28:** Test pit on west side of south guy trench at updated area for Structure 12.

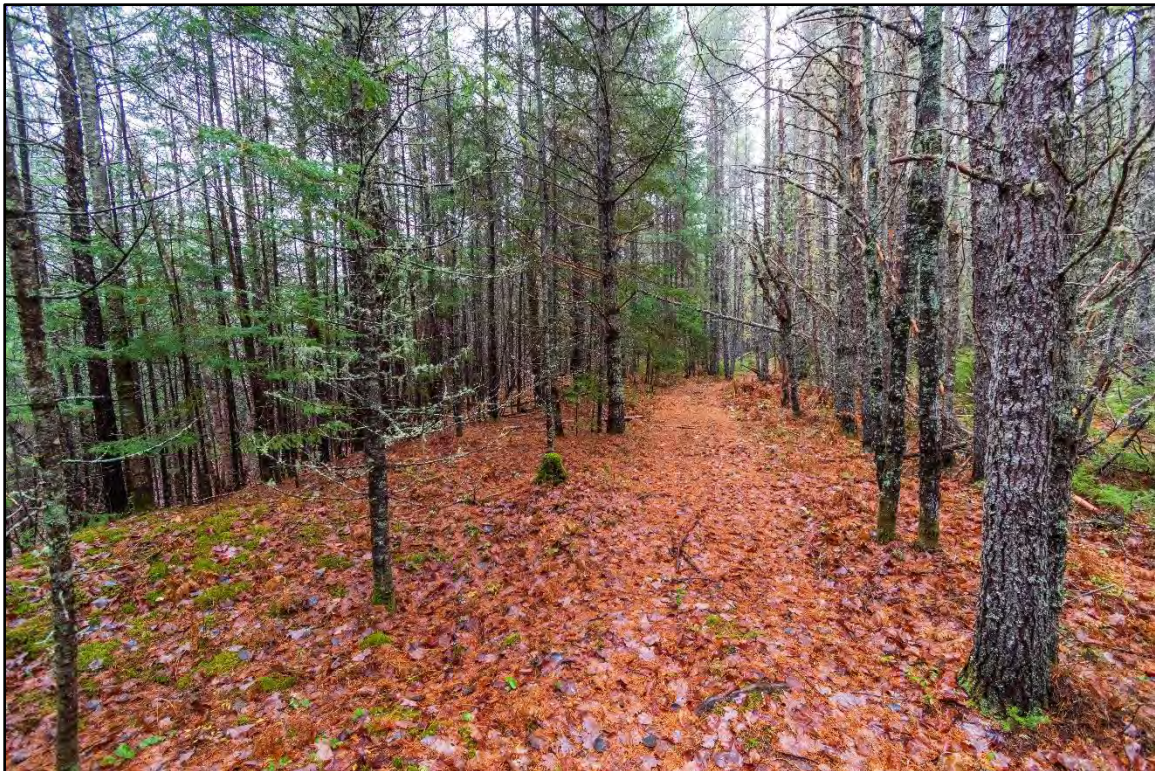
**Figure 29:** Proposed access road, west of Structure 18 – facing east.

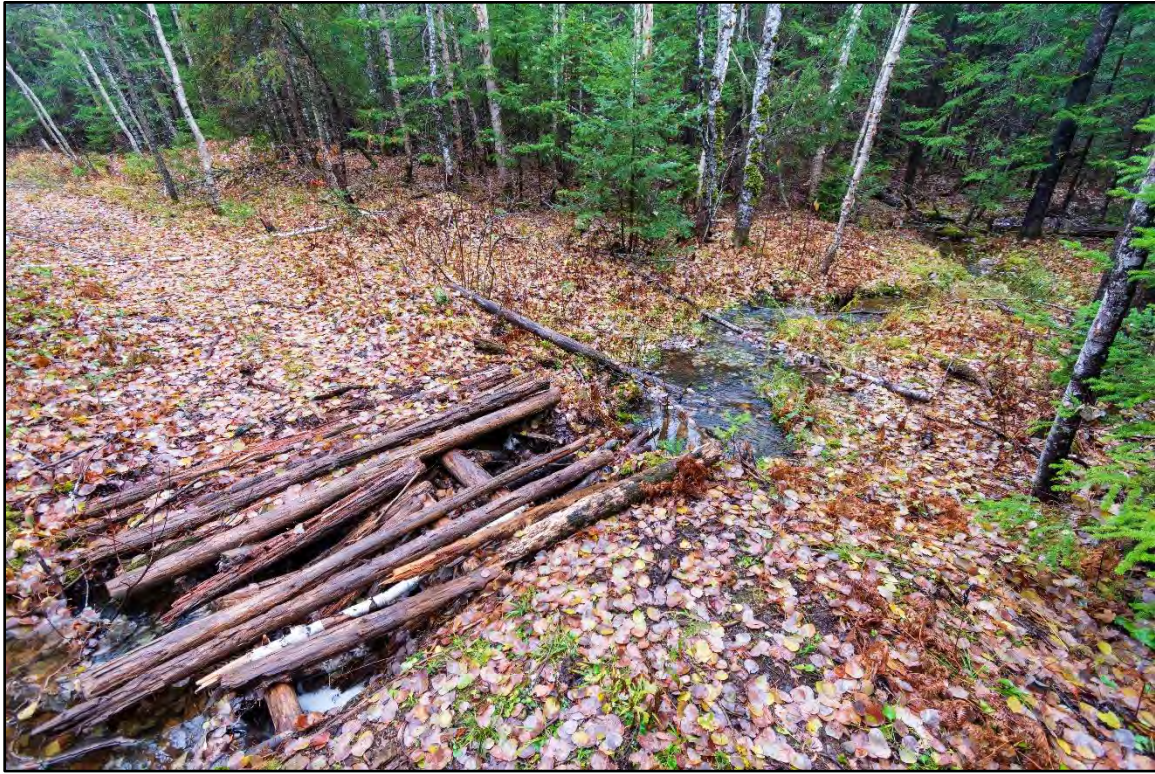
**Figure 30:** Proposed access road at stream crossing.
