LITTLE

MARSH

CREEK

WATERCOURSE ASSESSMENT, JULY 2018

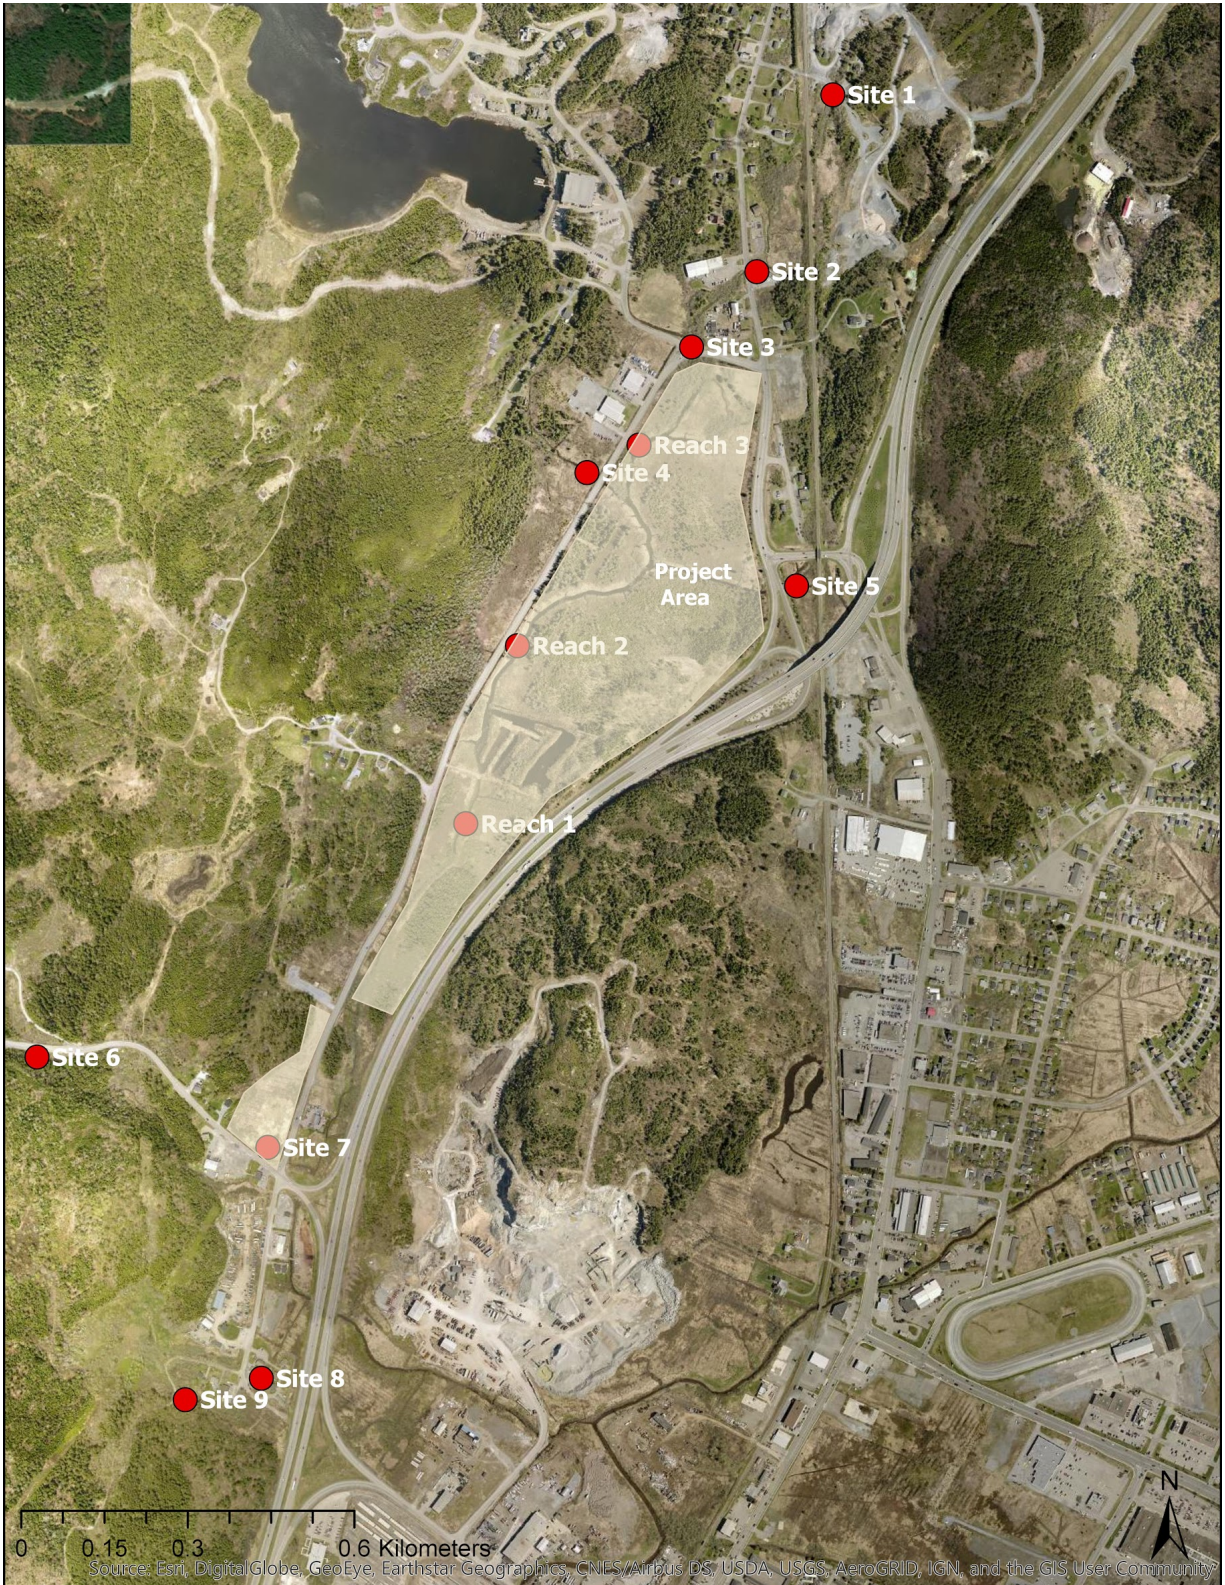
Figure 1: Map of electrofishing survey sites completed between June 19 – July 10, 2018.

Reach 1 was located downstream of the project site where two barrier nets were set 50 m apart (45.32183, -066.03529 and 45.32223, -066.03503). The habitat was found to be mostly tall grasses and shrubs with very little stream cover and a silty substrate. In order to calculate fish abundance, two passes with the electrofisher were conducted in the reach on July 3, 2018. A total of 78 fish were found along the reach between the two passes and 8 different species were identified (Table 1). Fourspine stickleback was the most abundant fish species found in this reach at 38.5%. Due to the highly silted stream conditions causing diminished visibility, greater numbers of fish were caught in the second pass than the first pass and therefore abundance could not be determined for this reach.

Reach 2 is located near the middle of the stream within the project site (45.32501, -66.03381 and 45.32457, -66.0342) and barrier nets were set 50 m apart. The habitat at this reach was found to be mostly tall grasses and shrubs with very little stream cover and a silty substrate. Two passes with the electrofisher were made to determine fish abundance on July 9, 2018. A total of 14 different species were caught between the two passes with a total of 655 individuals (Table 2). Fourspine stickleback was the most abundant fish caught along reach 2. Following the Zippen two-pass

Reach 3 is located upstream of the project (45.32819, -66.03093 and 45.32806, -66.03124) and the barrier nets were set 25 m apart. The habitat at this reach was found to be mostly tall grasses and shrubs with very little stream cover and a silty substrate. Two passes with the electrofisher were made to determine fish abundance on July 10, 2018. A total of 9 different species were caught between the two passes with a total of 608 individuals (Table 3). Ninespine stickleback was the most abundant fish caught along this reach at 37.2%. The abundance for this reach was also calculated for this 25 m reach following the same method and was determined to be 1,037 ± 177 individuals.

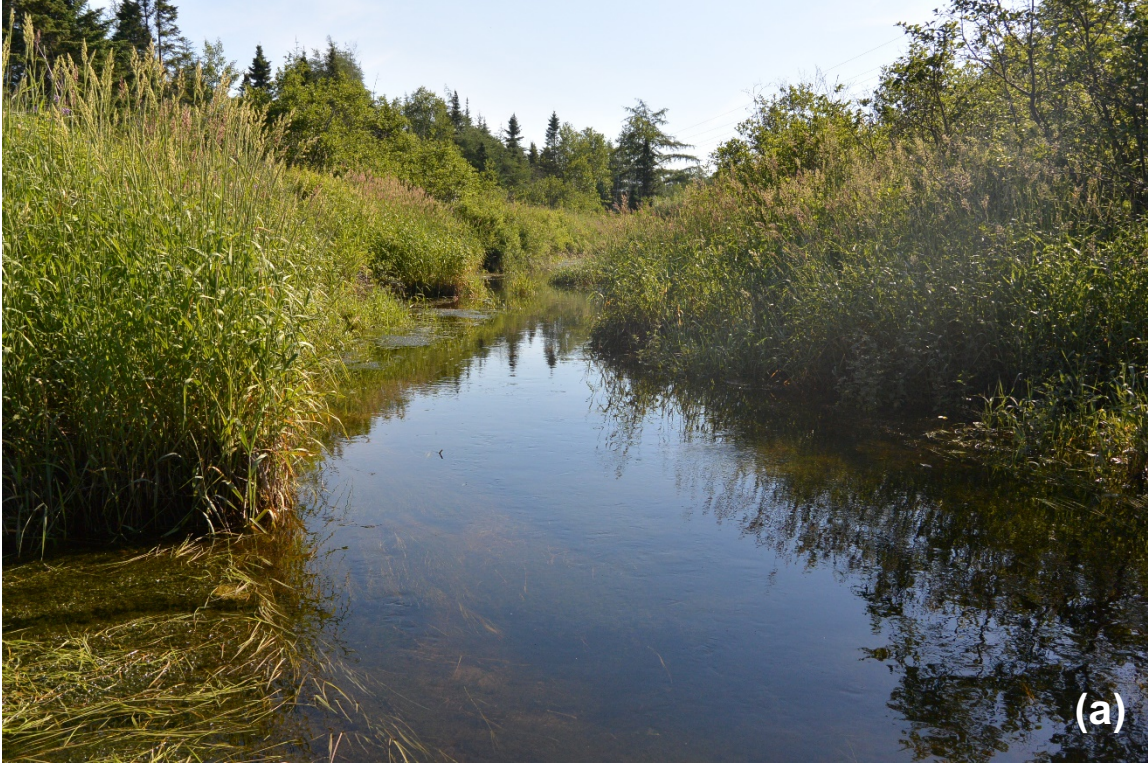
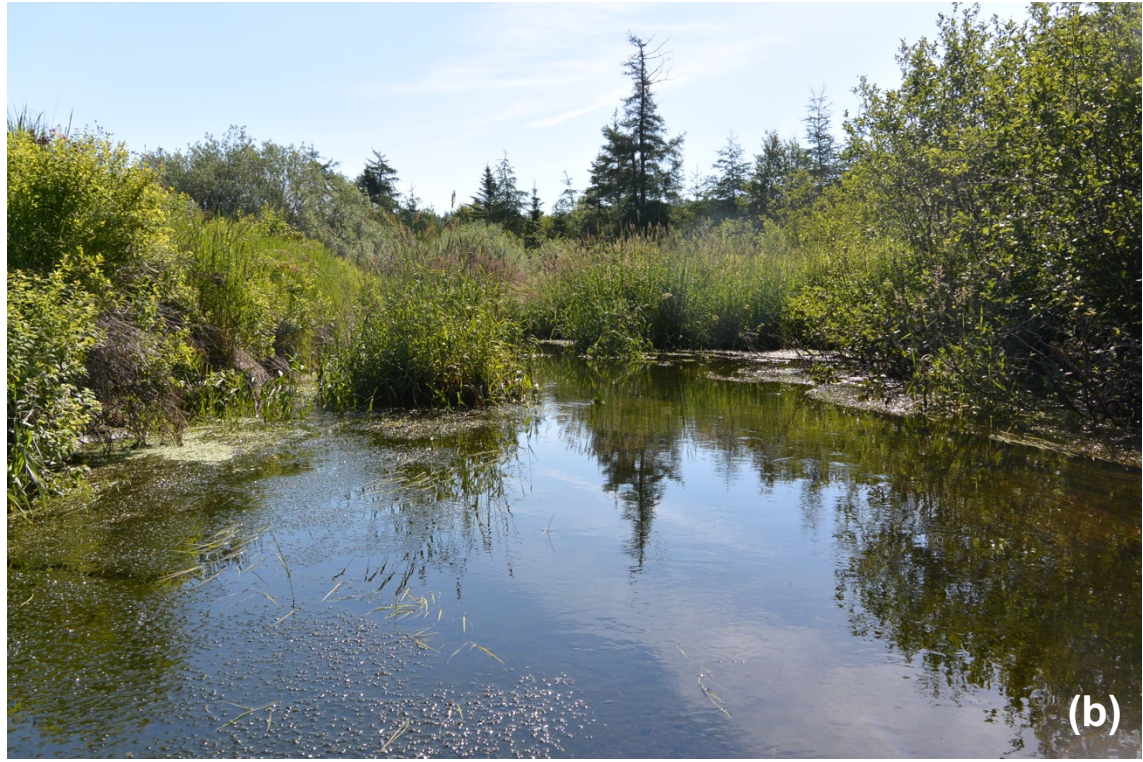
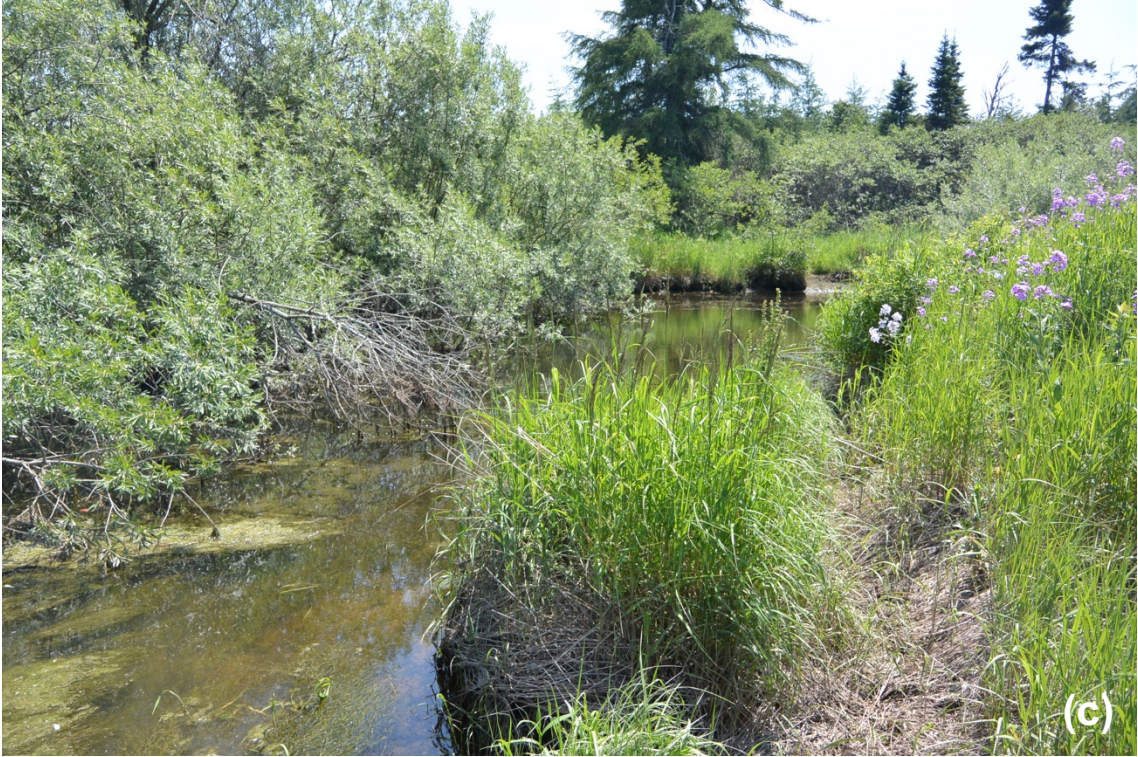
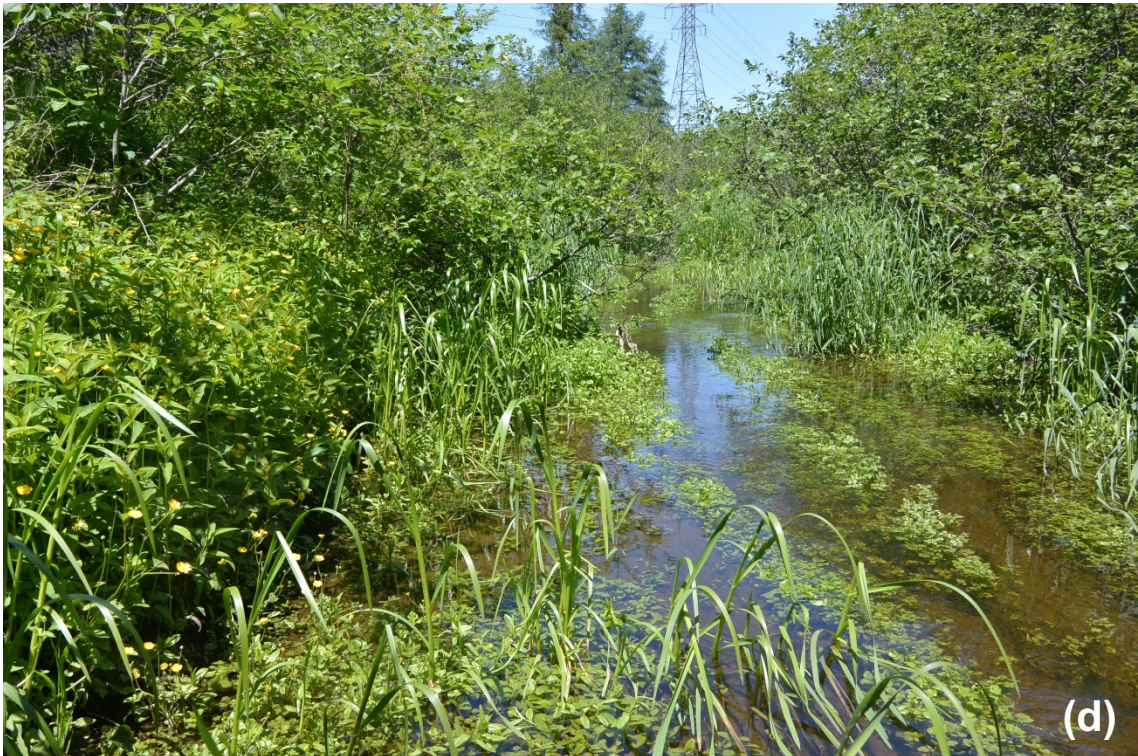
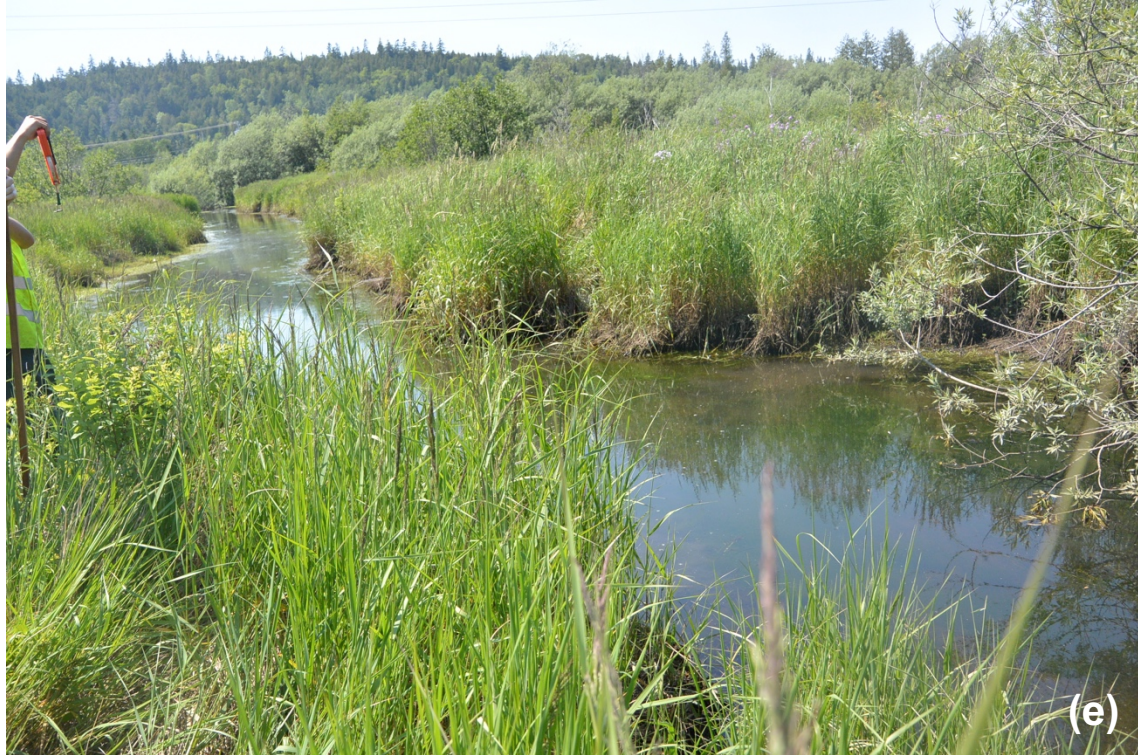
*Figure 1. Multiple images (a, b, c, d & e) of various sections along Little Marsh Creek that fall within the project area.*

A full habitat assessment was conducted between June 22, 2018 to July 12, 2018 within the proposed project area. The habitat surrounding the watershed in the project area showed little change along the 1390 metre stretch. The vegetation consisted of mostly tall grasses, alders and willow species (Appendix 2, Figure 1). Some areas along the watercourse were found to have fern species or coniferous trees along the bank. Stream cover was sparse in most areas, but when willow was abundant, sections of the stream were found to have good cover due to overhang. The stream was found to have a silty substrate throughout the project area, with the water depth ranging from 30 cm-110 cm. The stream width ranged between 4.5 m-12 m and had minimal channel flow.

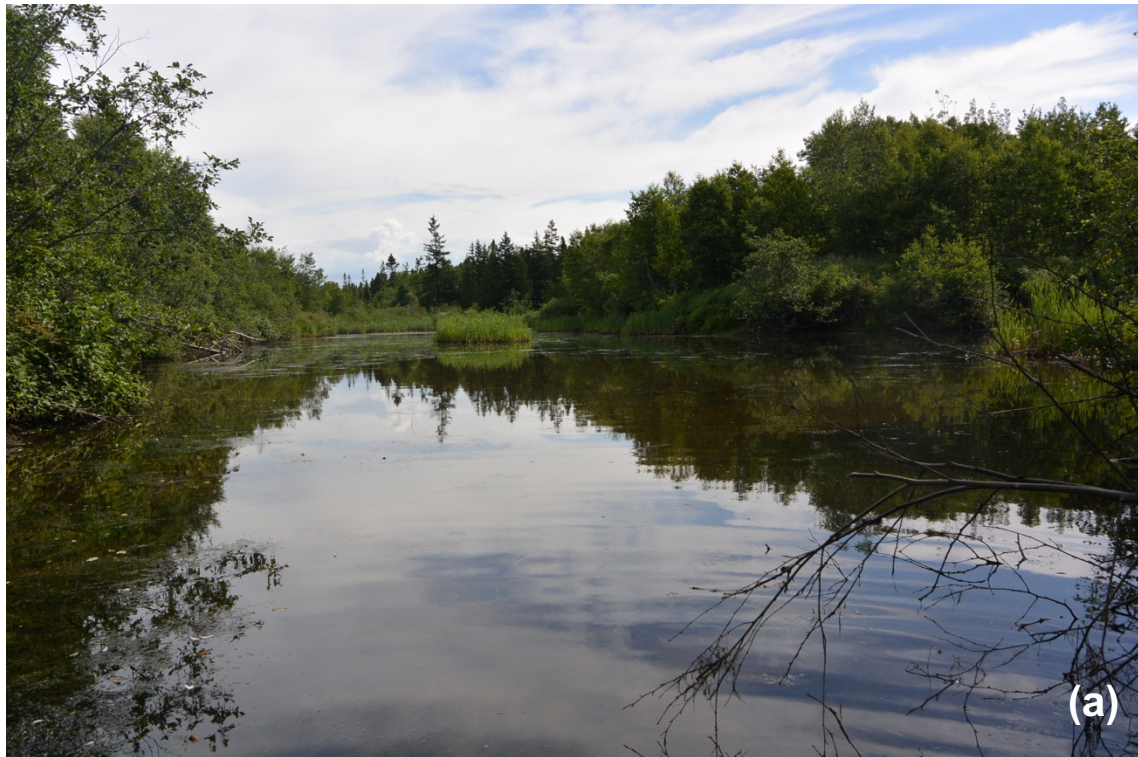
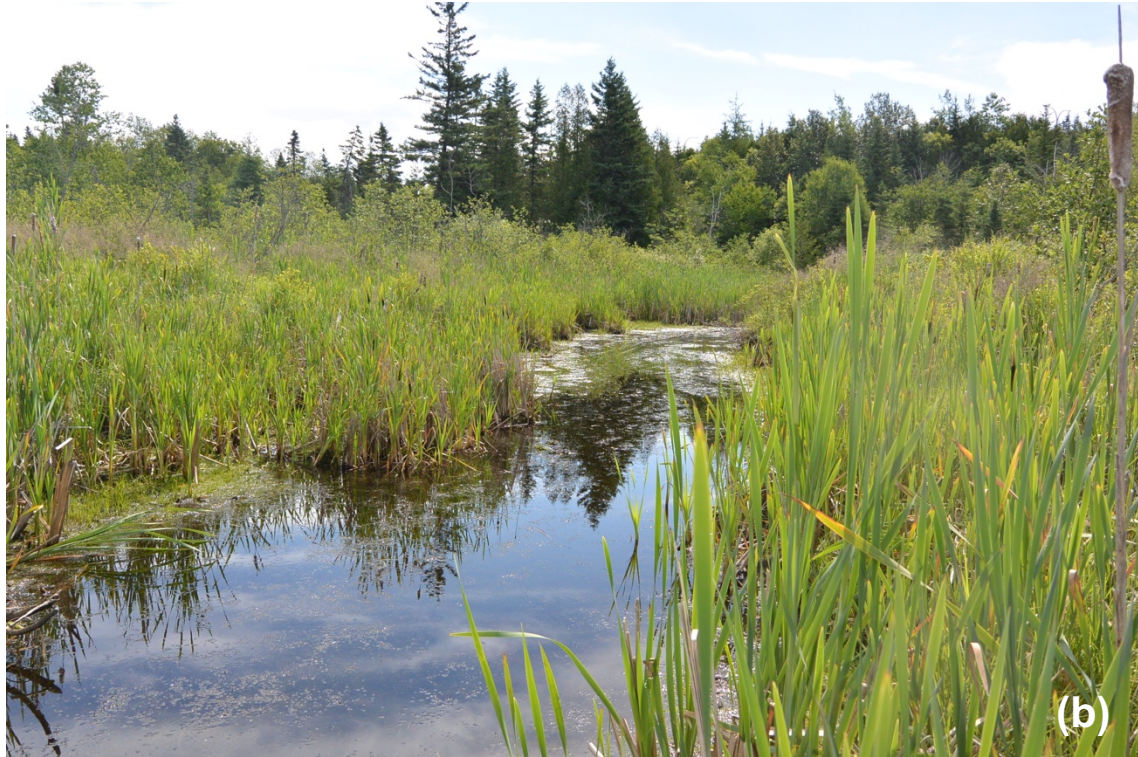
*Figure 2. (a) Retention pond found east of Little Marsh Creek that drains into the watershed, specifically into the project boundaries (45.32259, -66.03386). (b) Outlet to the retention pond, surrounded by cattails and tall grasses (45.32354, -66.03324).*

A retention pond (0.52 ha) can be found east of the watercourse (45.32259, -66.03386) with an outlet that feeds into Little Marsh Creek (45.32354, -66.03324) (Appendix 2, Figure 2). A mixed forest surrounds the pond with wetland grasses on either side of the outlet. Although fishing efforts were not conducted in the pond, fish were seen swimming during the habitat assessment.

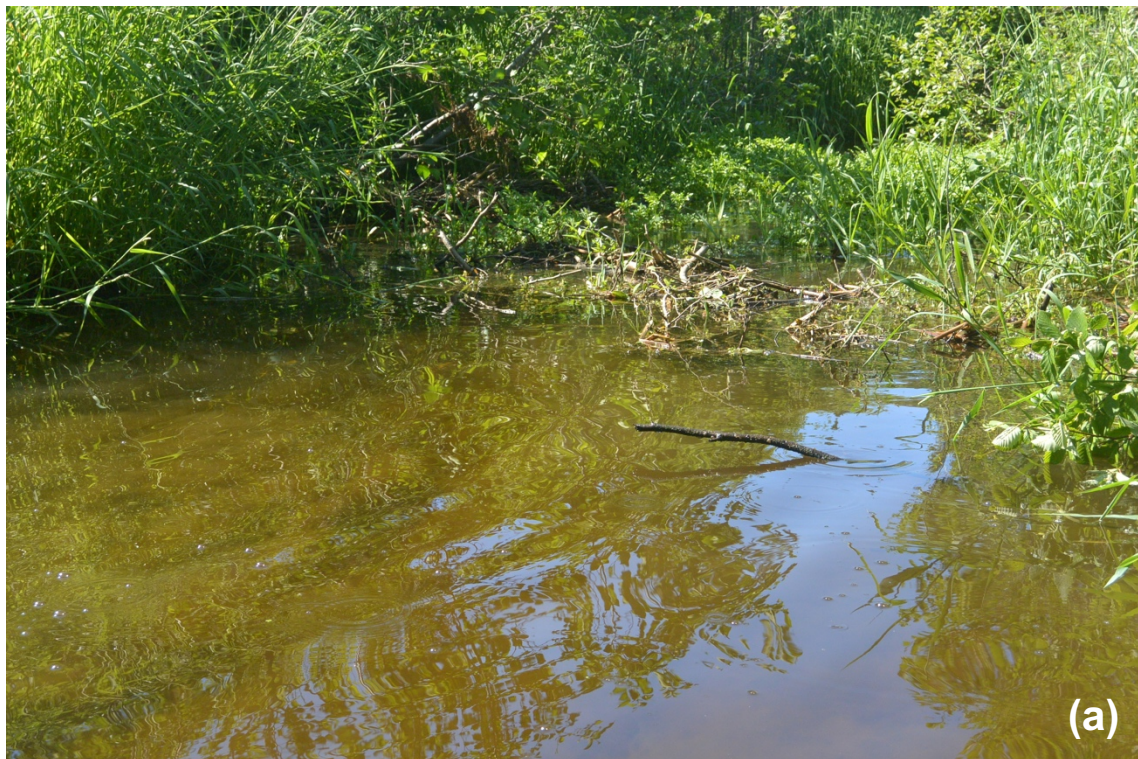
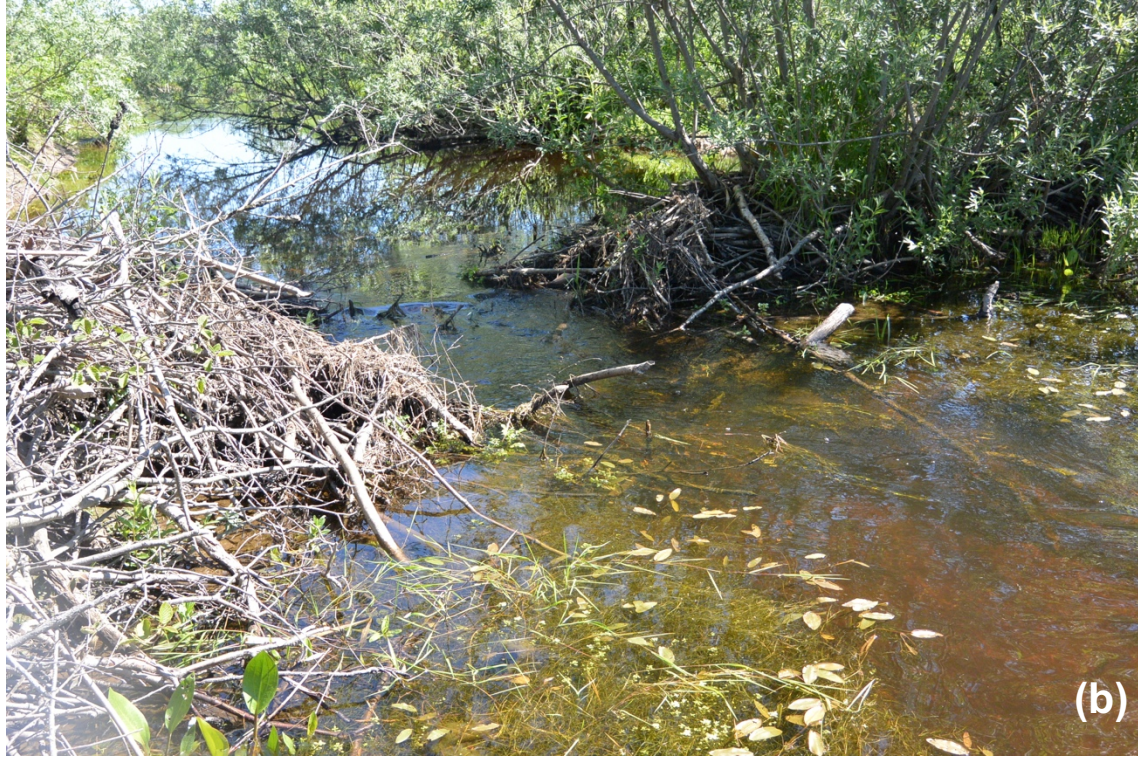
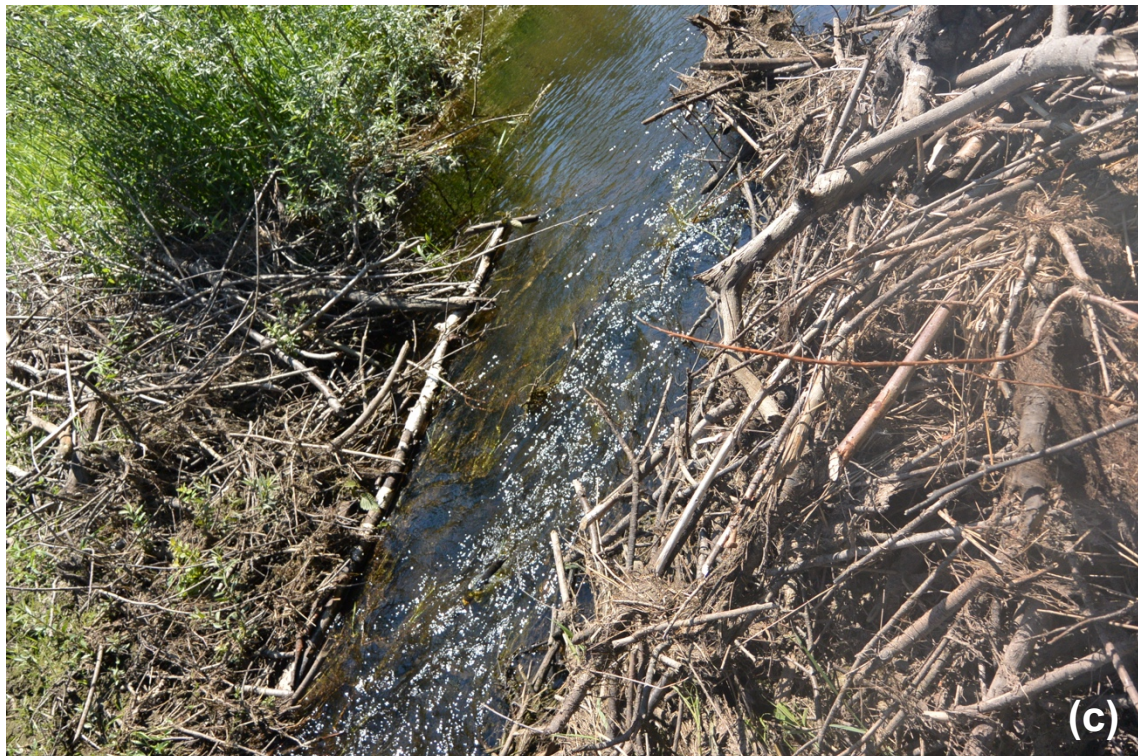
*Figure 3. Beaver dams found along Little Marsh Creek that have been damaged to allow for natural stream flow. (a) 45.322291, -66.035046 (b) 45.32383, -66.03473 (c) 45.326126, -66.03102*

During the habitat assessment it was found that the project site contains natural barriers that once likely blocked fish passage. There were remnants of three beaver dams along the stream that have signs of human removal, likely to allow for water flow and some pooling can still be seen upstream and downstream of the dams (Appendix 2, Figure 3).

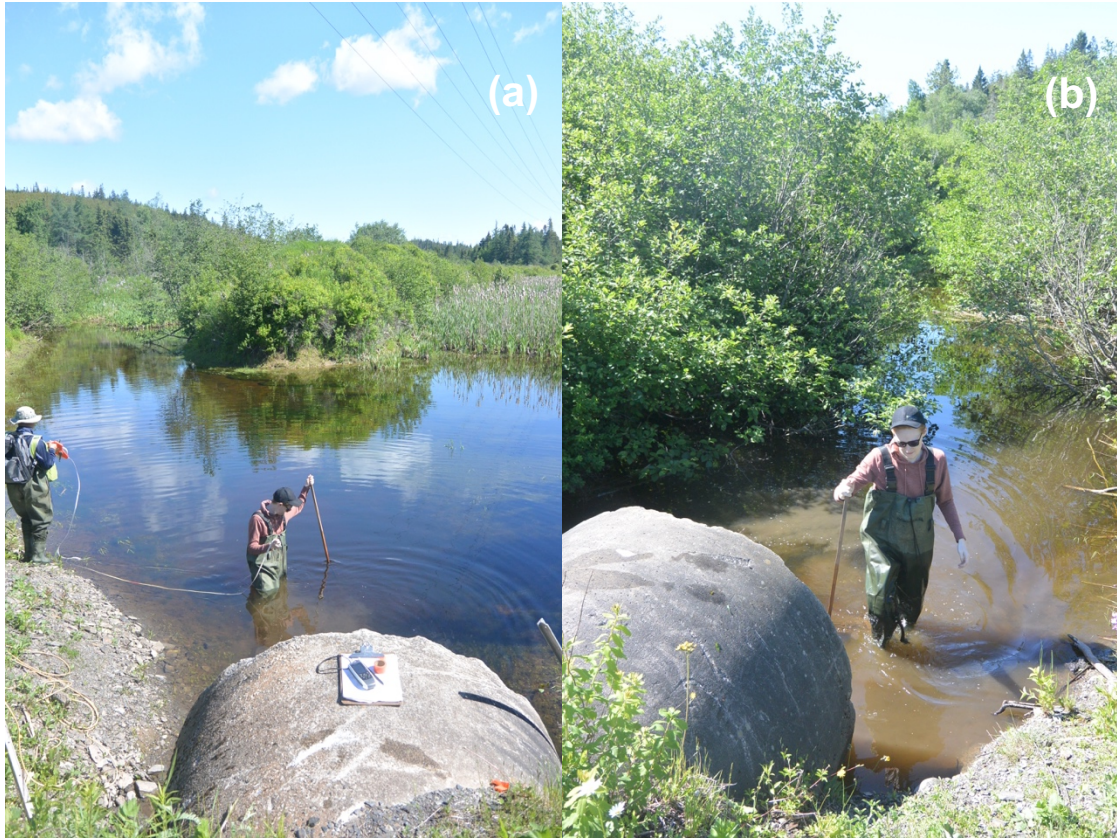
Figure 4. Large culvert found along Little Marsh Creek (45.32282, -66.03483). (a) Upstream of the culvert (b) Downstream of the culvert

A large culvert can be found within the project site and can be accessed easily from Ashburn Road (45.32282, -66.03483) (Appendix 2, Figure 4). However, there seems to be no evidence that this culvert is causing any barriers to fish passage.

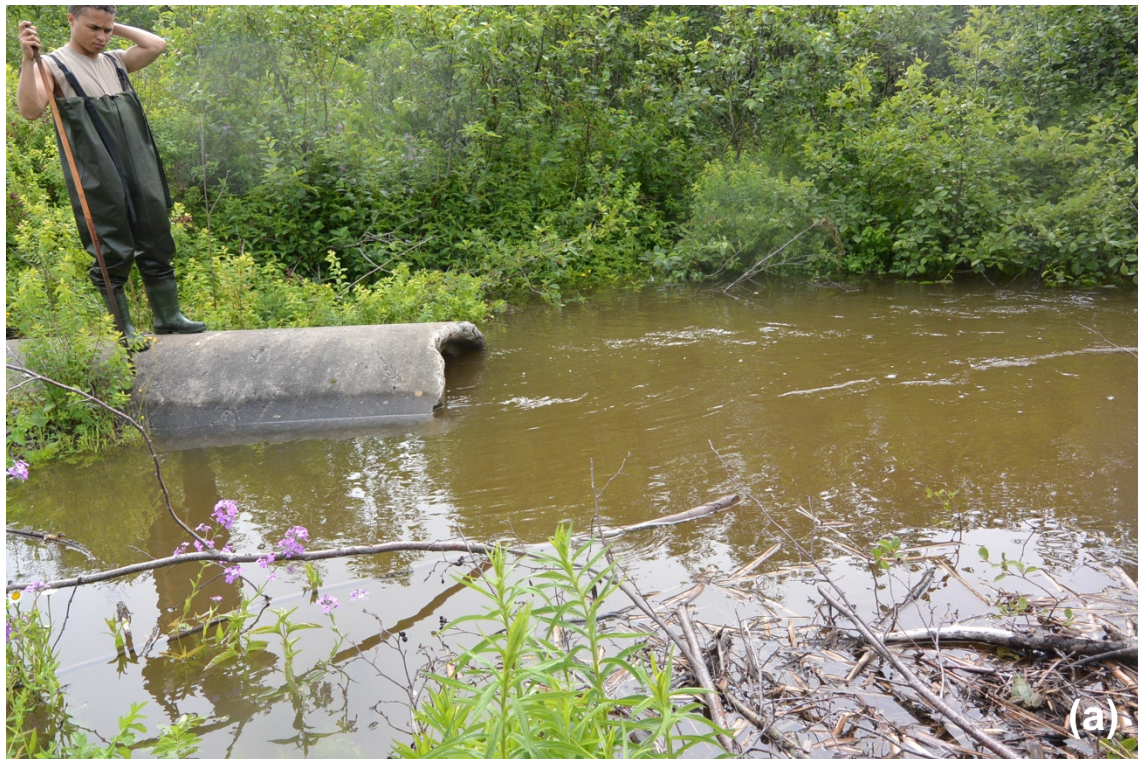
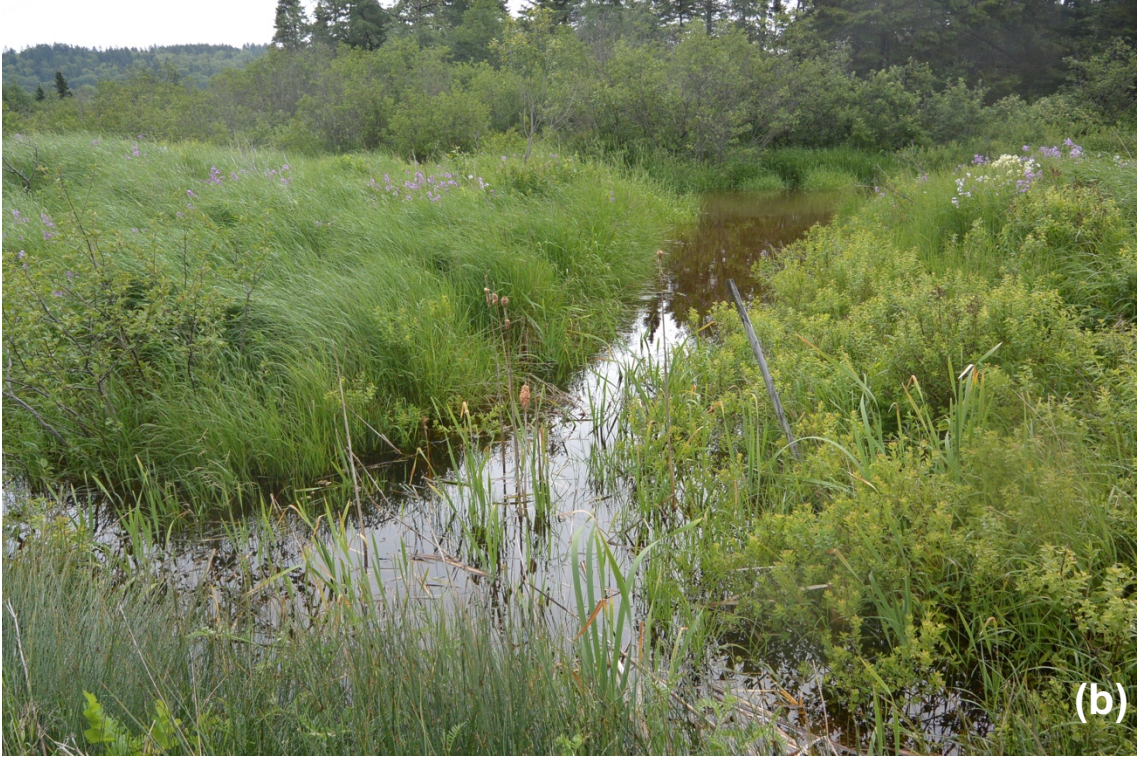
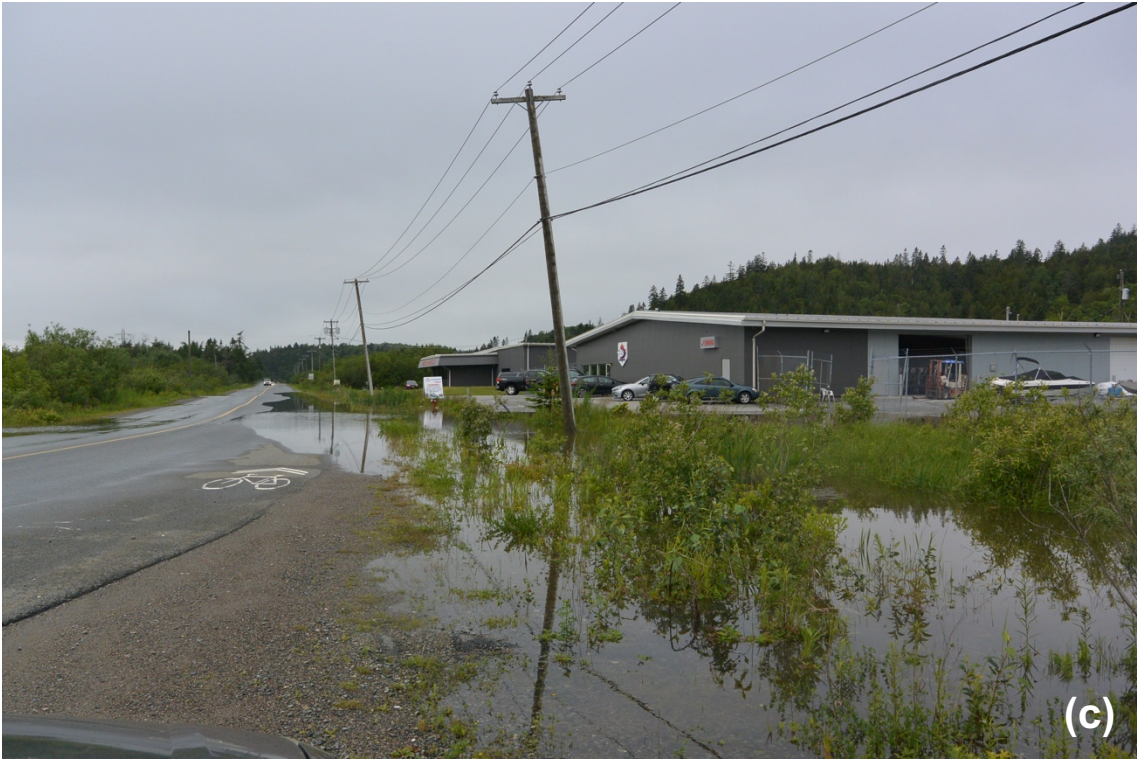
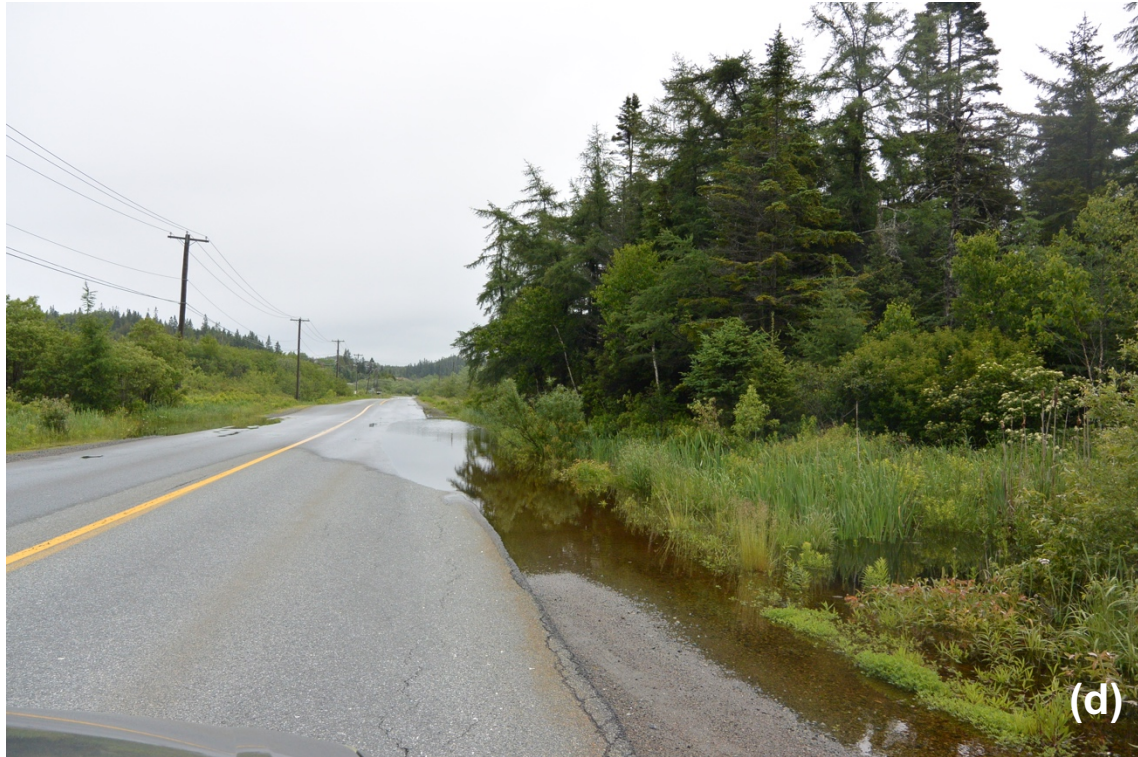
*Figure 5. Aftermath of a major rainfall event on June 28, 2018 (65.5mm of rain) in Little Marsh Creek within the proposed project area. (a) Flooding near the culvert (45.32282, -66.03483). (b) Flooding along the stream near Ashburn Road (c&d) Flooding on Ashburn Road.*

On June 28, 2018 a major rainfall event (65.5mm of rain) was observed to have caused water levels in the project area to become very high and flood sections of Ashburn Road (Appendix 2, Figure 5). This demonstrated that there exists a high variability of flow and channel depth within the project site, suggesting that further assessments may be necessary during seasonal freshet events.
